BUILDING TYPOLOGIES AND FAILURE MODES OBSERVED IN THE 2015 GORKHA (NEPAL) EARTHQUAKE

**Dmytro Dizhur^{1,2}, Rajesh P. Dhakal³, Jitendra Bothara⁴ and
Jason M. Ingham⁵**

ABSTRACT

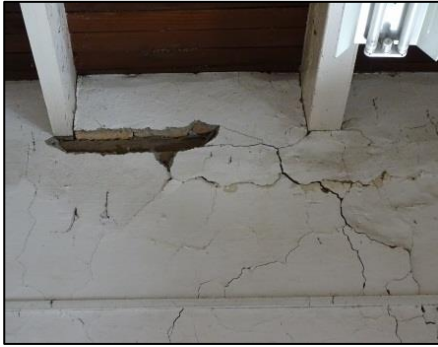
27°40'51.54"N 85°19'6.54"E

Movement of the floor diaphragm relative to the loadbearing URM walls was commonly observed in all types of URM buildings, and in some cases permanent movement of the floor joists relative to the adjacent wall of up to 100 mm was recorded, as shown Figure 23a. In some cases movement of the floor diaphragm led to full collapse of the heavy brick and mud floor topping, as shown in Figure 23b. Dislodged heavy roof tiles (see Figure 23c) were commonly observed, and on close inspection these roof tiles were usually not secured to the supporting timber framing below.

(a) Pull out of the timber joints supporting floor diaphragm

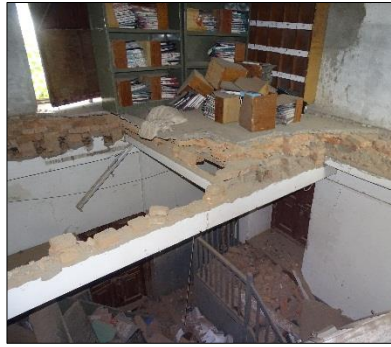
27°40'47.88N 85°18'49.41E

(b) Floor collapse, also showing bricks and packed mud overlying floor joists

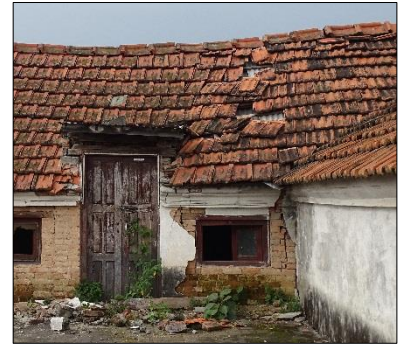
27°40'47.88N 85°18'49.41E

(c) Dislodged heavy roof tiles

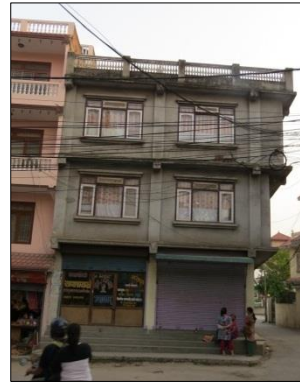
(a) Cantilever/overhanging floor levels resulting in severe elevation irregularity

Figure 36: Common adverse irregularity features of RCFMI buildings in the Kathmandu Valley.

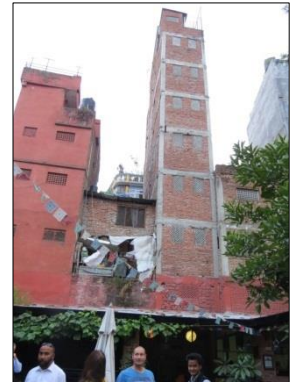
(b) Slender building with split levels and no seismic separation gaps between buildings

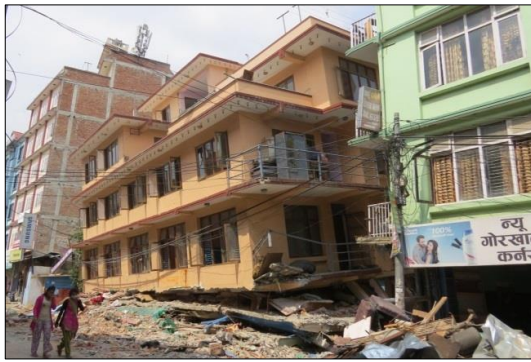
A major problem with current Nepalese RCFMI buildings is the formation of a soft storey mechanism, particularly at (but not limited to) the ground storey. Typically the ground floor of such buildings functions as an open shop-front or similar, in order to satisfy the functional requirements of street-front or ground-level uses (without masonry infills), thereby reducing the stiffness and capacity when compared to the portions of the building containing masonry infills.

(a) Soft storey collapse example 1

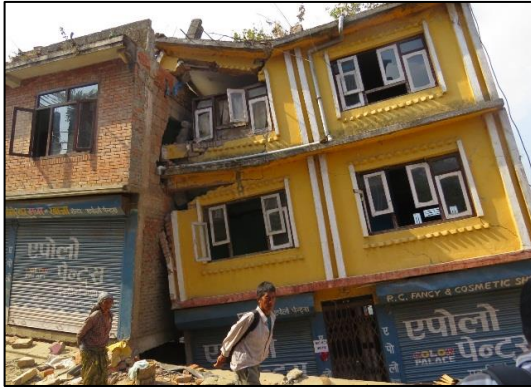
(b) Soft storey collapse example 2

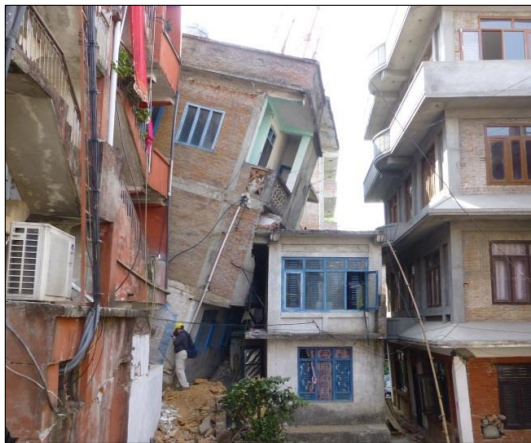
(c) Soft storey collapse example 3

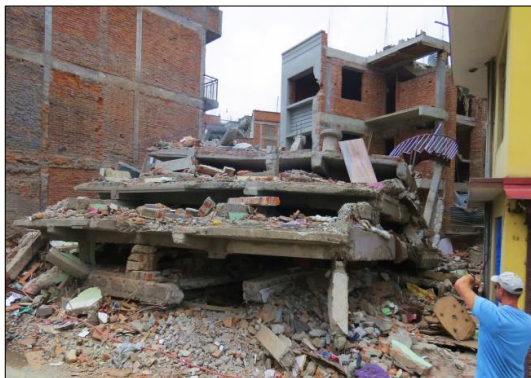
(d) Pancake collapse

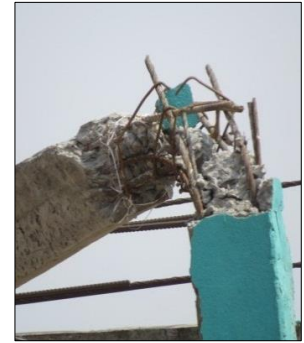
integral part of seismic construction. Some of the commonly encountered detailing problems are insufficiently large spacing of ties in columns and beams, inadequate anchorage of reinforcement, improper bending of hooks, insufficient reinforcement in the beam-column connections, insufficient concrete cover, and improper splicing of reinforcement. Poor construction quality was widely observed during the post-earthquake inspections, with some commonly encountered examples provided in Figure 38.

(b) Insufficient lap splice length

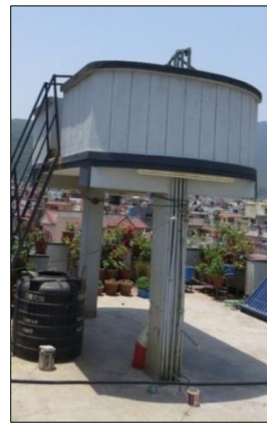
(a) Cantilevered RC support platform

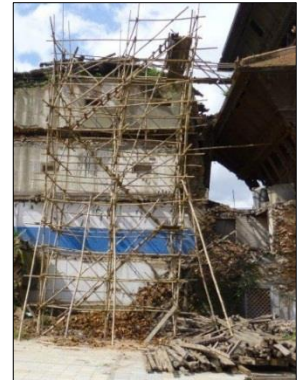
(b) Example of shoring using bamboo members

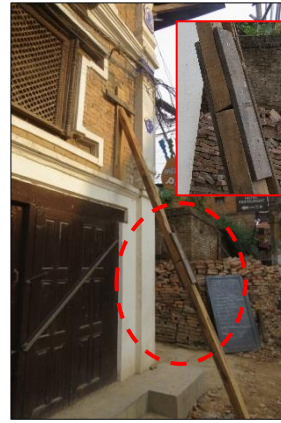
(a) Example of a splice detail with three nails per side in a timber brace

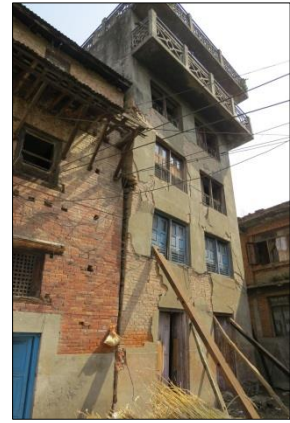
(b) Temporary propping of a near collapsing five storey residential URM building

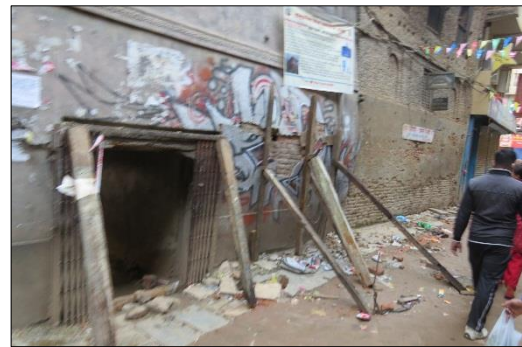
(c) Example of propping against extreme bulging of a five storey building
