## MASONRY PERFORMANCE IN EARTHQUAKES

O. A. Glogau\*

The original text of this paper was presented to the Structural Masonry Seminar, University of Canterbury, 3 to 5 September, 1974.

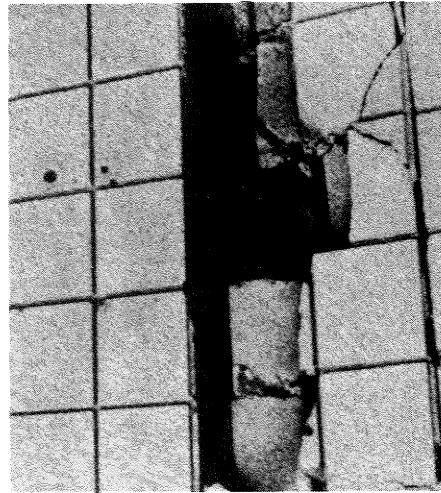
Fig 10 (6)

Fig. 14 also shows how reinforcement in the horizontal joint plane and near the surface is a contributing factor of early disintegration. The "open end bond beam" unit which is standard for all M.W.D. high lift grouting work has several features that reduce the potential for the type of failures seen in Figs. 10 to 14. The webs, lowered by 2½", allow placing horizontal reinforcement well below the level of the horizontal mortar joint plane. The open end of the units is not so much specified because of convenience in laying - in high lift construction the vertical reinforcement is generally introduced after laying of units - but because it restricts vertical mortar beds to the surfaces of the walls and ensures that grout is in contact with most of the web of adjacent units resulting in a more homogeneous wall.

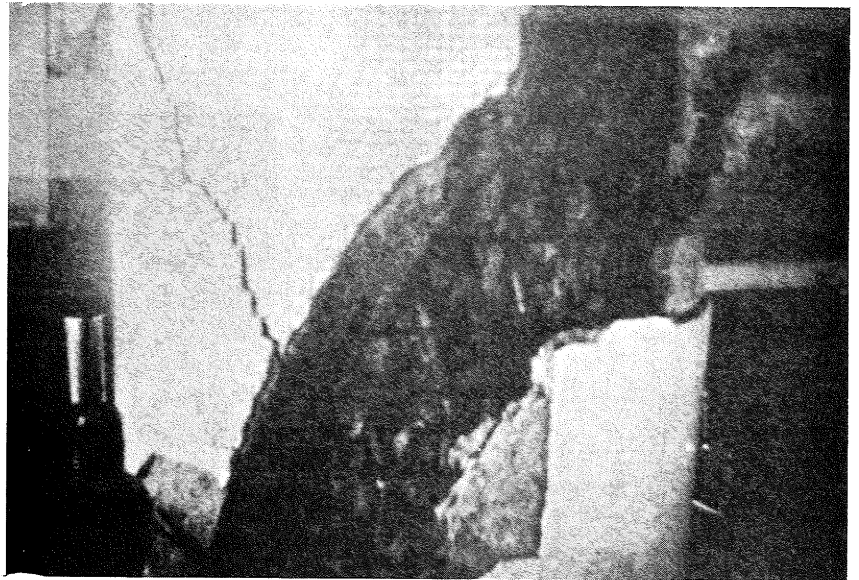
Fig 17 (4)

- (a) Formation of accidental column hinge mechanism. Figs. 15 to 17 show how very weak hollow masonry partitions in the upper stories of the Macuto Sheraton resulted in lower storey column hinge mechanisms aggravated by high axial loads.
- (b) Attracting shear to parts of the structure not designed for it and resulting in column failures. Fig. 18 shows how the infilling panels at the ends of a building

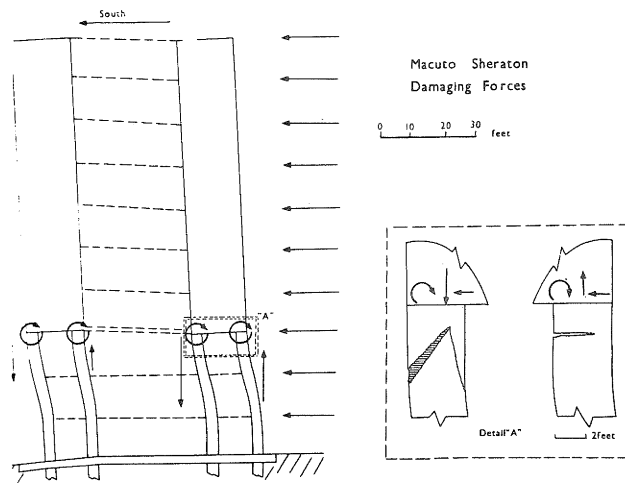
Macuto Sheraton, transverse section showing the column loadings that caused damage during the severe lurch towards the south.

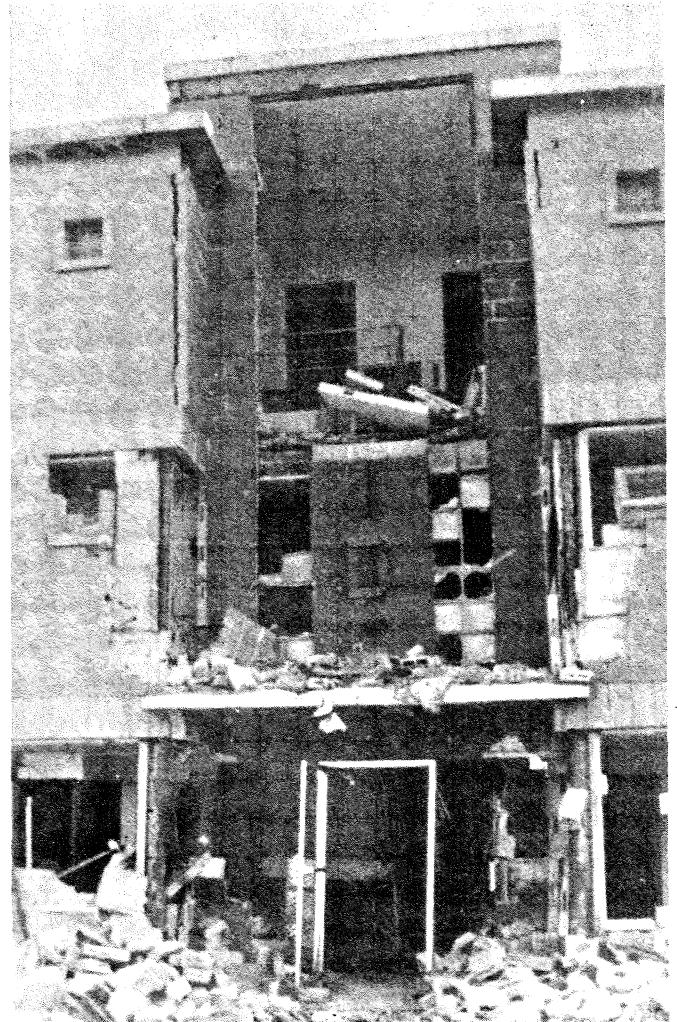
Fig 19 Hillside Manor Apartments. (5i)

(c) Becoming a danger to occupants in and around the buildings due to failure of the panels themselves. Fig. 19 is from Anchorage. The definition of "means of egress" does not include the words "from this world"! Falling masonry was also a hazard widely experienced in Caracas (4). Also see Fig. 23 (Managua Earthquake). If infilling panels are not to become just inadequate shear walls they must be separated more than in a merely token manner. That this applies also to infilling walls in shear wall buildings becomes self evident from Figs. 20 and 21. The exterior panels in the R.C. shear wall Elmendorf Hospital did not know that they were to be non-structural! Note again the spalling of face shells.

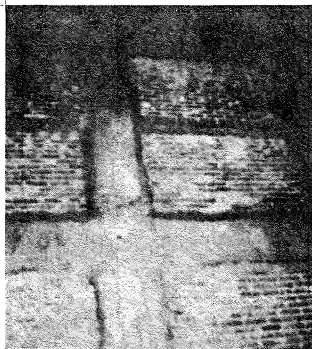
interior of masonry wall. Note tie member sub-dividing masonry infilled wall.

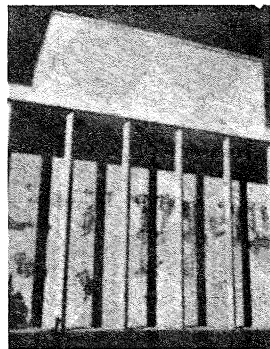
Spalled plaster off exterior of south wall.

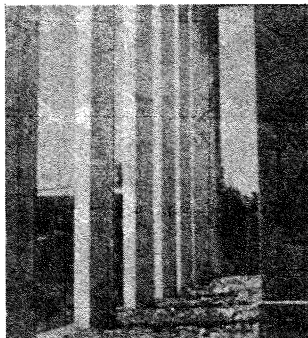
The marble veneer was not dislodged from the tall columns.

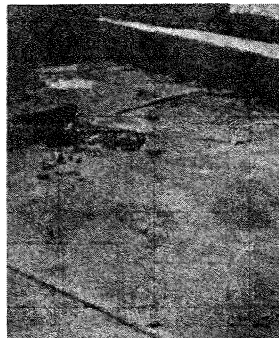
Slight ground settlement occurred around building.

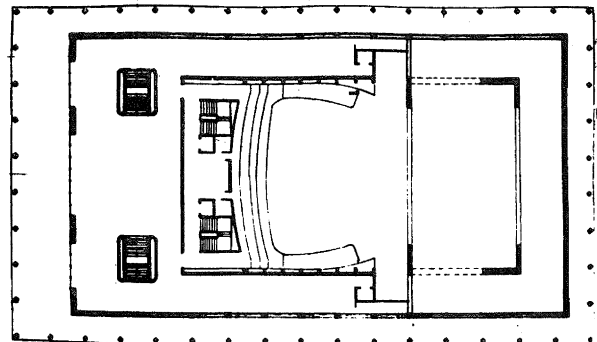
Fig 24 (2ii) National Theatre, Managua

An example of infilling panels that did not fail is shown in Figs. 24 and 25. The National Theatre was located on the south shore of Lake Managua in MM zone VII - VIII, north of the Palacio National. The surrounding concrete frames were very substantial and so was the thickness of the panels which was evidently sufficient to resist face loadings by arching and good tensile resistance.

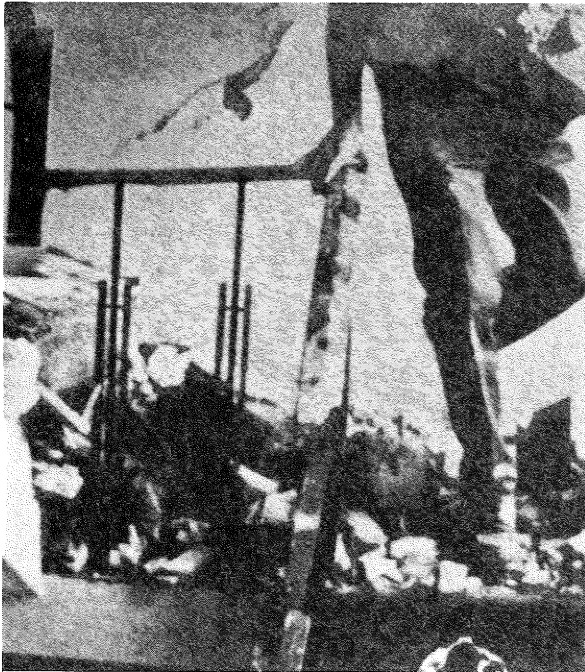
Fig 26 (2 iii)

Fig. 28 (Anchorage) shows that electric wiring is a "must" in buildings with 4" unreinforced partitions. Note remains of 4" partition overhanging doorway. Failure of the type shown in Fig. 29 was common and resulted in loss of life. Fig. 26 shows the danger of means of egress. Fig. 29 is proof that there is nothing peculiar about overseas earthquakes. The failure occurred in 1972, Te Aroha, New Zealand.

-Stairs Littered with Debris, Banco Central.

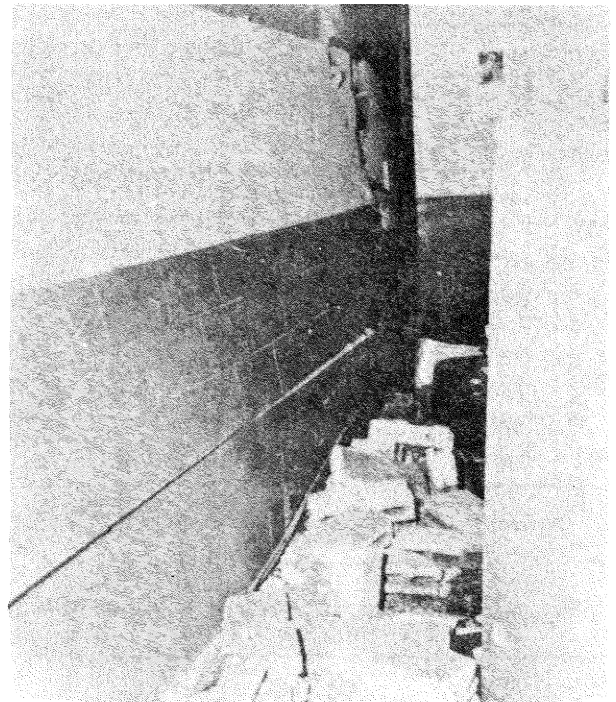
Fig 27 (5i)

-Failed hollow concrete block partition in a barracks building. Elmendorf Air Force Base. U. S. Air Force photograph.

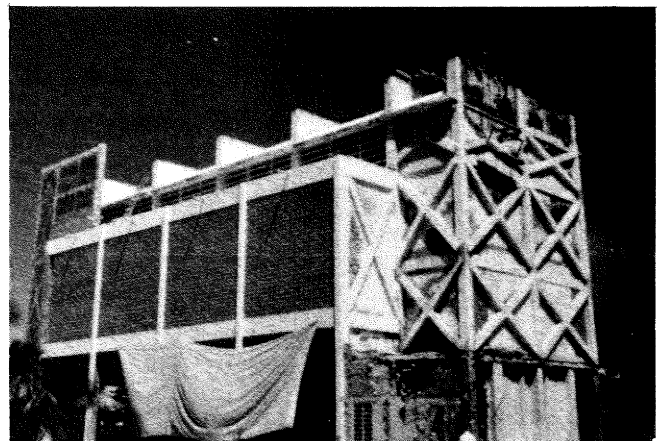
Decorative screen walls in multi-storey buildings failed extensively during the 1962 Acapulco earthquake, Fig. 37 (17).

Decorative masonry screen walls failed extensively during the 1962 Acapulco Earthquake (17)

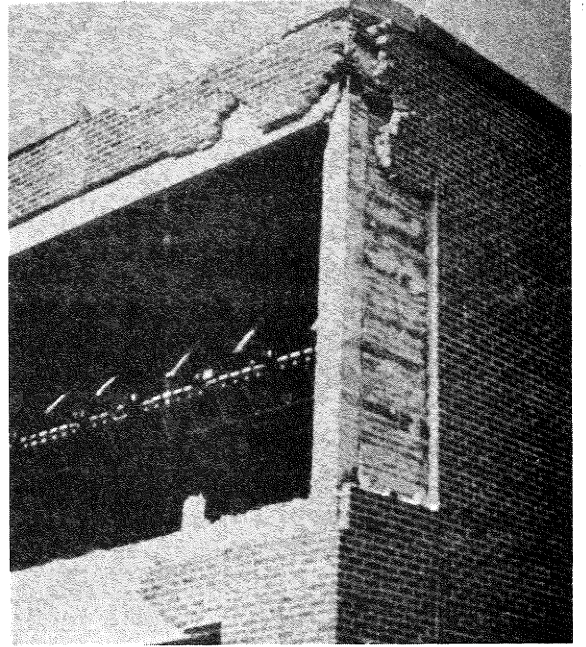
Fig 39 (5i)

The most common form of masonry veneers in N.Z. is of the tied variety. Tied veneers can fail due to a number of causes including lack of adequate ties (Fig. 38, 1935 Montana). Poor performance has, however, also occurred where apparently substantial quantities of ties were used. Fig. 39 (Anchorage), Fig. 40, shows a veneer on timber failure from Inangahua, N.Z. 1968.
