## THE VERACRUZ EARTHQUAKE OF 28 AUGUST 1973

H. M. Irvine\*

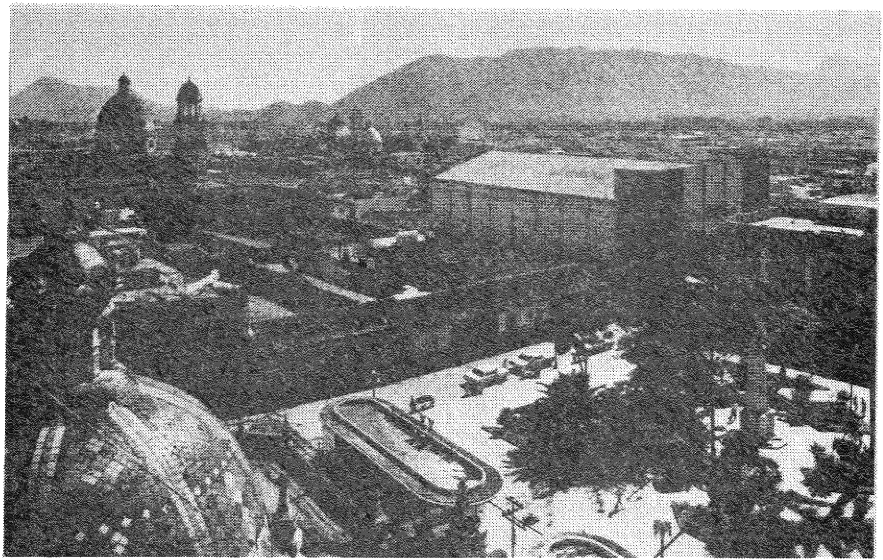
There was quite extensive damage to a variety of buildings in Orizaba (110,000 pop.). Many houses collapsed but, since these failures were, in general, similar to those mentioned earlier, they will be passed over in order to concentrate on descriptions of larger, more modern buildings which often fared badly in the earthquake. Figure 4 shows a general view of Orizaba taken before the earthquake.

FIGURE 4: VIEW OF ORIZABA TAKEN BEFORE THE EARTHQUAKE.  
NUMEROUS OLD CHURCHES IN THE AREA WERE BADLY HIT  
BY THE EARTHQUAKE.
