DAMAGE TO FREEWAY STRUCTURES IN THE SAN FERNANDO EARTHQUAKE

J. H. Wood* and P. C. Jennings**

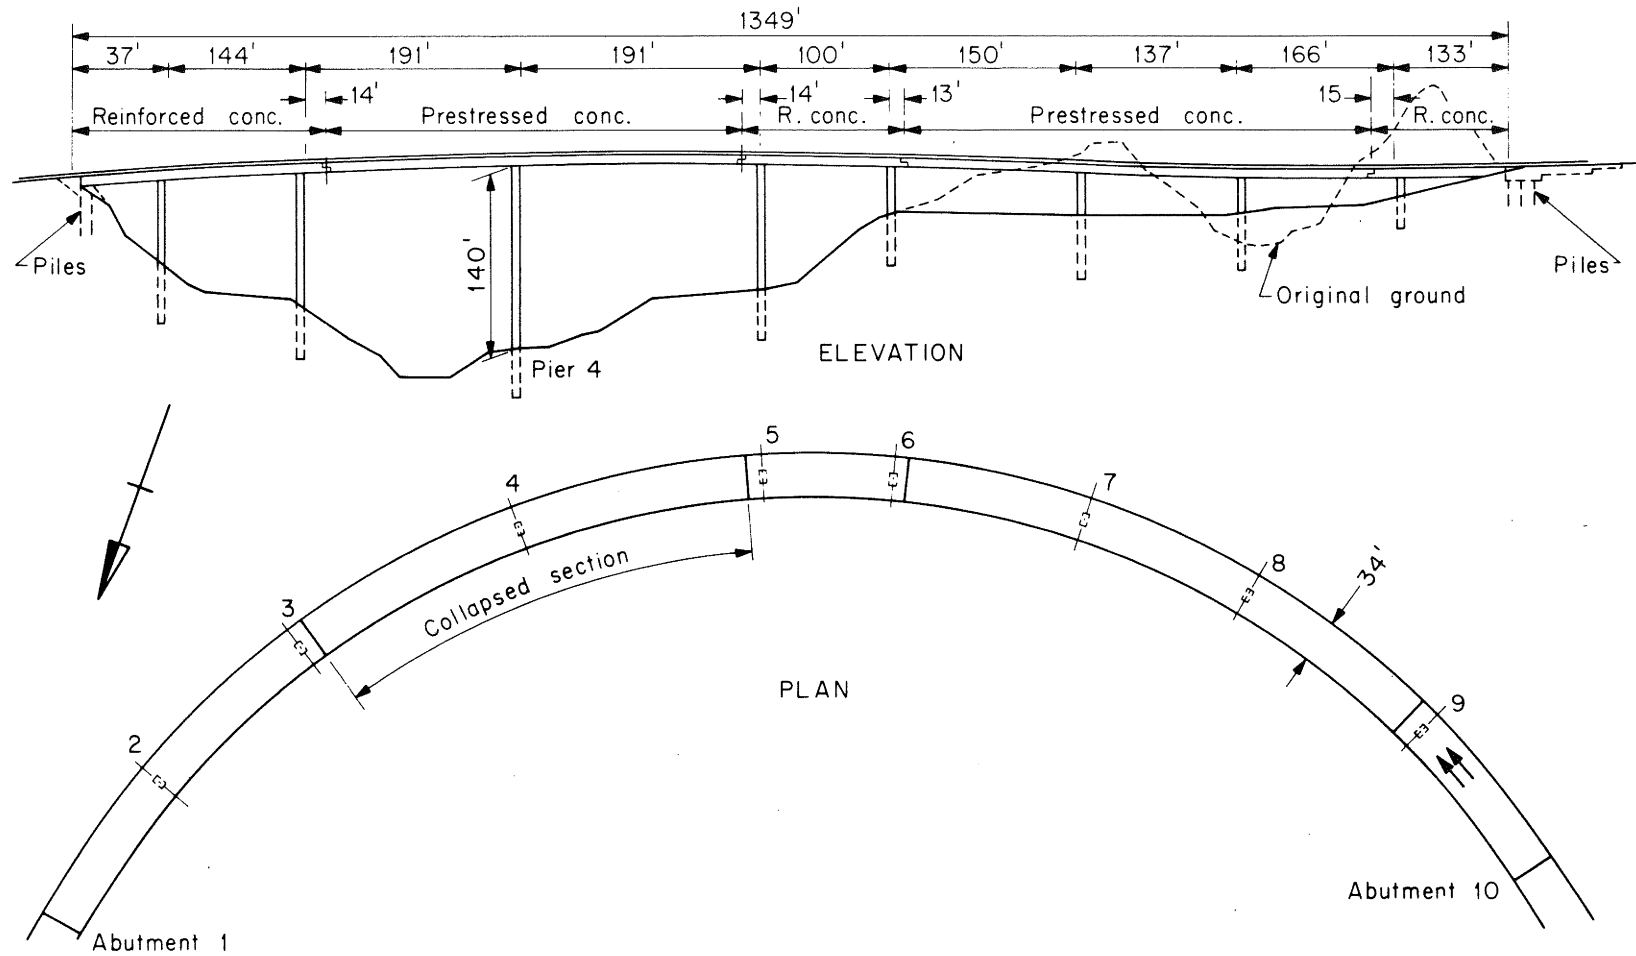
Fig. 3

SOUTH CONNECTOR OVERCROSSING

GOLDEN STATE - ANTELOPE VALLEY FREEWAY INTERCHANGE

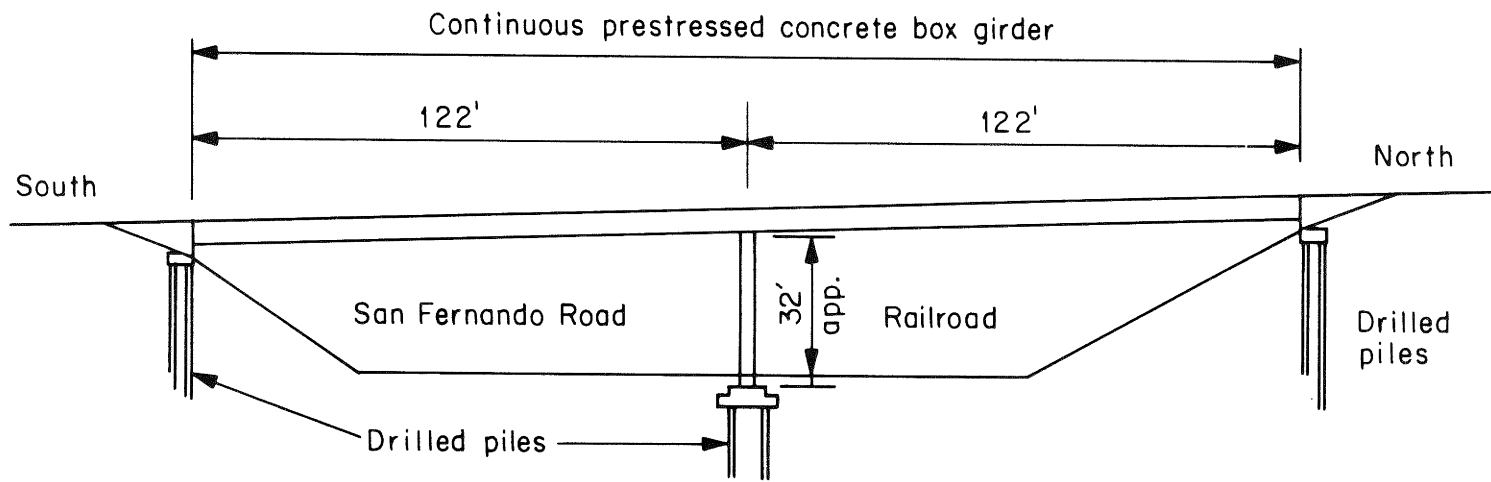
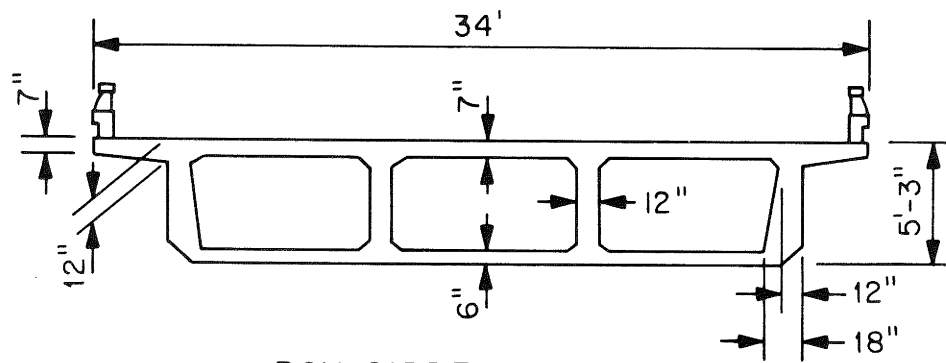
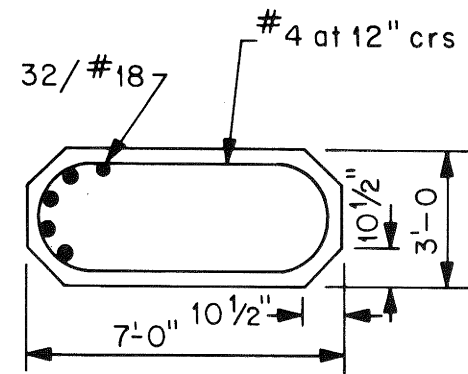
SAN FERNANDO ROAD OVERHEAD (TRANSITION)

This two-span, continuous, prestressed concrete box bridge carries two lanes of northbound Golden State freeway traffic to the eastbound Foothill freeway and crosses both the railroad and San Fernando Road. Dimensions and details of the 240 ft long bridge are given in Fig. 18 and the structure can be seen in aerial view Fig. 12.

Severe damage occurred at the base of the central column (Fig. 12) but unfortunately the bridge was quickly demolished before an inspection could be made. Photographs that were unavailable for this report indicated that the failure in the column was basically from overstress in bending. The relative simplicity of this particular structure would make it suitable for a detailed analysis.

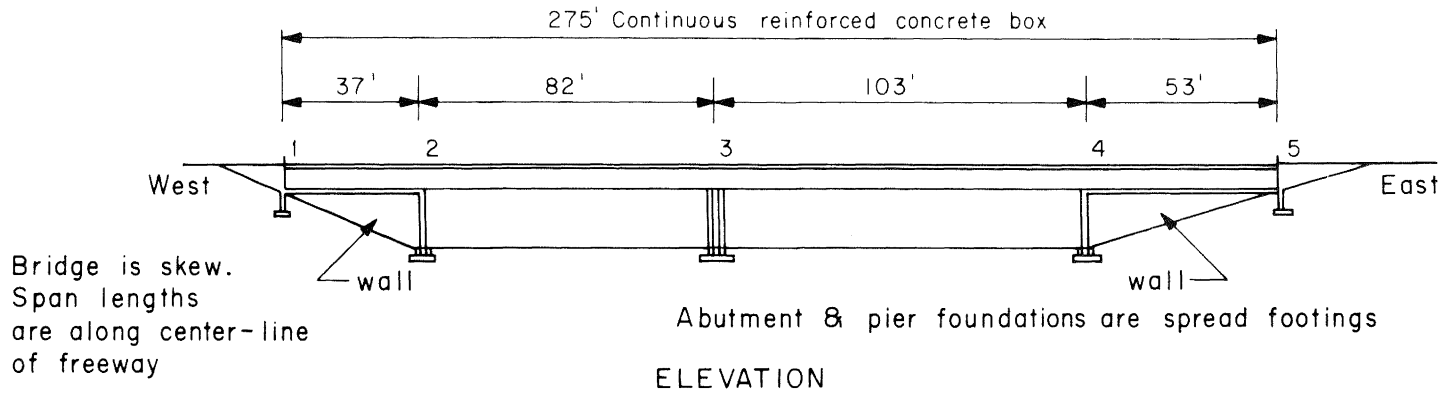
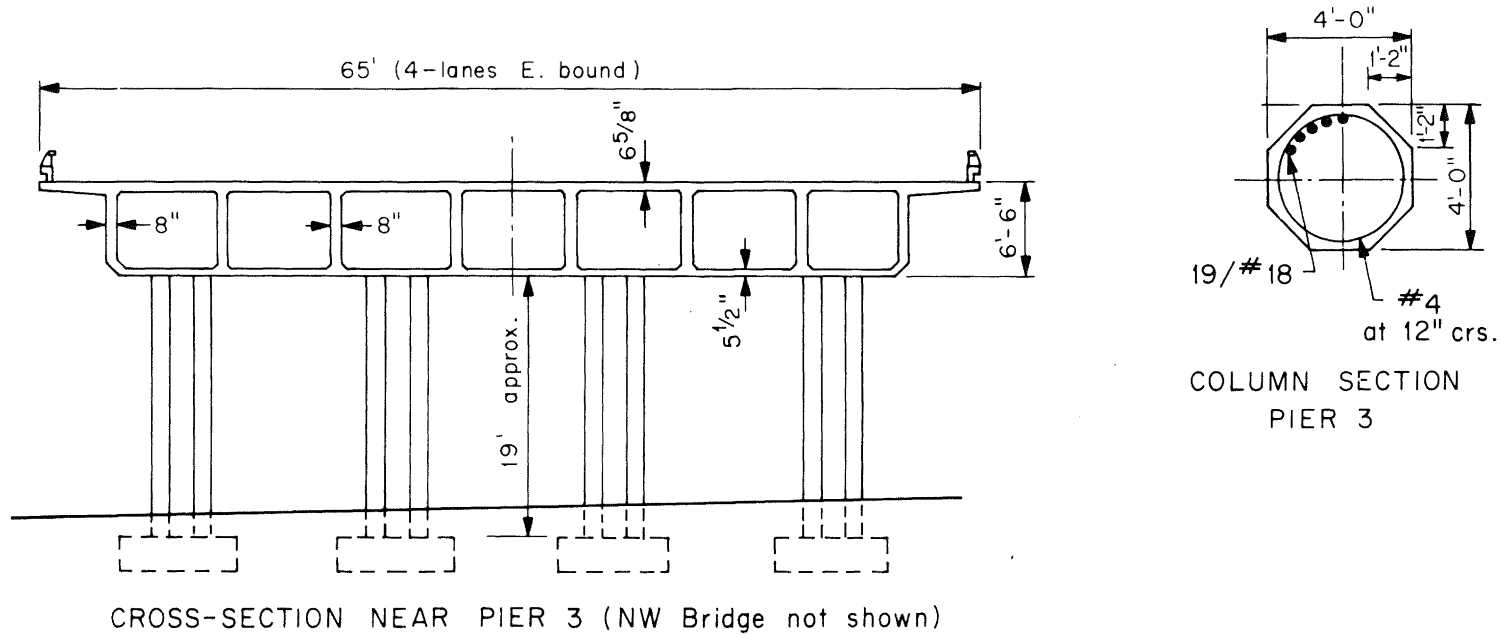
FOOTHILL BLVD. UNDERCROSSING - S.E. BRIDGE

eastern bridge are illustrated by the photographs Fig. 27 to Fig. 29. As seen in the figures, severe failures occurred in three of the four columns of the central pier. The central columns of the northwestern bridge appeared undamaged but fractures in the street concrete median strip indicated relatively large movements of the columns. Spalling occurred at the tops of two of the end span columns of the northwestern bridge and cracking occurred at the tops of some of the other end span columns. The end span columns are located between retaining walls which were structurally separated from the columns by a 1/2 in layer of soft material. Apparently the walls exerted a stiffening influence on the damaged columns under the northwestern bridge.

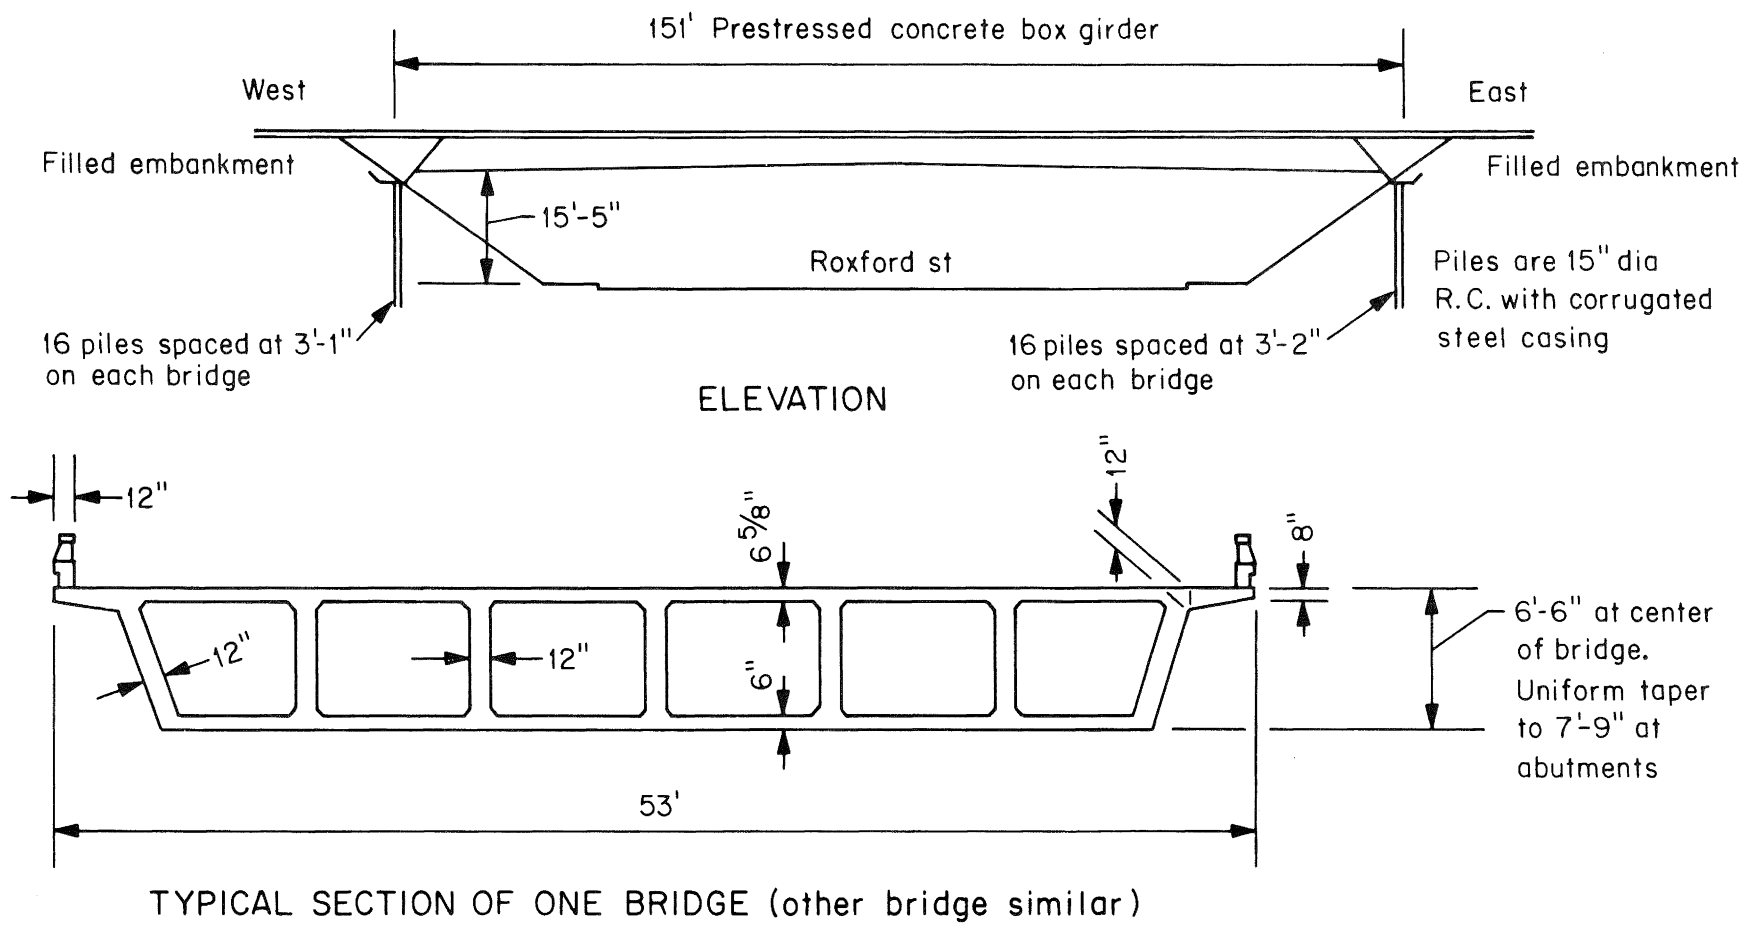
ROXFORD STREET UNDERCROSSING

Both bridges suffered lateral pile failures and the large displacements of the bridges caused extensive damage to the abutment wingwalls and approach pavement. Details of the damage and failures can be seen in Fig. 31 to Fig. 34. A 5 ft section of some of the piles was exposed for inspection and it appeared that the piles had hinged at the underside of the abutments and sheared through the soil. The eastern abutment of the southern bridge received a permanent transverse displacement of approximately 2 ft 6 in and the western abutment moved several inches in the same direction. The eastern abutment of the northern bridge displaced transversely approximately 1 ft but no significant permanent displacement occurred at the other abutment.
