THE 2014 SOUTH NAPA EARTHQUAKE AND ITS RELEVANCE FOR NEW ZEALAND

Bruce Galloway¹ and Jason M. Ingham²

ABSTRACT

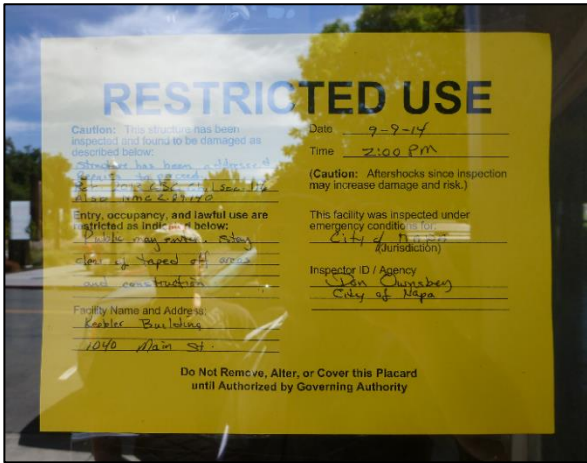
The yellow and red placards observed in the downtown area of Napa were often ambiguous with regards to the description of the form and location of damage observed. Figure 8(a) shows the yellow placard for a damaged building which indicates that the “Structure has been addressed. Repairs to proceed”, but does not describe what the damage is. The placard also indicates that “Public may enter. Stay clear of taped off areas”, without describing where these taped off areas are. Figure 8(b) shows a red placard for a badly damaged building (being worked on by contractors) which notes simply “Do not enter or approach”.

(a) Yellow placard

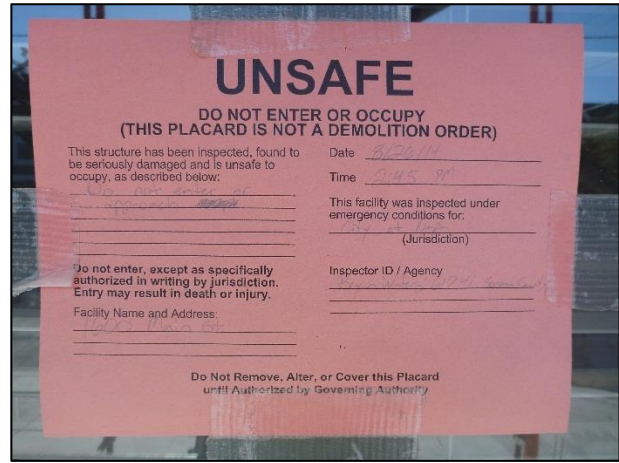
(b) Red placard

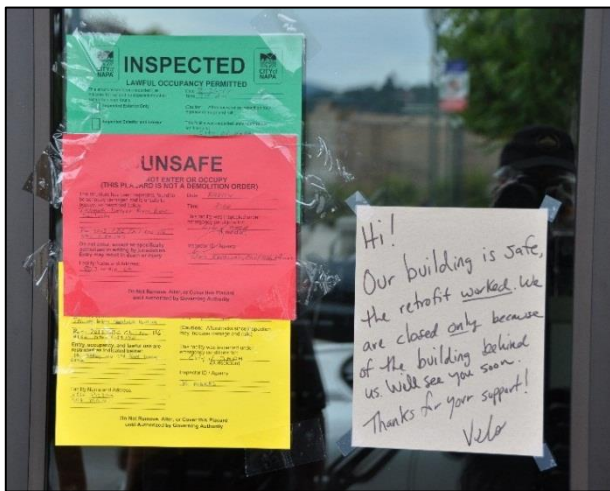
(a) Multiple placards (Source: Fred Turner)

Problem that had been encountered with placarding in conjunction with the Canterbury earthquakes were also encountered in Napa, such as placing different placards on different entrances to the same building, as well as not removing placards that had been superseded by a reassessment. Figure 9(a) shows multiple placards affixed to the door of a single building. While the placard status of a building may change over time, the current version of ATC-20 does not define a policy as to whether placards should be supplemented or replaced.

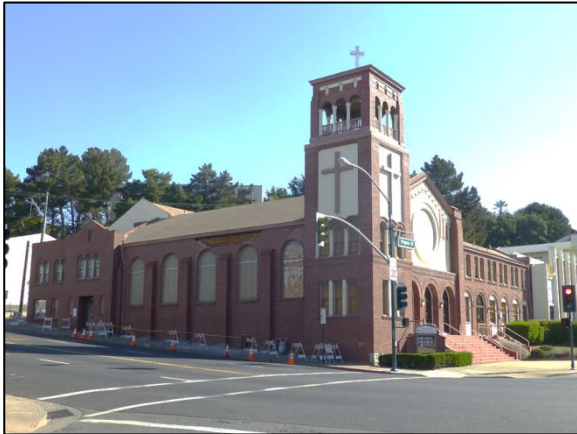
(a) Ineffective Barricading

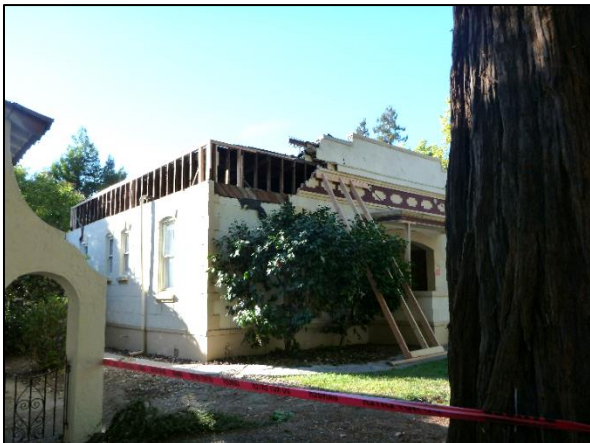
(a) Raking props

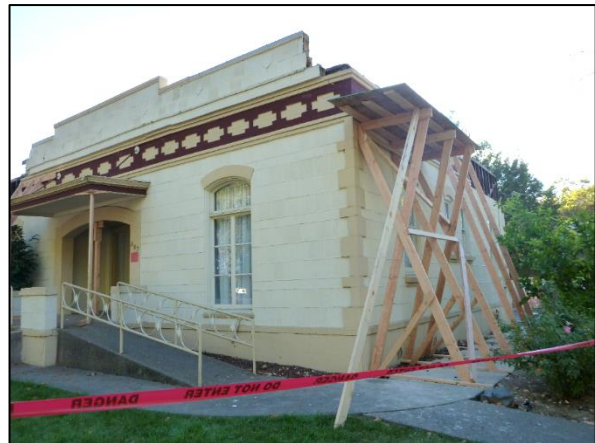
(b) Combination of props and fall protection

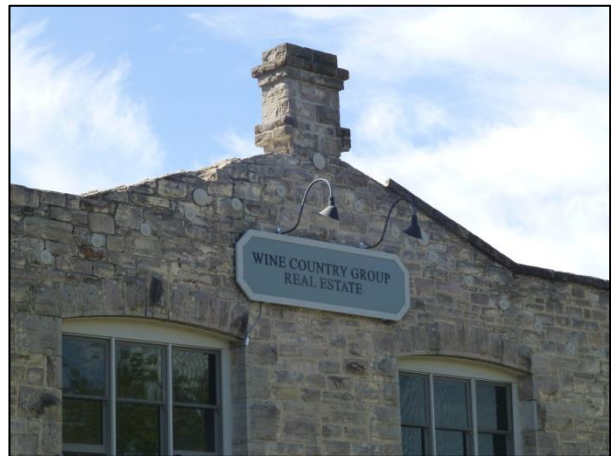
(d) Loss of capping stones to a stone masonry building in Napa

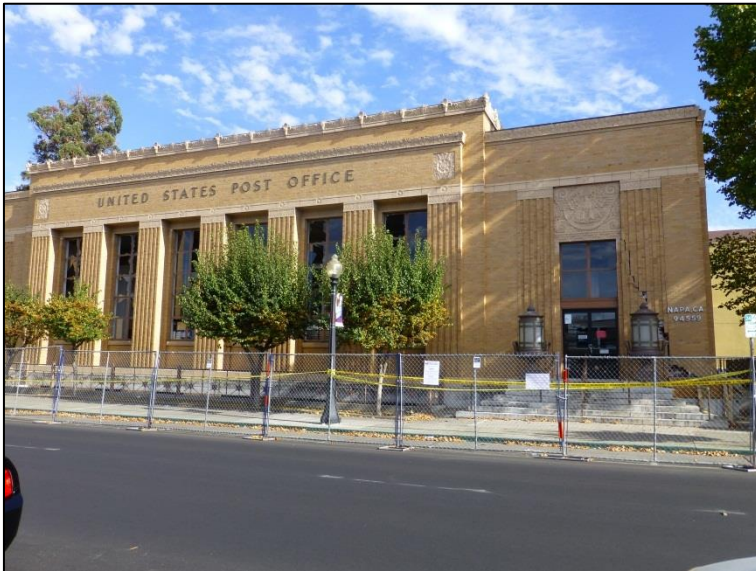
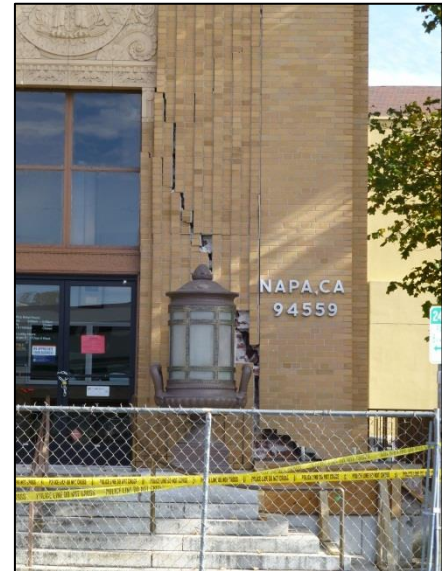
(a) Overall view

(b) Right pier

Figure 22: Prominent diagonal pier cracking in Napa Post Office.

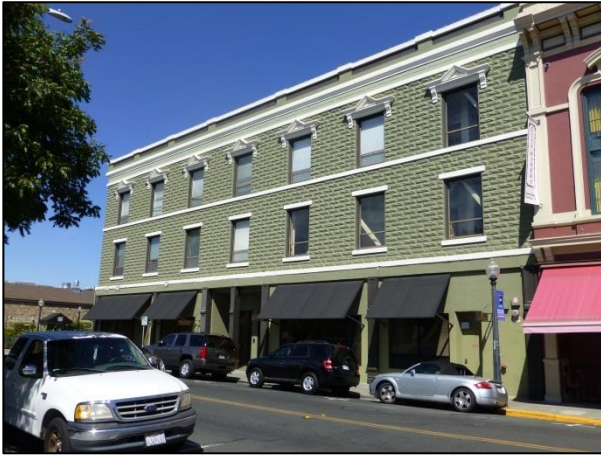
The Main Street Exchange building (also known as the Keebler building) located in Napa at 1040 Main Street is an historic URM building built in 1906. From the building's exterior, diagonal bracing could be seen in several windows (see Figure 24(a)) and there was evidence of deformation incompatibility, with visible tearing of surface linings around an exposed retrofit member (see Figure 24(b)). When entering the central atrium of the building a complex arrangement of 3-dimensional steel bracing was evident, comprised of Ordinary Concentrically Braced Frames (OCBF) using both tube steel and double-angle braces, hybrid steel moment frames that utilized deep trusses at the second floor to form the horizontal beam elements, and conventional steel moment frames at the upper levels, as partly shown in Figure 24(c). Similarly to the external observations, there was clear evidence that the steel framing had been subjected to significant deformations, with bolted connections showing plastic deformation and a number

(a) Street view of building, with diagonal bracing visible in some windows

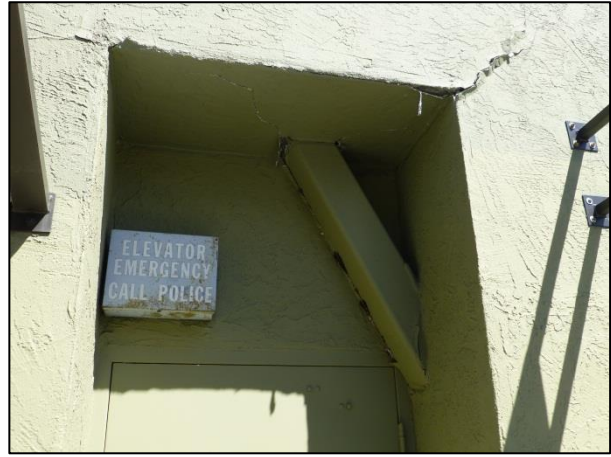
(b) Evidence of building deformation visible in recess on building exterior

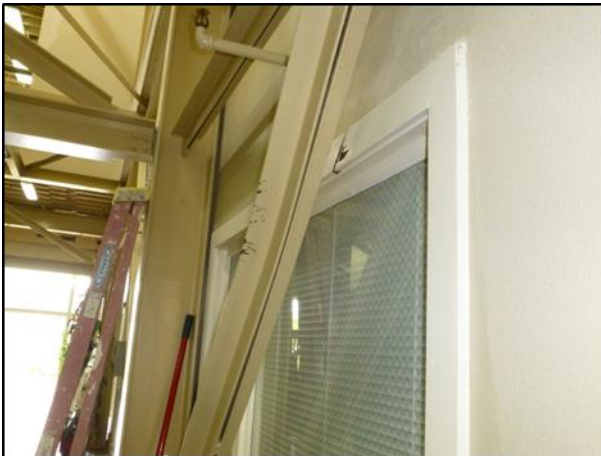
of diagonal bracing remaining in a plastically deformed shape, but also clear evidence that buckling had been in the order of 50 mm or more and restricted by contact with window framing (see Figure 24(d) and (e)). Comments were conveyed to the authors that the observed brace and gusset buckling are performance characteristics that would typically be expected of older retrofit systems, where capacity design principles were not explicitly considered, nor where ductility demands were likely to be concentrated if the frames were loaded inelastically [52]. Many of the connections between the steel framing and the internal face of the street-front wall showed significant distress (see Figure 24(f)) and it was concluded that whilst the retrofit had cleared aided in transmitting earthquake loads in a manner that enabled the building to be re-occupied after the earthquake, it was also clear that section sizes had been too small to provide adequate stiffness and ensure that excessive masonry deformations were avoided.

(e) Evidence that brace had buckled and come into contact with window frame

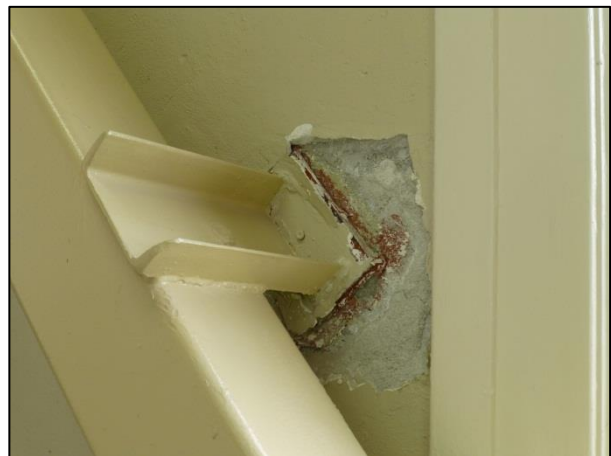
(f) Distress at connection between steel framing and URM exterior wall

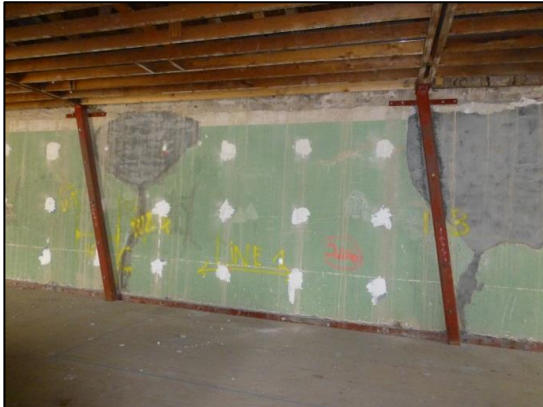
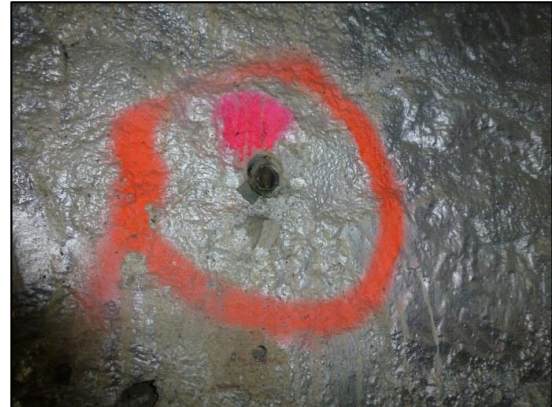
(a) Lay-out of through-wall anchors

(b) Close-up of through wall anchor

- Cross-wall securing of the multi-leaf stone masonry walls using $\frac{3}{4}$ inch (19 mm) epoxy grouted anchors at regular spacings (see Figure 25 (a) and (b)), finished flush with the interior surface and extending to 3 inches (76 mm) from the exterior wall surface
- Comprehensive securing of walls to diaphragms, including horizontally-oriented timber blocking to transfer loads into the diaphragm (see Figure 25(c))
- The addition of supplementary concrete walls to strengthen the building in the transverse direction (see Figure 25(d))
- Steel framing around openings (see Figure 25(d))
- Supplementary securing of joists to walls (see Figure 25(e))
- Stiffening of timber diaphragms using horizontally-oriented steel braced frames (see Figure 25(f))

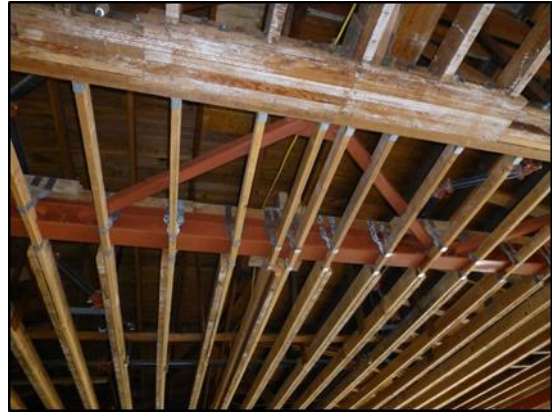
(f) Stiffening of diaphragms using steel bracing

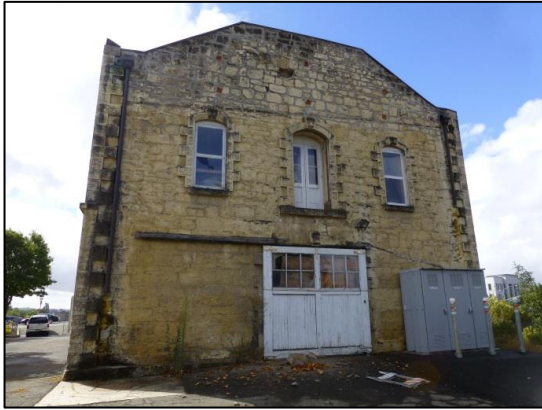
(a) Isolated fallen stone on building exterior

Post-earthquake observations confirmed that despite experiencing very high ground accelerations, the building was effectively undamaged. Several discrete stones had spalled from the exterior leaf of the building on the north and south facades (see Figure 26(a), (b)), and damage had accumulated at the spandrels of the masonry framed wall that received no supplementary bracing (see Figure 26(c)). However, the overall condition of the building is shown in Figure 26(d), indicating that the strengthening appeared to have been extremely successful.

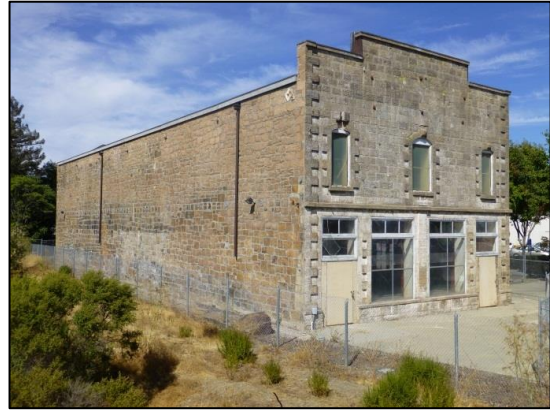
(d) Overall appearance of building

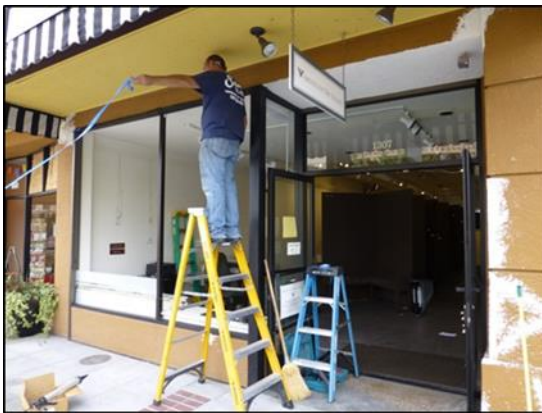
(a) Remediation of shop frontage

The authors had limited opportunity to comprehensively review non-structural damage, although several store fronts were in the process of having broken windows repaired and cosmetic improvements being made, as shown in Figure 27(a). Of particular note was the Andaz Hotel, where a fire sprinkler was activated during the earthquake and continued to cause water damage for several hours before being identified and turned off (see Figure 27(b)). This water damage resulted in extensive damage to furnishing and floor linings (see Figure 27(c), (d)).

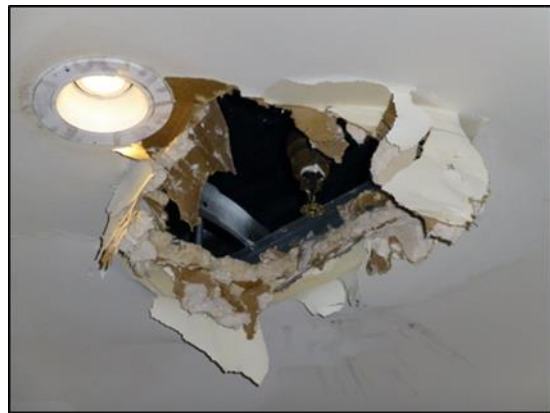
(b) Water sprinkler that was activated during earthquake

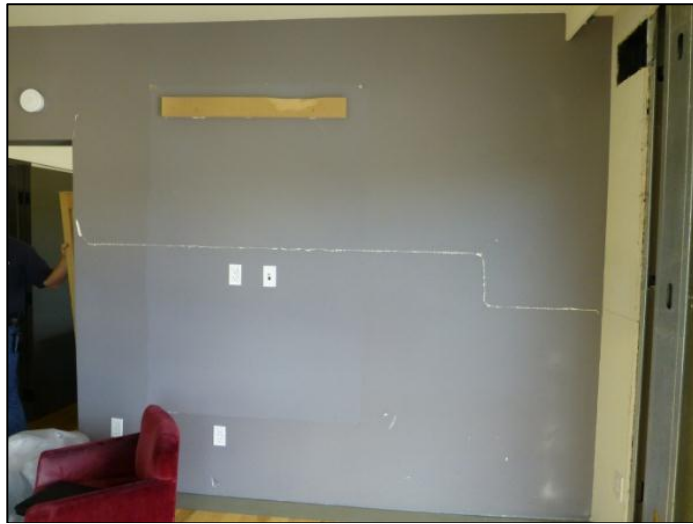
(a) Interior walls

Further non-structural damage within the Andaz Hotel was observed in the form of damage to wall linings (see Figure 28(a)) and significant loss of cladding stonework (see Figure 28(b)).

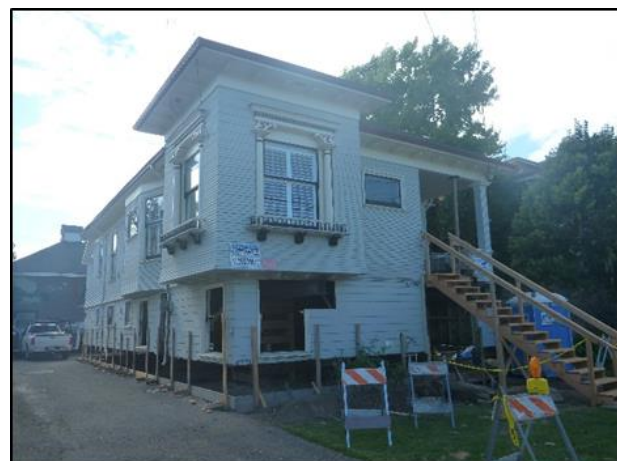
lines or to level a dwelling built on a slope. Several residential houses were observed with cripple wall failures, as typically expected from Californian building stock (Figure 31(a)). Just three weeks after the earthquake several of these cripple wall failures were already in the process of being repaired, with the houses jacked up on cribbing while the foundations were replaced (Figure 31(b)). At one such construction site the contractor advised that the replacement of the foundation wall would be complete within 3 weeks at a cost of US\$50,000.

(b) House foundations under repair

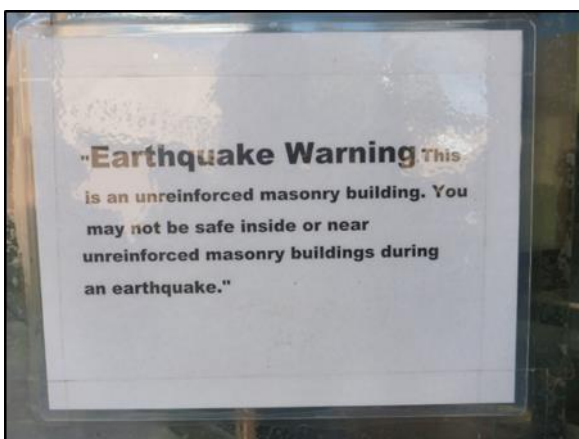
The local population's awareness of earthquake risk is considered to be relatively high. This awareness is partly a result of the regular earthquakes occurring in California, and in particular the 2000 Yountville event. As a result of a number of ordinances, building owners are required to strengthen buildings that are assessed as having poor earthquake performance, or notify the public of the potential danger (Figure 32).

Figure 32: Warning notice in Napa.

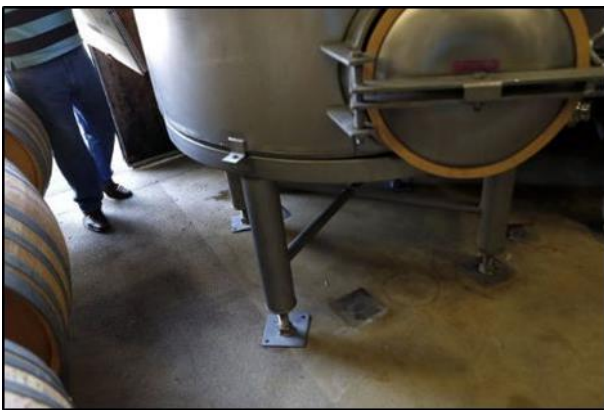
An EERI reconnaissance team observed damage to steel storage tanks, including global sliding failure (Figure 37a), anchor bolt pull-out, and elephants foot buckling of the base of the tank walls. However, failure of steel storage tanks wasn't widespread and may have been due to the fact that most tanks were empty at the time of the earthquake. Observed steel tank failures were reported to have not posed a major life safety concern.

(a) Sliding of steel tanks [63]

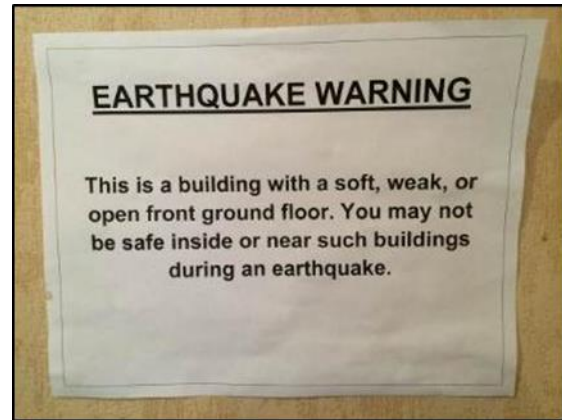
and ironically, the accommodation in Berkeley was deemed to be a ‘soft storey’ building although the reality was much different (see Figure 40). As such, selecting single storey motel-style accommodation is recommended, given that having reliable information on the seismic performance of potential hotels is unlikely.

(a) Warning sign

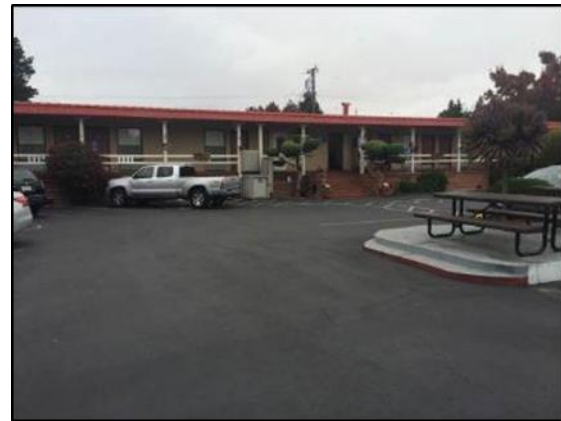
(b) Photo of the building
