DAMAGE TO CIVIL ENGINEERING WORKS AND RESULTING CIVIL DEFENCE PROBLEMS

G. L. Evans*

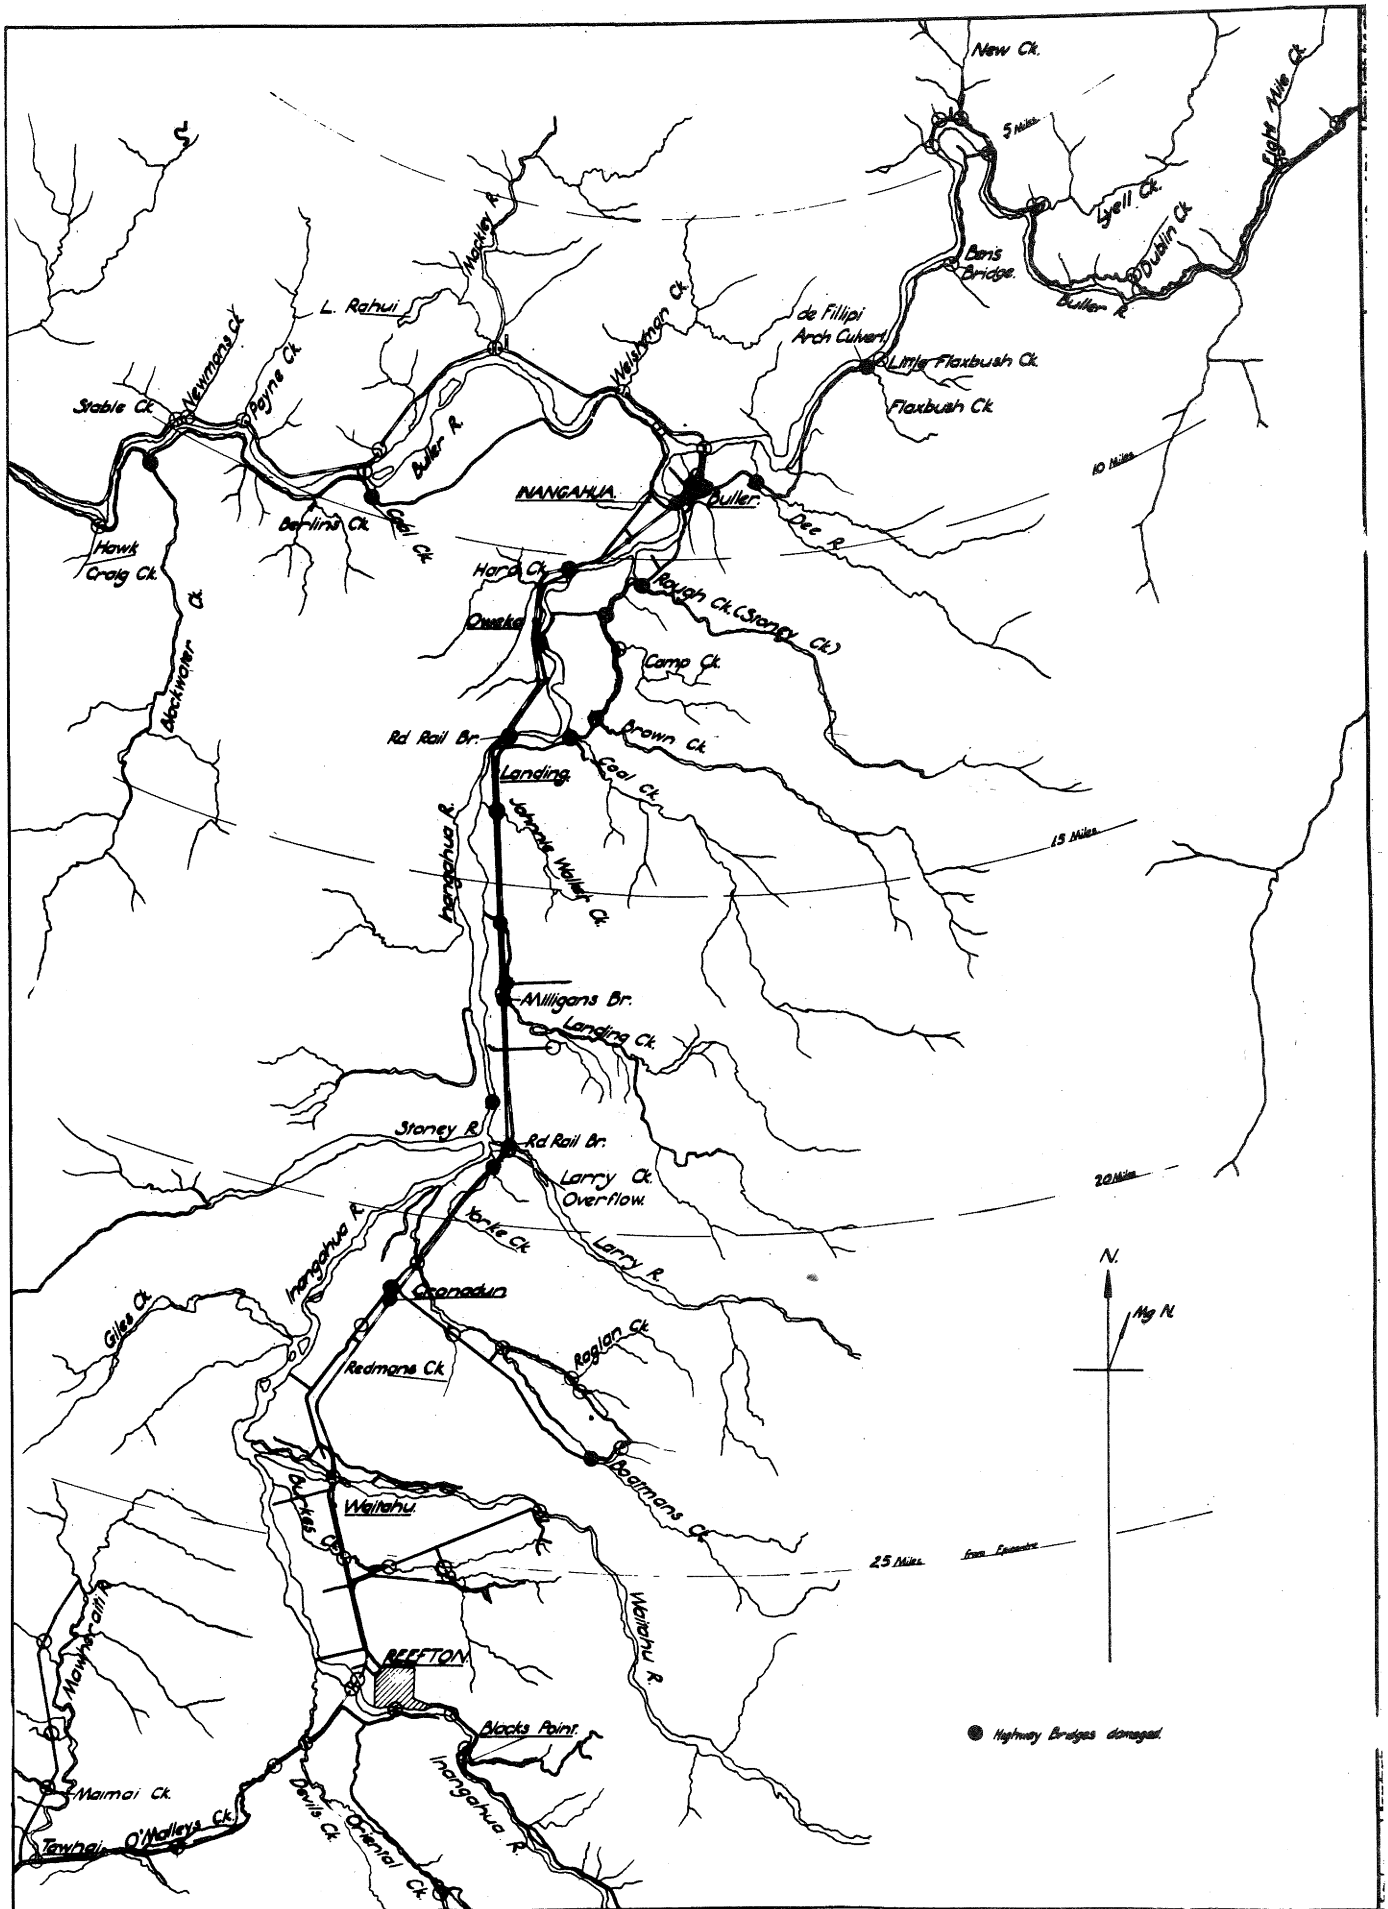
FIG. 1. MAP SHOWING HIGHWAY BRIDGES IN INANGAHUA COUNTY

Within 25 miles of Inangahua, 50 highway bridges have been examined and 30 of these show displacement or damage. (Fig 1)
