# DAMAGE IN CHRISTCHURCH AND CANTERBURY

P. J. Moss\*

## DAMAGE FROM GREYMOUTH TO HOKITIKA

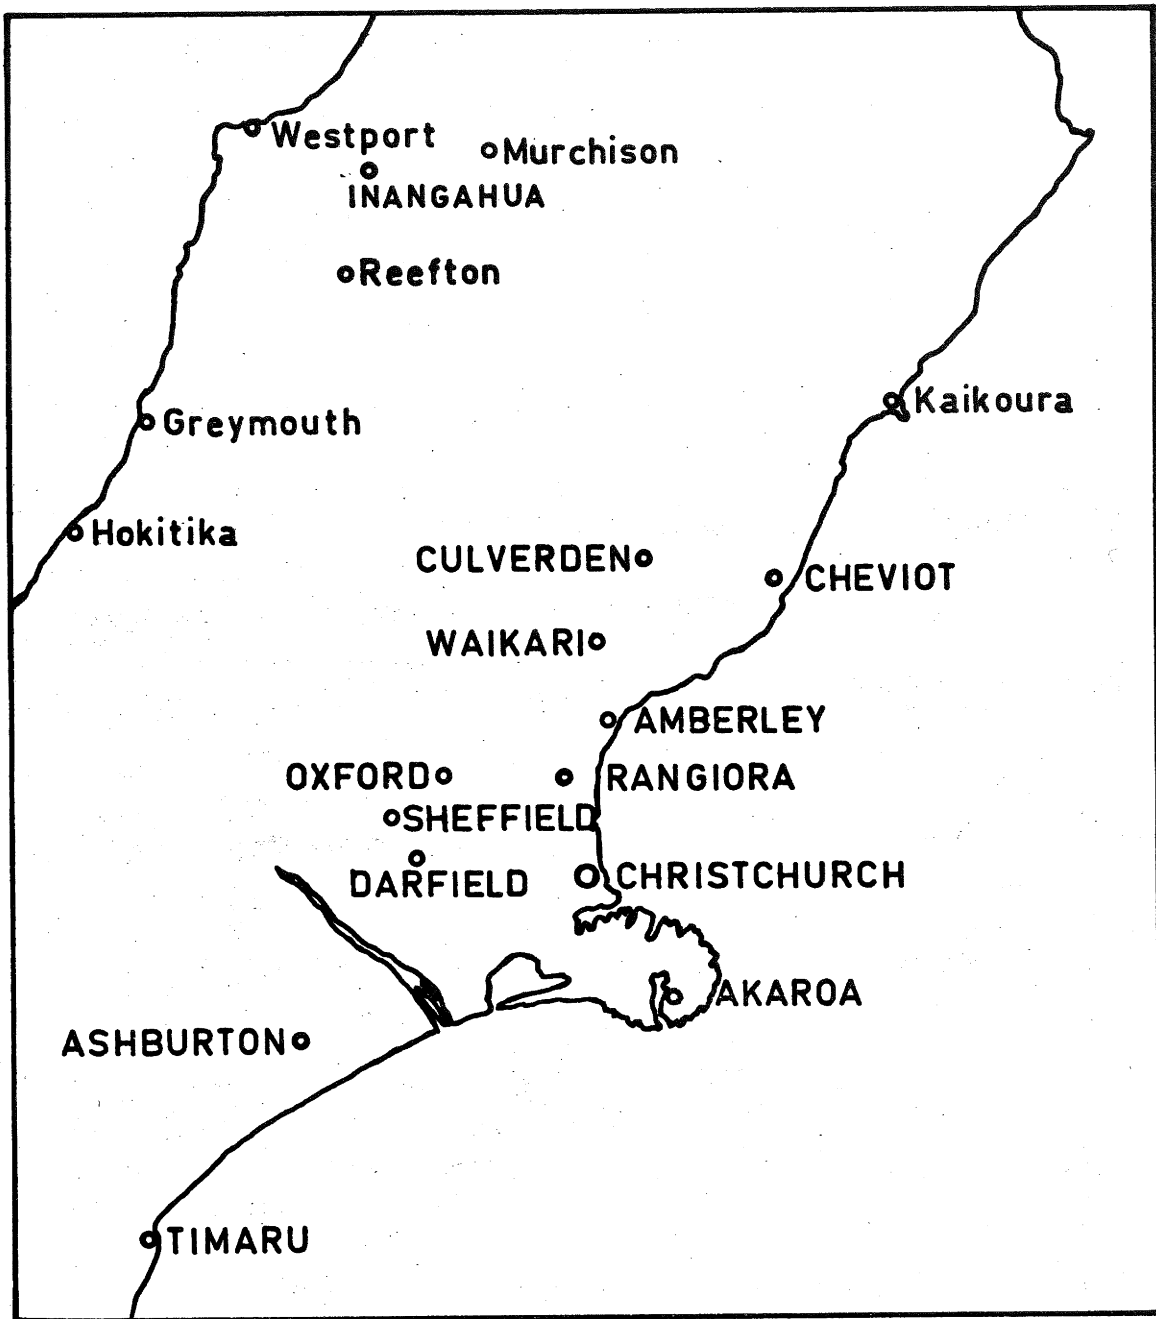
In general, light damage occurred throughout North Canterbury while there was very little damage in South Canterbury. In addition to those areas shown in figure 1, some damage occurred in the area extending up to 20 miles south and southwest of Christchurch. Rangiora, 20-25 miles north of Christchurch appears to have been almost free from damage while areas further north were affected. Culverden and Waikari were damaged more extensively than Cheviot which has suffered considerable damage in previous earthquakes.

**FIGURE 1.** The Canterbury area in relation to Inangahua and the West Coast.
