EARTHQUAKE DAMAGE TO THREE RAILWAY BRIDGES 1968 INANGAHAU EARTHQUAKE

+ J. P. Hollings, B.E., D.I.C. M.I.C.E. M.N.Z.I.E.

1.0 Synopsis

This report describes in detail the measured deformations and damage suffered by two combined road-rail and one rail bridge in the 24.5.68 Inangahua earthquake. The measured deformations are plotted in diagram form for each bridge and photographs of all typical damage are presented. No interpretive or analytical material has been included.

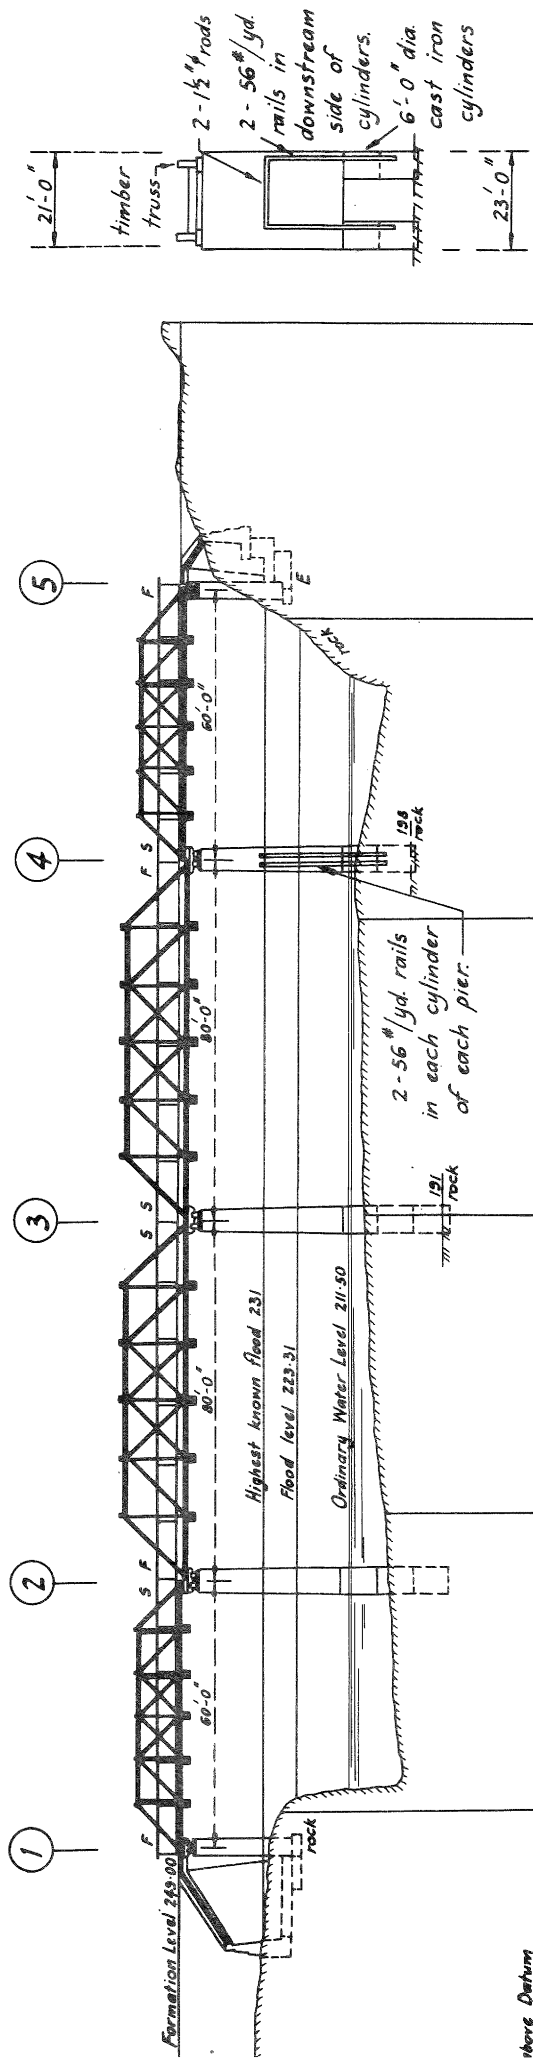
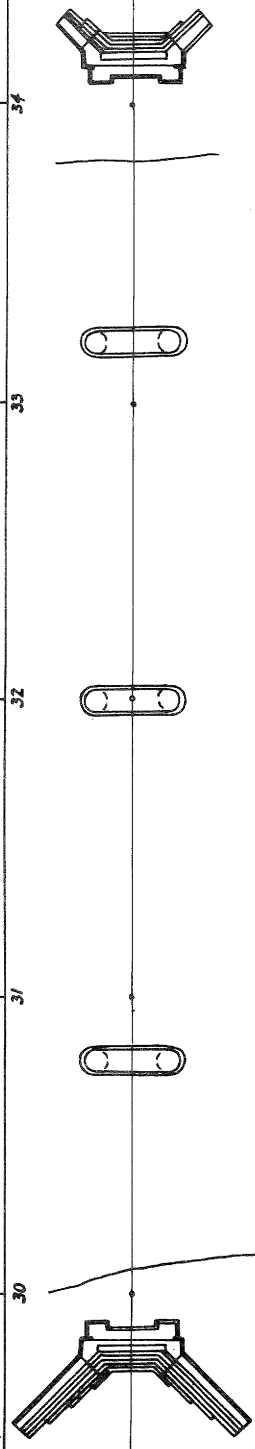
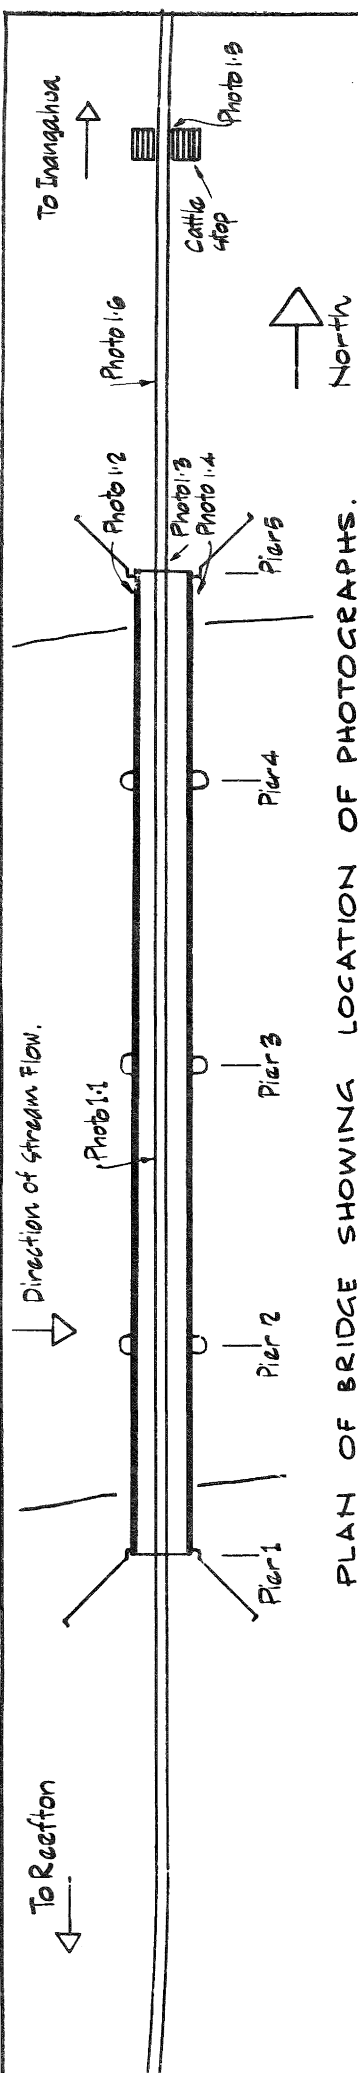
FIGURE 1A

Copies of the original construction plans are still in existence and Figure 1A shows the general arrangement of the bridge as traced from these plans.

Some of this lateral movement at Pier 4 had occurred before the earthquake and is reported to be due to heavy flood debris loads.

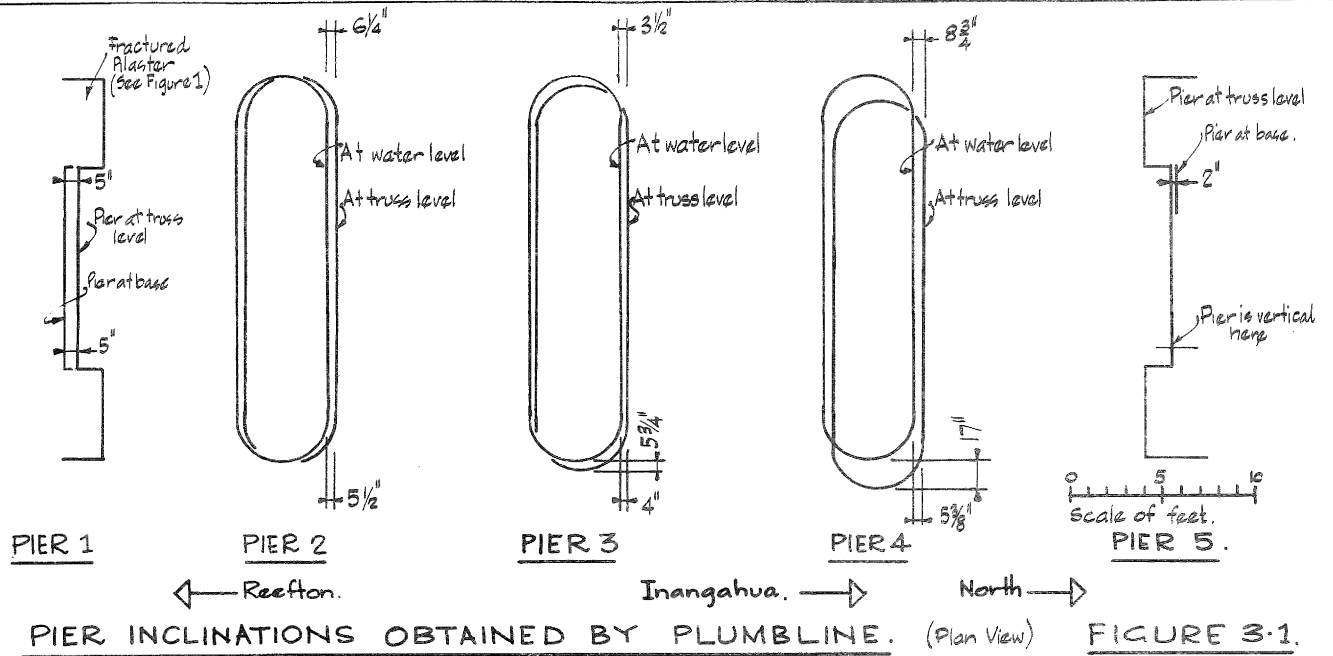
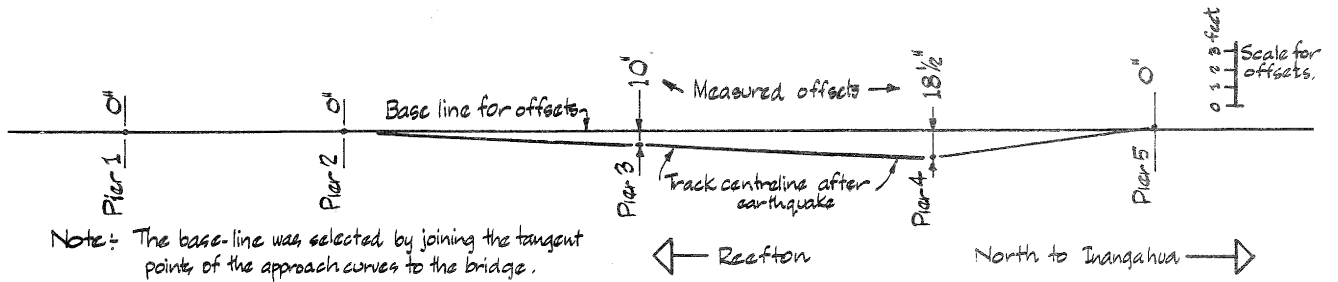
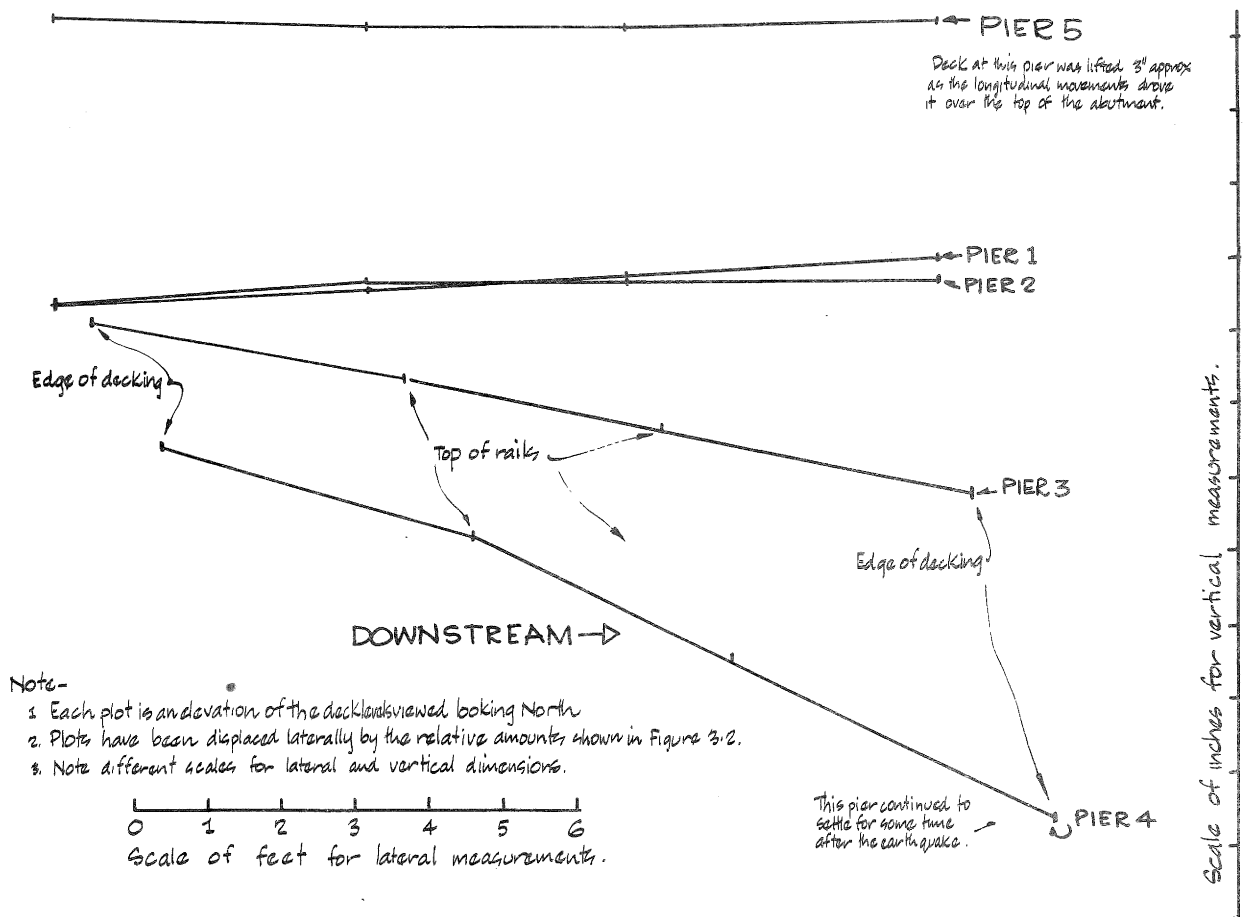
4.2 Showing lateral displacement of pier 4

EVIDENCE OF LONGITUDINAL MOVEMENTS

(South End of Bridge).

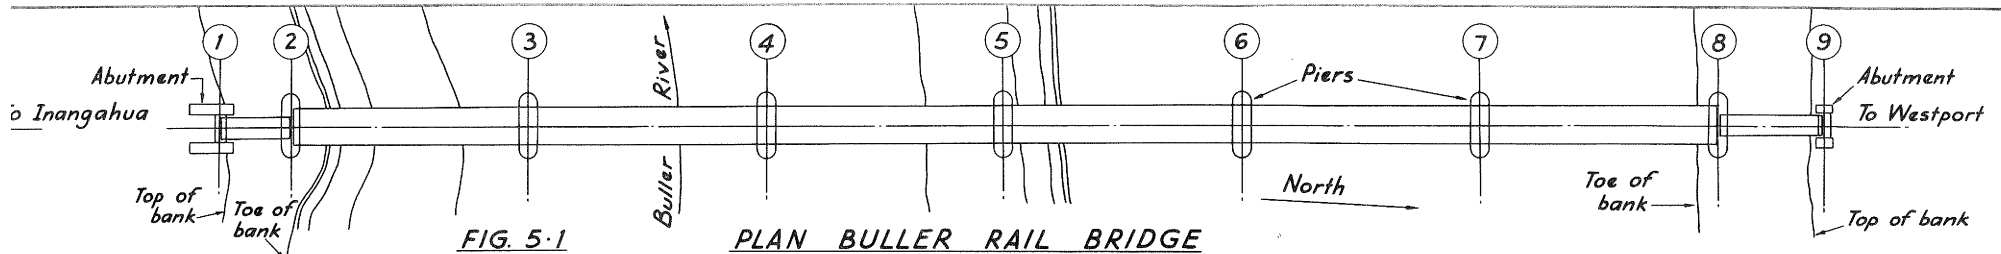
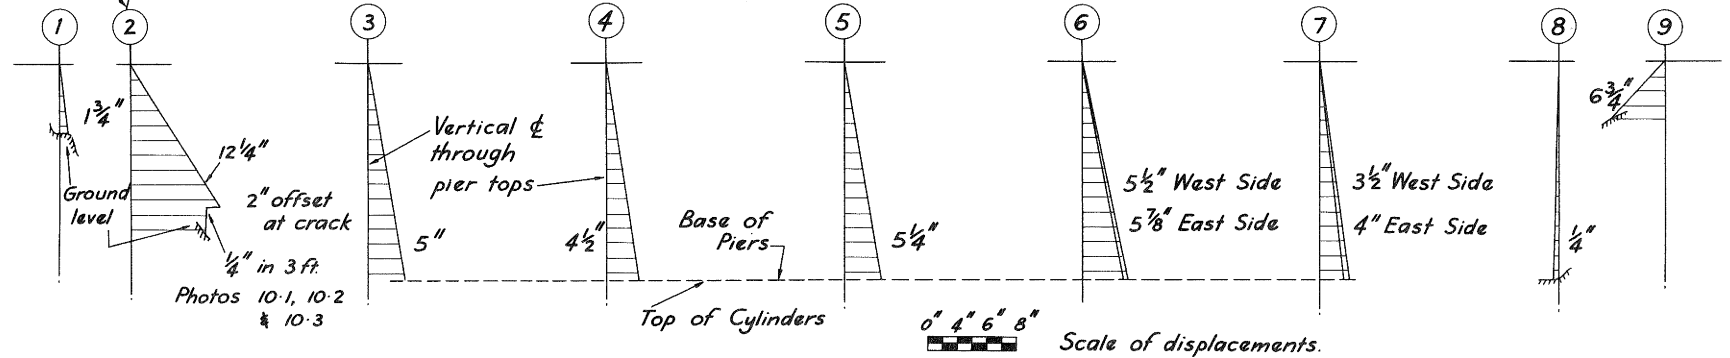
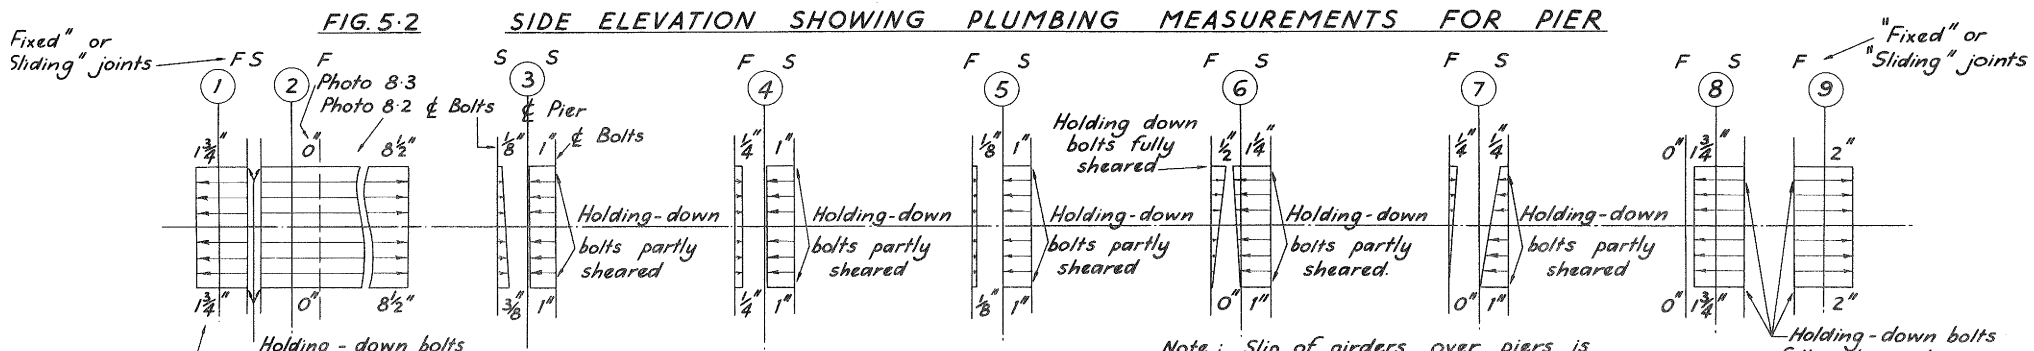
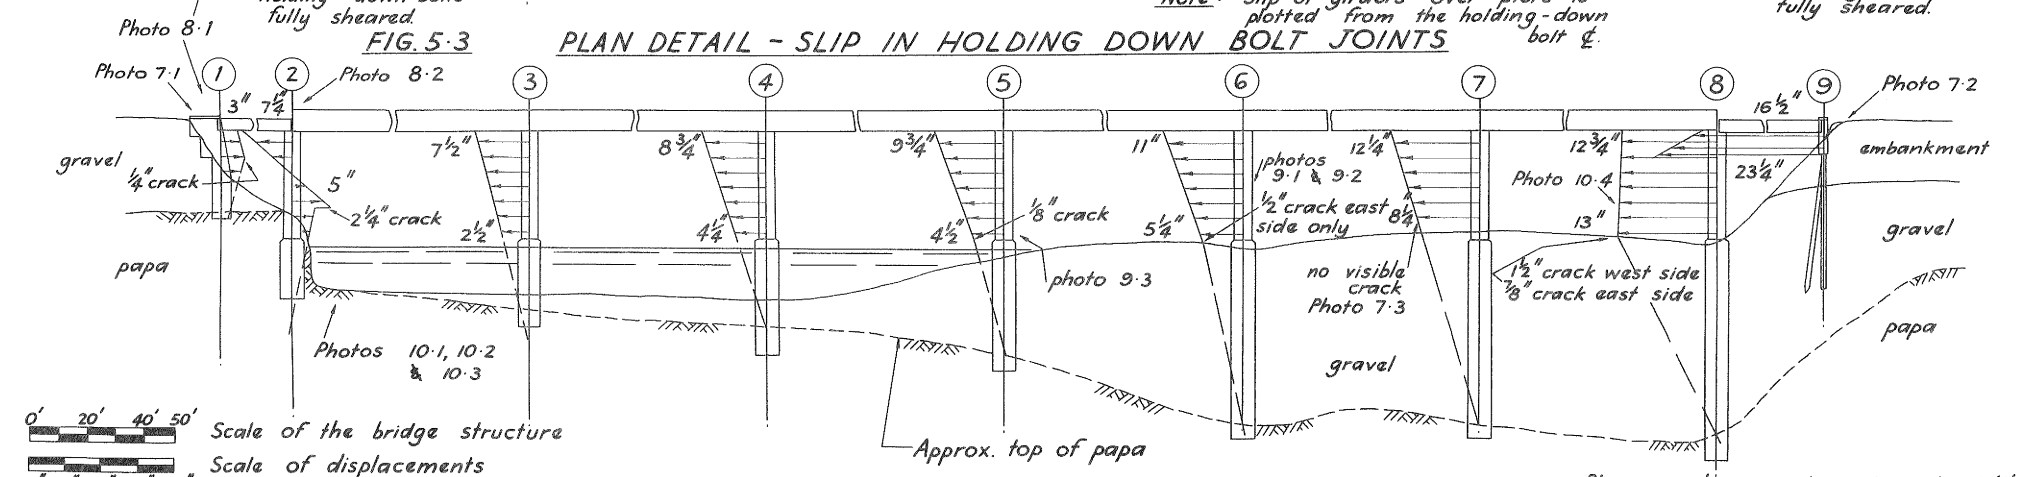
FIGURE FIVE BULLER RAIL BRIDGE

All bolts in "sliding connections" to the main spans have partly failed while only one of the bolts in a "fixed" connection has failed see Figure 5.3.

If it is assumed that bedrock has not moved and that the only curvature in the piers is at the failure at ground level, the absolute movement of the piers can be determined from the measured lean above ground level. Thus Pier 7, which is the only pier without visible failure can be approximated as straight and its total deflection determined from its slope above ground level - see as in Figure 5.4.

The river gravel in the region of Piers 7 and 8 appears to have moved west taking the piers with it. The deck north of Pier 6 has been pulled west resulting in the failure of the west holding down bolts for girder 6-5 (see Figure 5.3) and a $\frac{1}{2}$ " crack on the eastern side of Pier 6 (see Figure 6.3). The top of Pier 8 appears to have been restrained by the deck as there is a crack in the western side of the base of this pier, - see Figure 5.3.

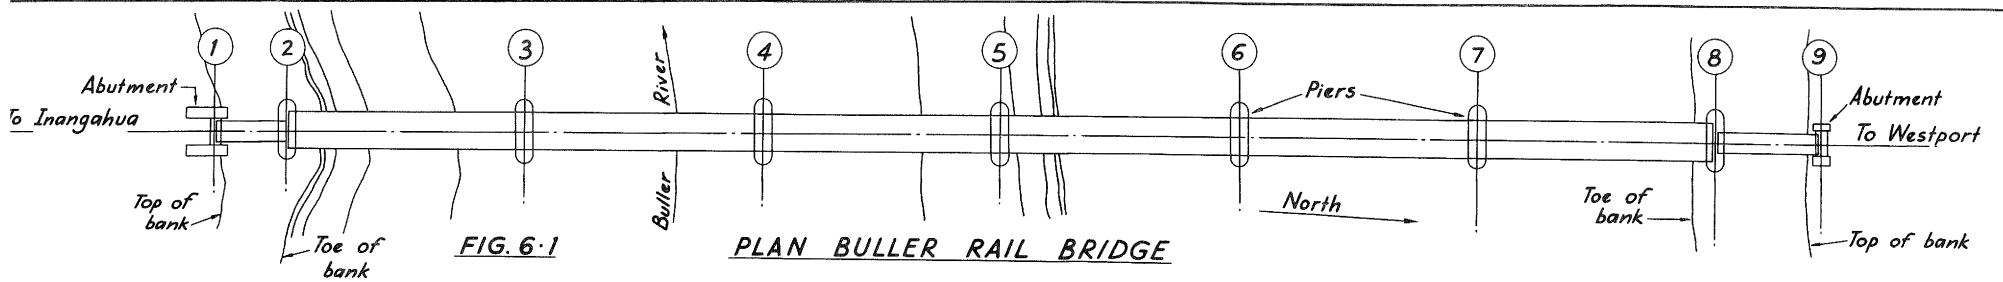
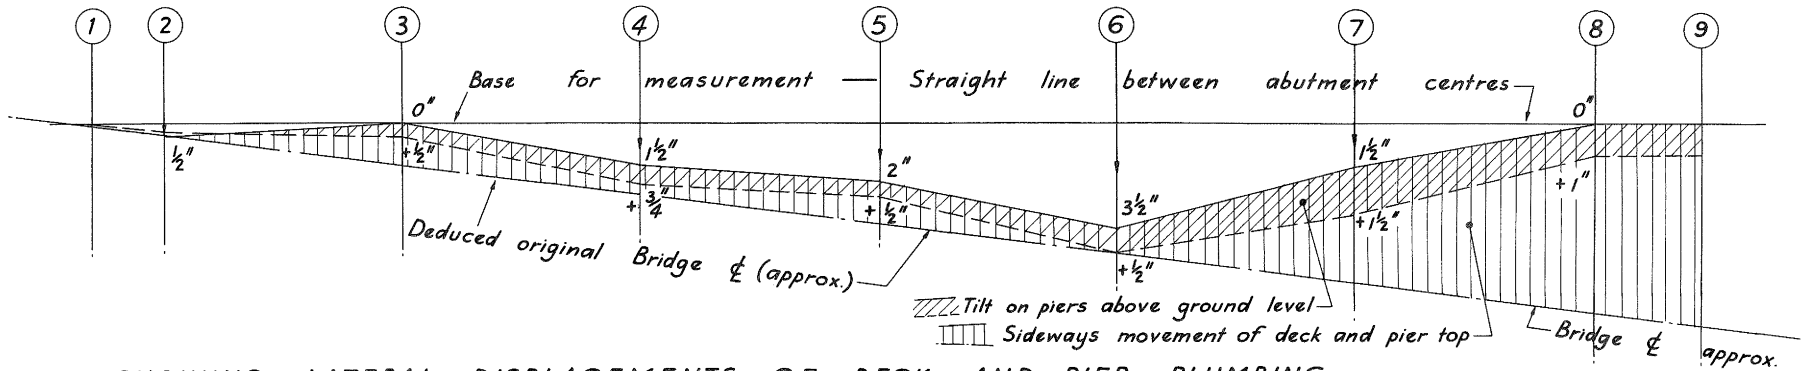
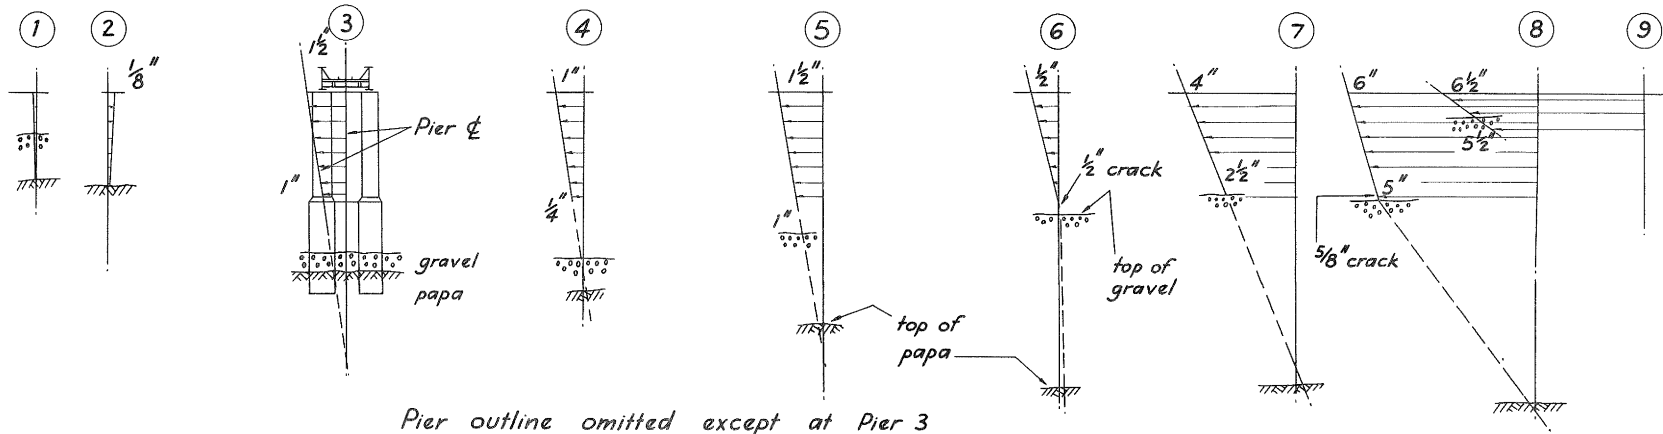
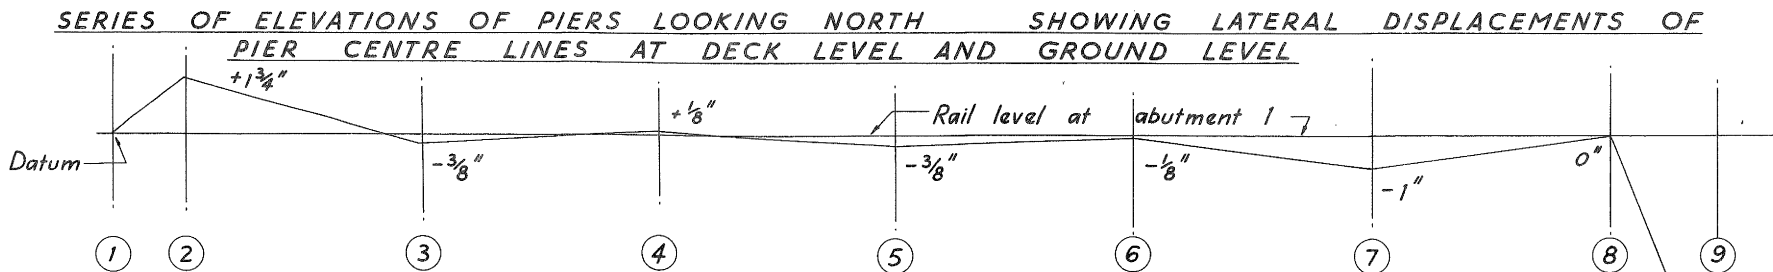
FIGURE SIX BULLER RAIL BRIDGE

The north embankment fill and possibly river gravel has also moved to the west. Figure 6.3 shows the total lateral pier movement combining measurements of offsets from a line between abutment centres, plumbing and crack width at ground level. Again the measured crack widths at the pier failure are consistent with the two assumptions that bedrock has not moved and all pier curvature is concentrated at the failure at ground level.

Plumbing, slip in joints and crack widths are combined to deduce total displacements. It is assumed that bedrock has not moved and all pier bending occurs at the plastic hinge.

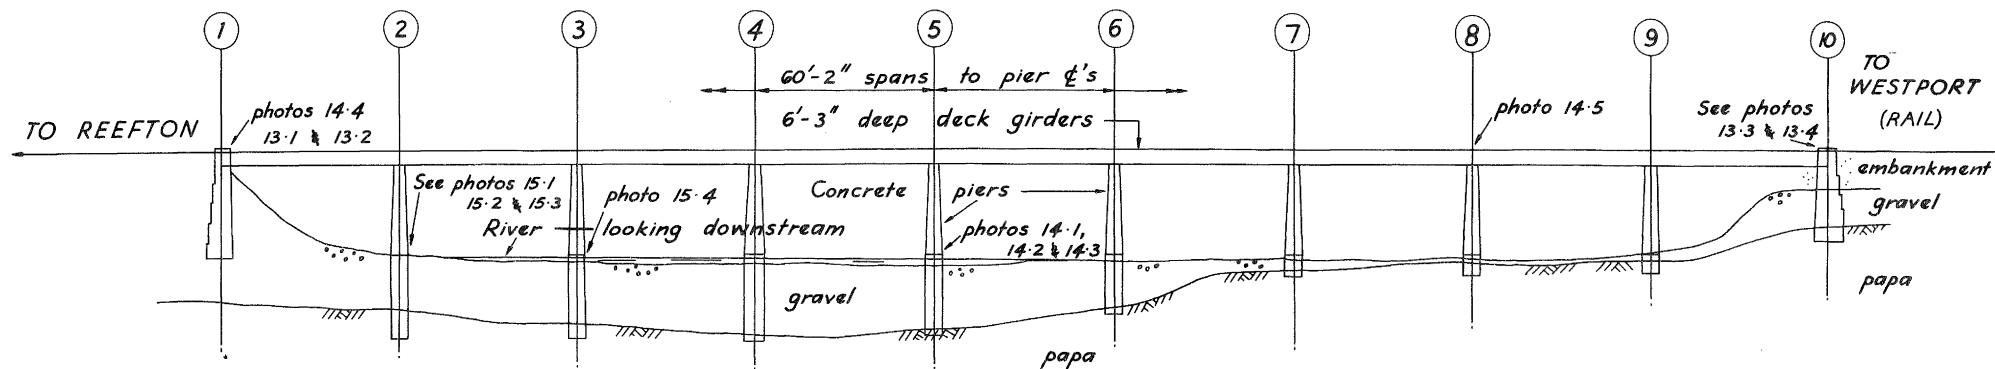
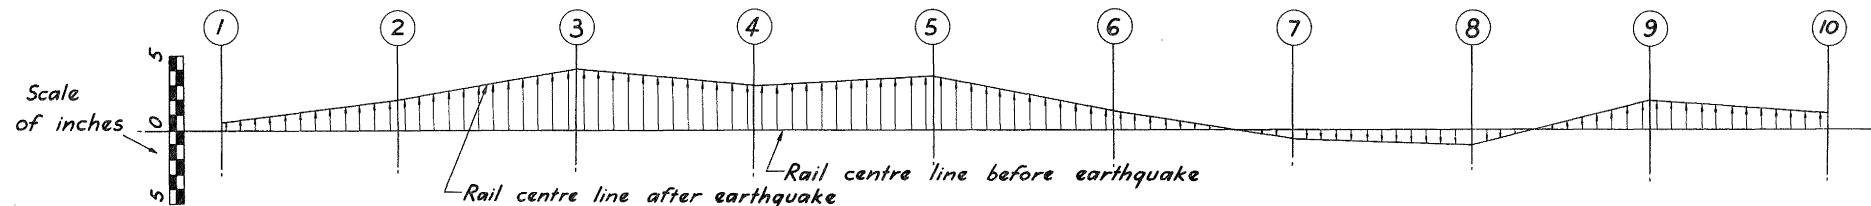
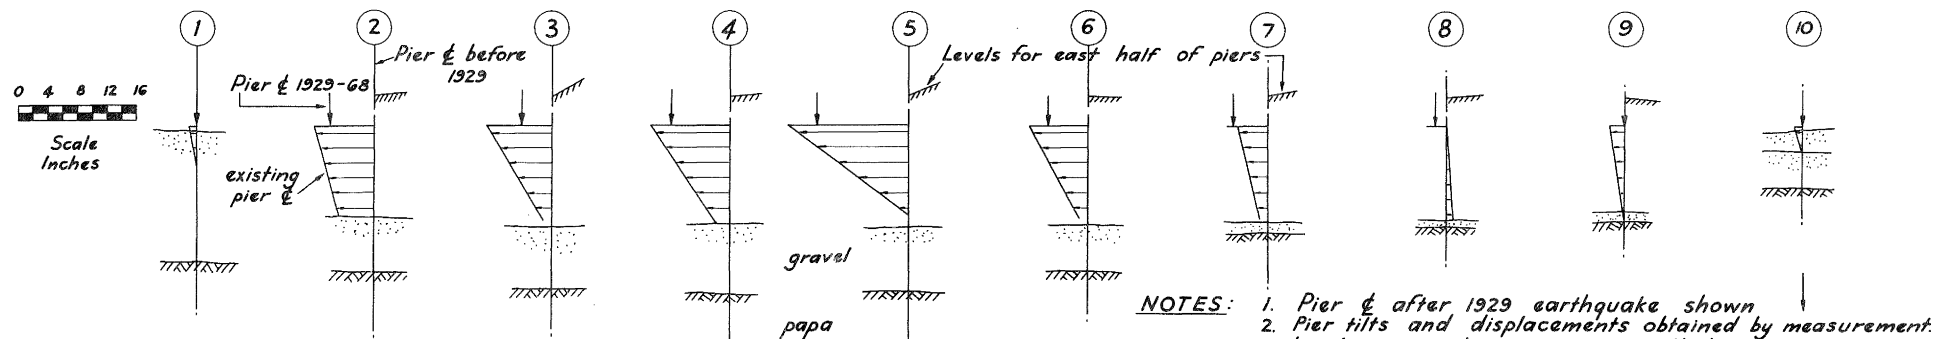
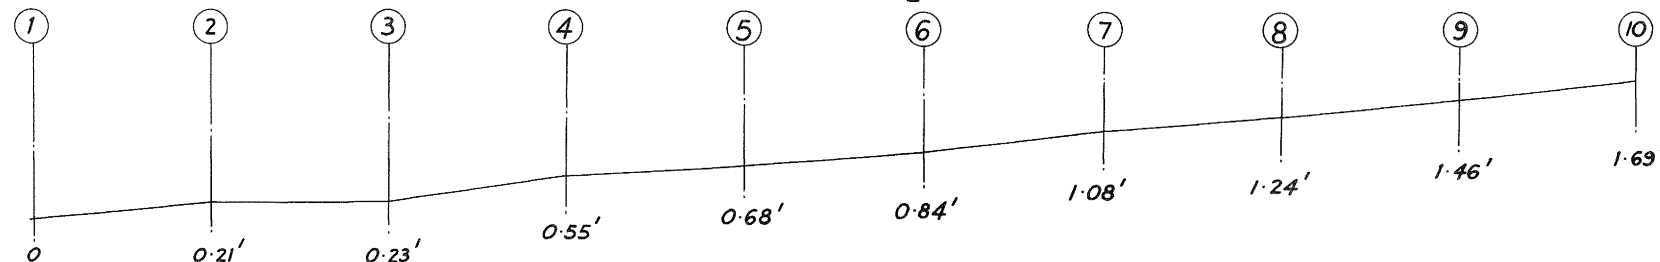
FIGURE ELEVEN INANGAHUA COMBINED ROAD & RAIL BRIDGE

FIG. 11-1 INANGAHUA COMBINED ROAD AND RAILWAY BRIDGE — ELEVATION LOOKING WEST

FIG. 11-2 PLAN SHOWING SIDWAYS DISPLACEMENT OF RAIL CENTRE LINE

FIG. 11-3 SERIES OF ELEVATIONS OF PIERS LOOKING NORTH SHOWING LATERAL DISPLACEMENTS OF PIER c/s.

FIG. 11-4 ELEVATION SHOWING RAIL LEVELS AT PIERS

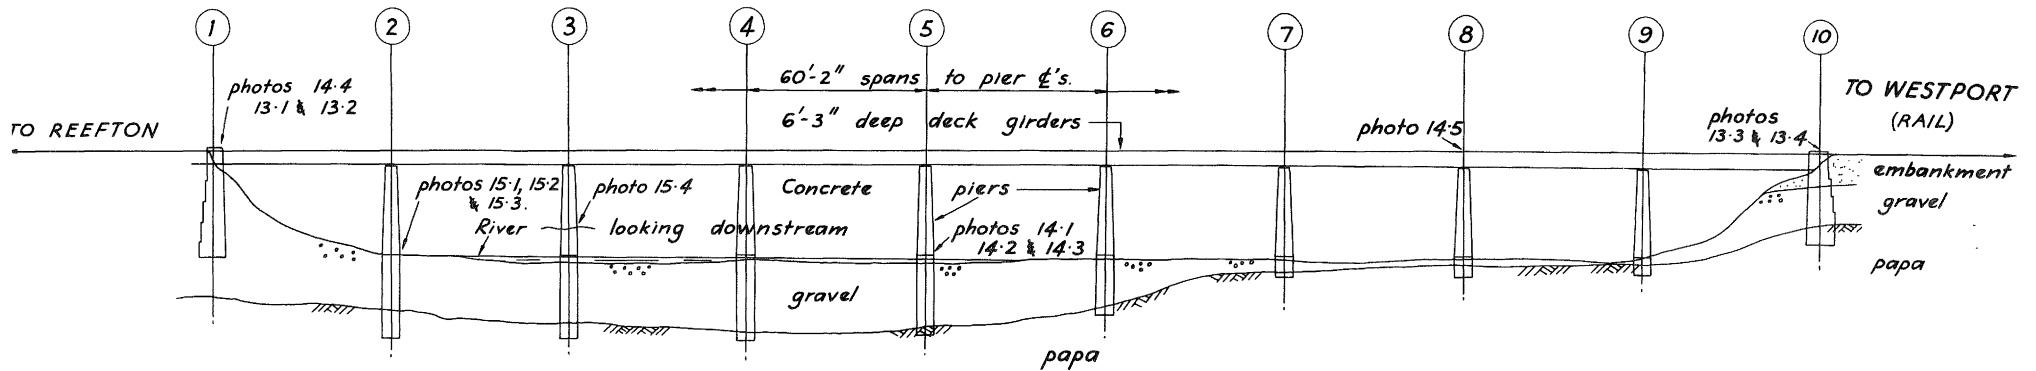
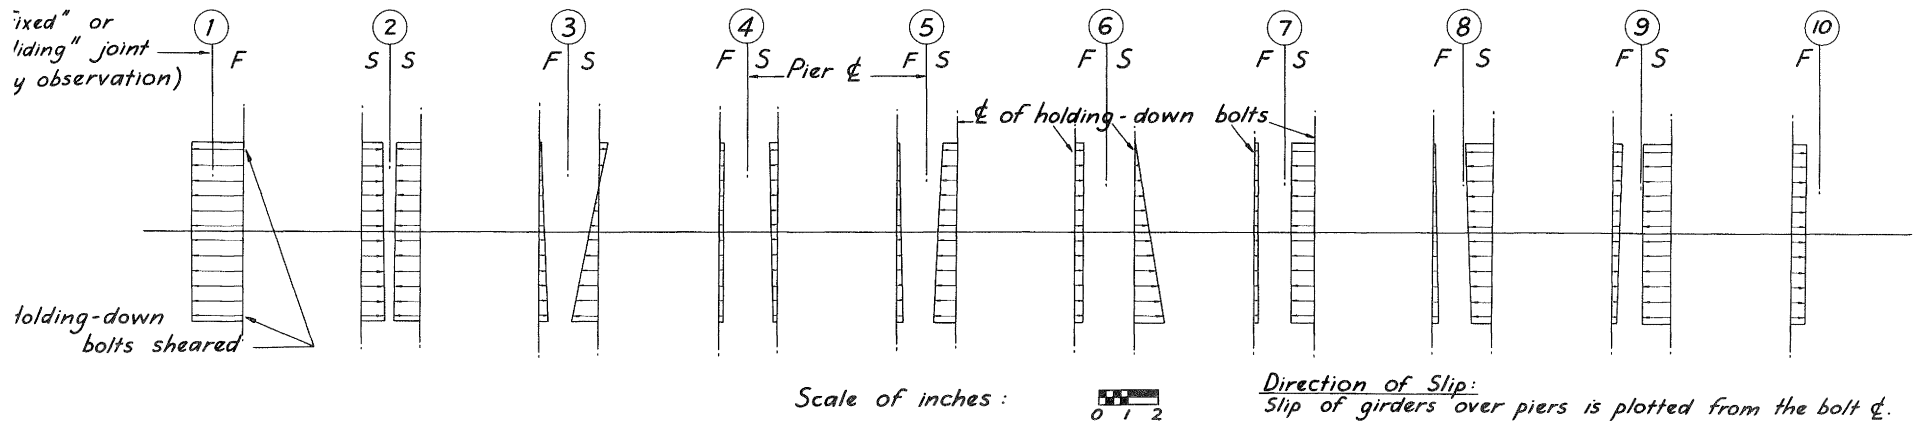
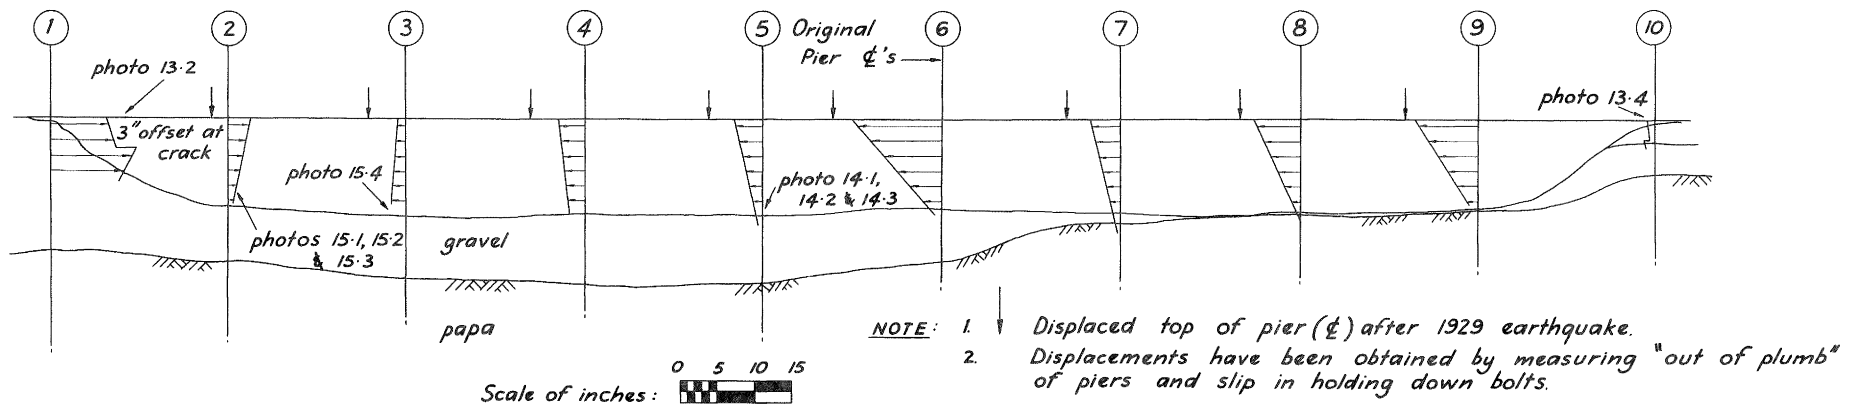
FIGURE TWELVE INANGAHUA COMBINED ROAD & RAIL BRIDGE

FIG. 12-1 ELEVATION — INANGAHUA COMBINED ROAD AND RAILWAY BRIDGE — LOOKING WEST.

FIG. 12-2 PLAN SHOWING SLIP IN HOLDING DOWN BOLT JOINTS

FIG. 12-3 ELEVATION SHOWING LONGITUDINAL PIER DISPLACEMENTS
