INANGAHUA EARTHQUAKE 1968

DAMAGE TO STATE HIGHWAYS

J. S. Douglas, A.M.I.C.E.*

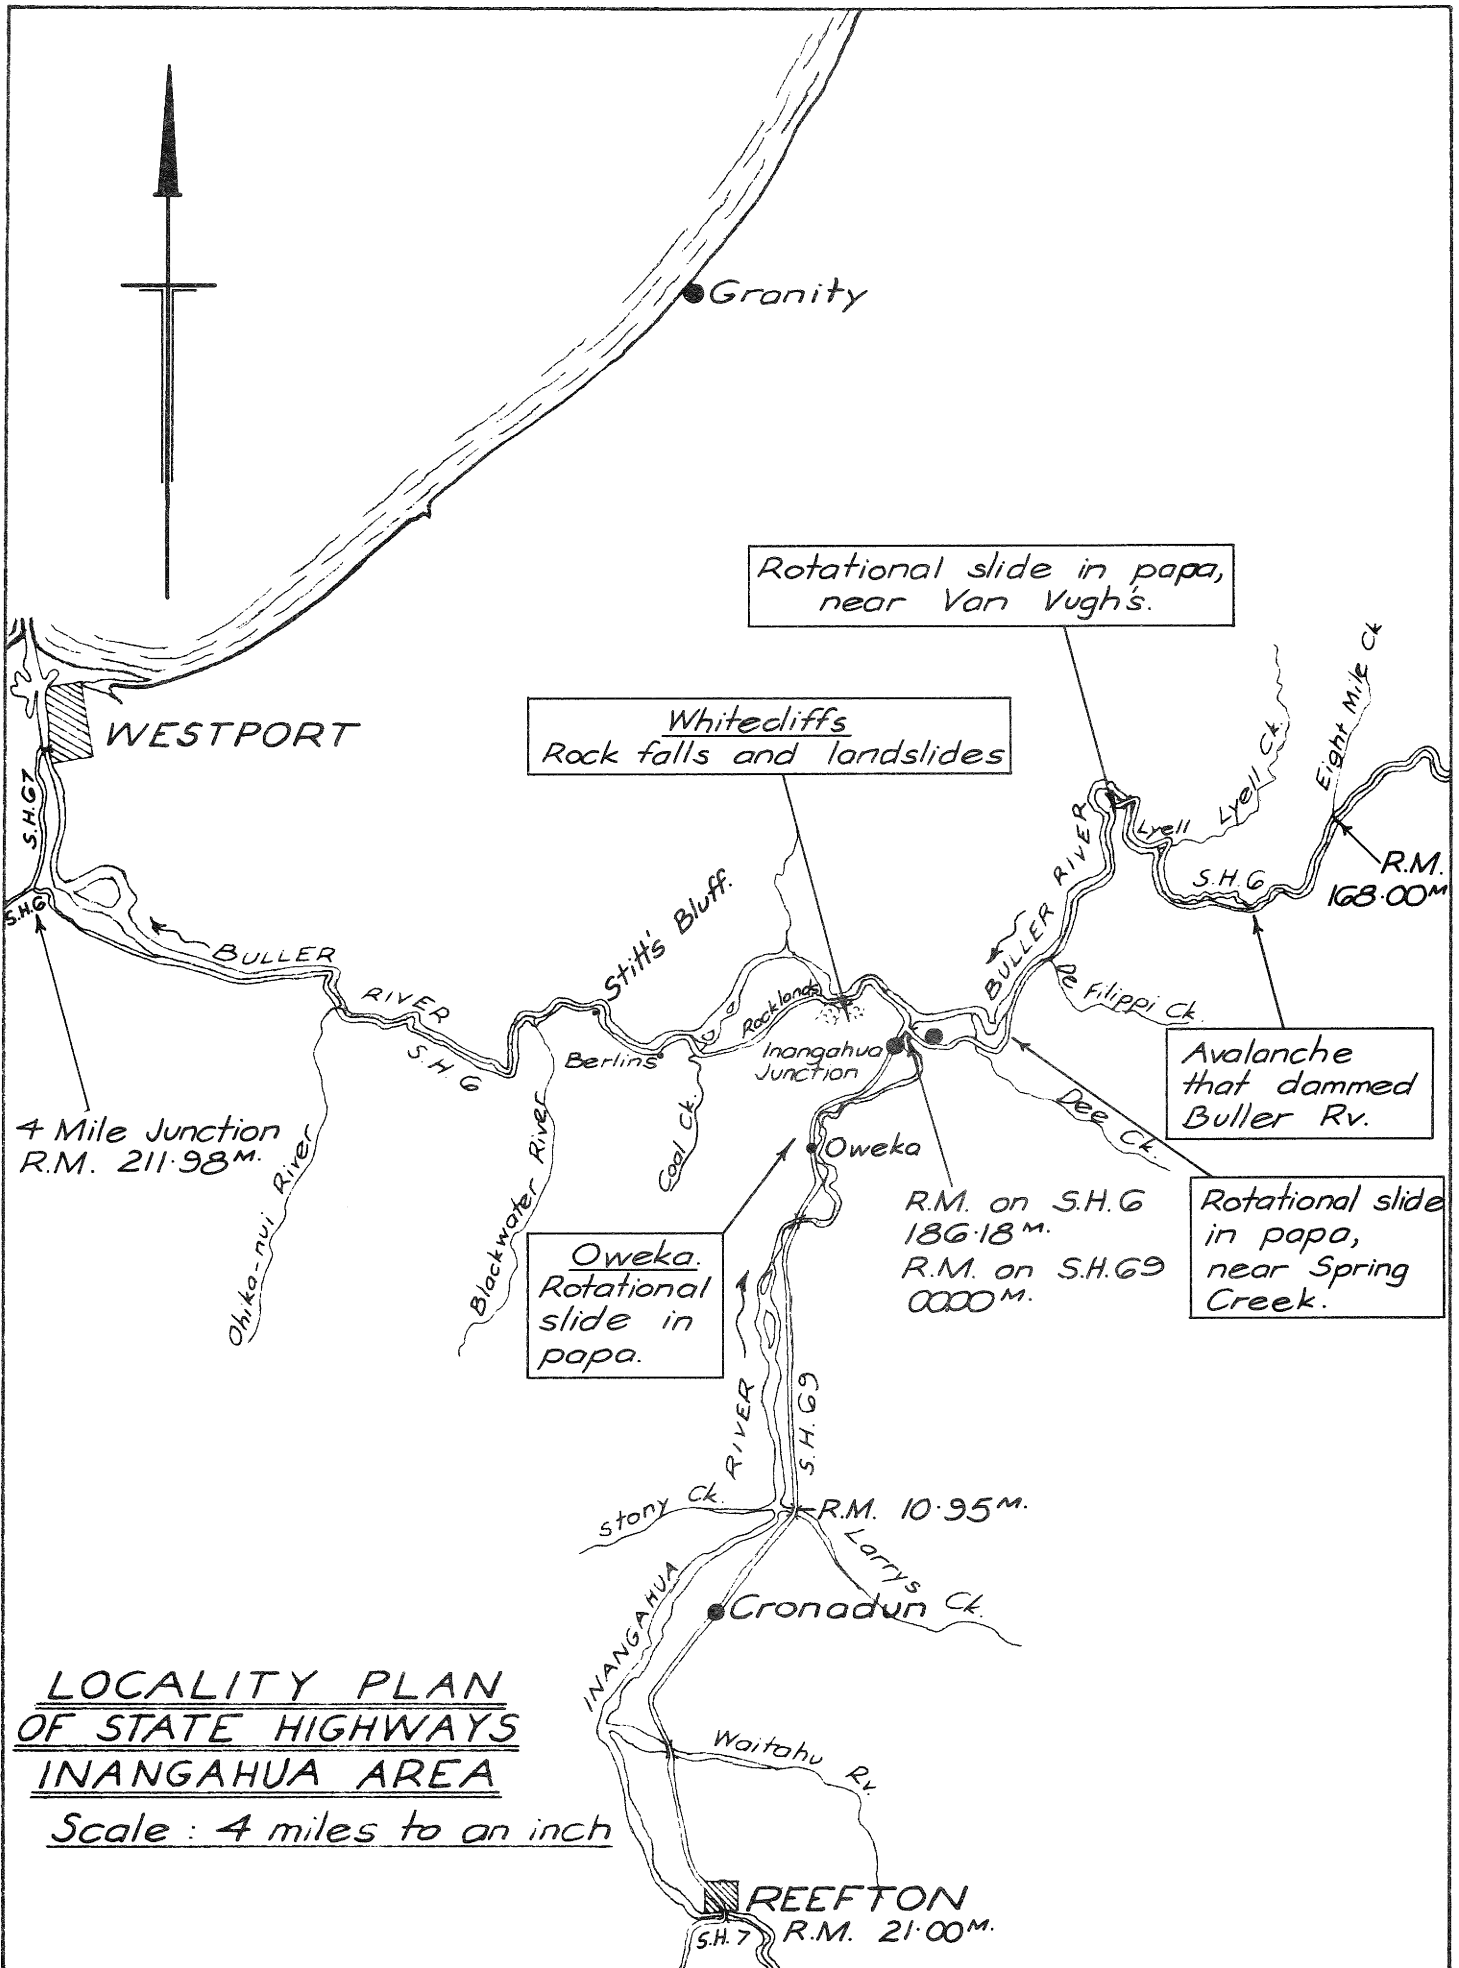
Rotational slide in papa,
near Van Vugh's.

Whitediffs
Rock falls and landslides

Avalanche
that dammed
Buller Rv.

Rotational slide
in papa,
near Spring
Creek.

Owaka.
Rotational
slide in
papa.
