## SEISMIC PERFORMANCE OF SCHOOL BUILDINGS IN 2017 EZGELEH EARTHQUAKE, IRAN

Mehdi Kahrizi<sup>1</sup> and Mehrzad TahamouliRoudsari<sup>2</sup>

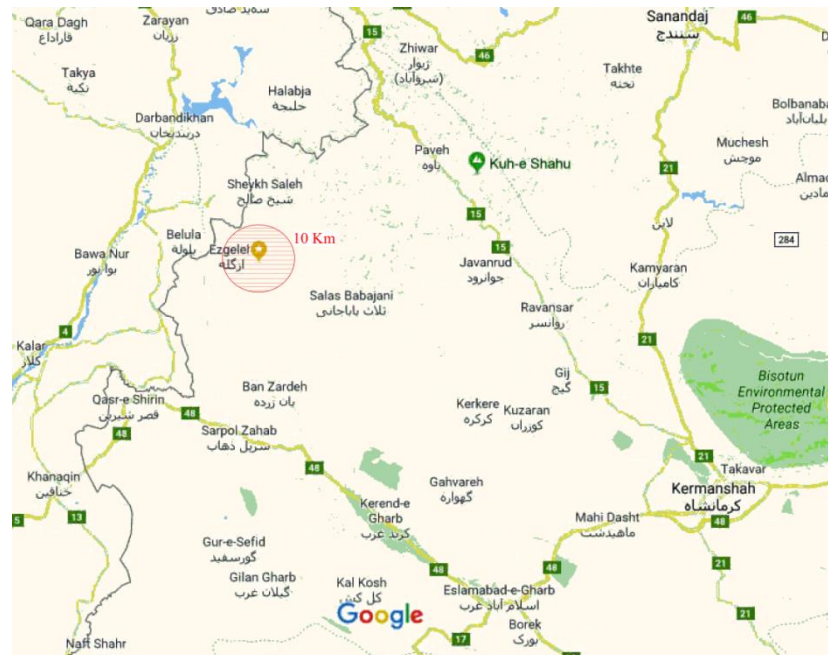
field of the earthquake and are shown in Figure 8. An assessment of the damage caused by the earthquake in the school buildings in these areas is brought in the following.

Figure 8: The near field of the fault within 10 km from the epicenter of the November 12th, 2017 Ezgeleh earthquake, Iran.

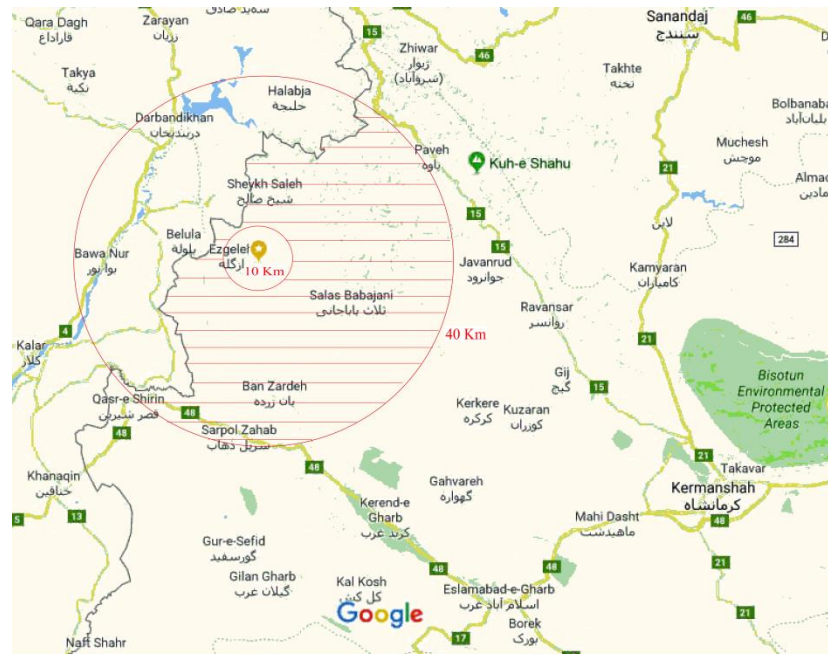
Figure 11: Area far from the fault located between 10 to 40 km from the epicenter of the November 12th, 2017 Ezgeleh earthquake, Iran.

This area, assumed to be the far-field of the fault, includes cities adjacent to the epicenter of the earthquake such as Paveh to the northeast, Javanrud to the east, Salas Babajani to the southeast, Sarpol-e Zahab to the south, and Ghasr-e Shirin to the southwest (Figure 11). Investigating the obtained records from the accelerogram stations in the region showed that despite being obtained at a distance approximately equal to those of other cities from the epicenter of the earthquake, the record of the Sarpol-e Zahab city was significantly higher. This can be due to the orientation of the fracture from the north to the south, which was the cause of Sarpol-e Zahab suffering the most damage.

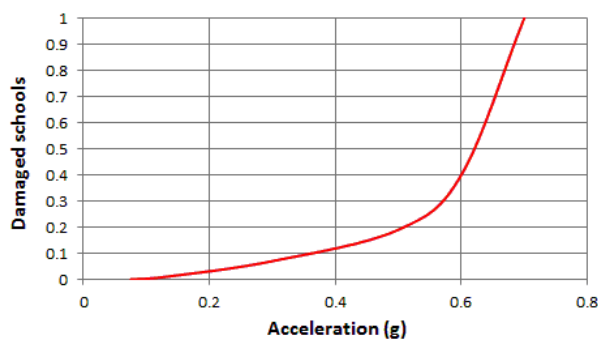
**Table 1: Level of damage sustained by school buildings with respect to seismic acceleration.**

No.	Maximum acceleration (g)	No. of damaged school buildings in equi-acceleration regions	Total number of school buildings in the equi-acceleration regions	Ratio of the damaged school buildings
1	0.075	0	43	0
2	0.13	1	97	0.01
3	0.3	6	81	0.07
4	0.5	12	63	0.19
5	0.6	22	55	0.4
6	0.7	78	78	1

**Figure 17: The level of damage sustained by schools in terms of earthquake acceleration.**
