THE SEPTEMBER 19TH, 2017 PUEBLA, MEXICO EARTHQUAKE: FINAL REPORT OF THE NEW ZEALAND RECONNAISSANCE TEAM

**Samuel Roeslin¹, Hugón Juárez-García², Kenneth J. Elwood³,
Rajesh P. Dhakal⁴ and Alonso Gómez-Bernal⁵**

ABSTRACT

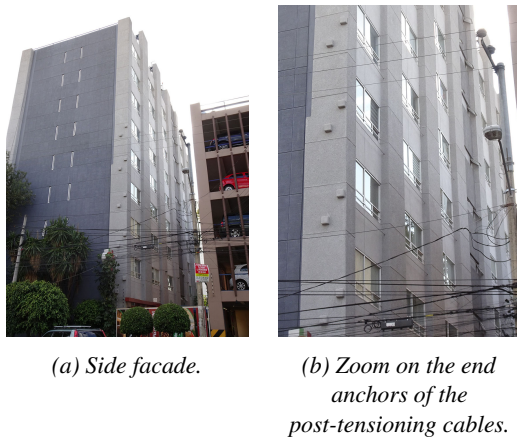
Figure 22: Building C.

to post-tension the deep beams in longitudinal direction. In Figure 22b, it is possible to observe the end of the post-tensioning cables. The exterior inspection revealed no damage after the 2017 earthquake.

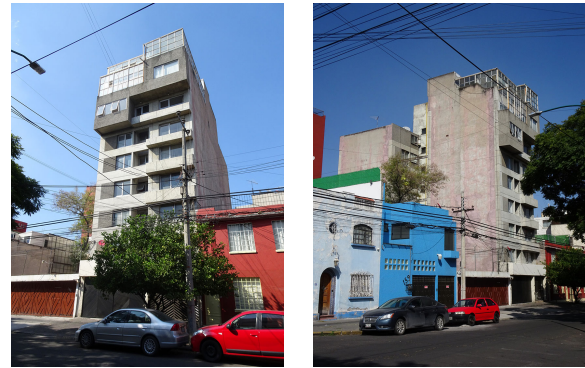
Figure 24: Building E.

Following the 2017 Puebla earthquake, the external inspection did not reveal any apparent damage to the facade facing the street, nor the perpendicular direction. The building is narrow and C-

shaped. An internal inspection would have enabled checking the behaviour of the retrofitted elements; nevertheless, inner access was not granted.

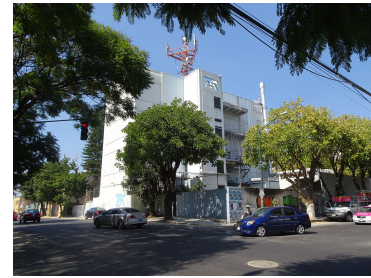
(a) Front view.

This six-storey office building was constructed in 1974. It is located in the north of Paseo de la Reforma in seismic zone III b. The structural system is a waffle slab supported by reinforced concrete columns. The material for the partition walls is solid clay brick masonry. The building is C-shaped in plan. Apart from minor cracking, the building did not experience notable

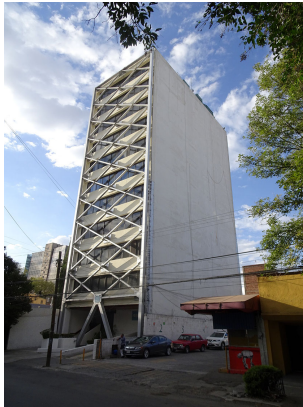
(a) Exterior steel bracing.

The NZSEE team after the 1985 Michoacán earthquake reported on the performance of this building in the 1985 earthquake. No damage was reported. The stiffer steel frames changed the build-

ing period away from the critical period range of 2.0 seconds. The exterior inspection following the 2017 earthquake did not identify any apparent damage to the facade or braces. Once again, the structural retrofitting seemed to have performed well.

added on both facades in the short direction (Figure 32). This led to an increase in stiffness in the east-west direction. Additionally, reinforced concrete infill walls increased the strength of the building in the north-south direction. Steel plates were used to strengthen columns which experienced shear and flexural cracks. The diaphragm was also reinforced. It is important to mention that these additional measures only increased the weight of each floor by an average of 6.5%.

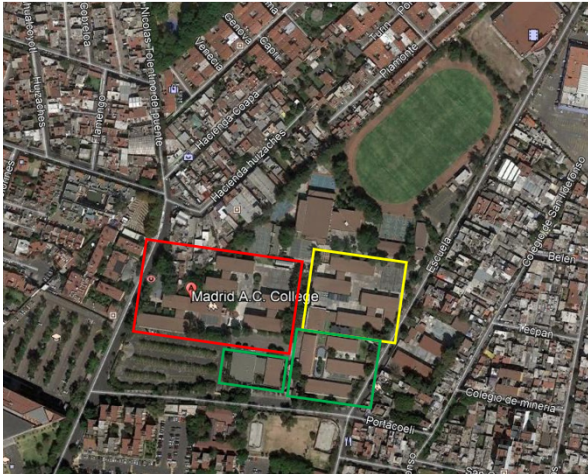
Following the 1985 Michoacán earthquake the multi-storey secondary and high school buildings (red square in Figure 34) were evacuated as they had experienced severe damage. These buildings were subsequently repaired and retrofitted with steel jacking and steel braces. The yellow rectangle shows the location of the primary school which was retrofitted at a later stage with

concrete walls. In the green rectangles are all the buildings (administrative buildings, library, kindergarten) which did not suffer any damage during the 1985 Michoacán earthquake. These buildings were one or two-storey structures and no strengthening was done on these buildings.

Figure 34: Colegio Madrid; Red square indicates buildings damaged in 1985 and repaired and retrofitted; Yellow square indicates buildings retrofitted after 1985; Green squares indicate buildings not retrofitted in 1985. Only buildings in green squares were damaged in 2017.
