FUNCTIONAL RECOVERY OF BUILDINGS FOR SEISMIC RESILIENCE OF COMMUNITIES: LESSONS FROM THE 2024 HUALIEN, TAIWAN EARTHQUAKE

**Alice Chang-Richards¹, Ke Jiang², Julian Rincon³,
Alex Shegay⁴, Julian Benito⁵, Bo-yao Lee⁶, Tomomi Suzuki⁷,
Jonathan Monical⁸, Tsung-Chih Chiou⁹, Lucas Hogan¹⁰
and Joe Byrne¹¹**

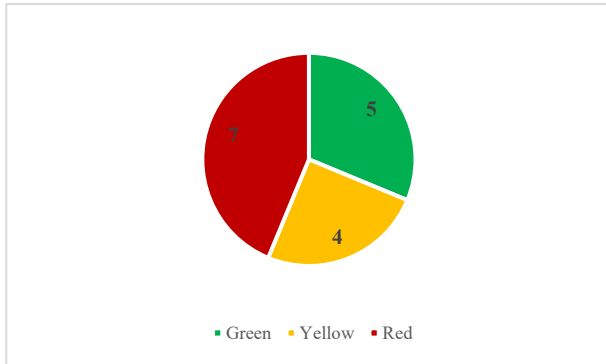
Figure 4: Placards of buildings visited (as of time of visit in May–June 2025).

As shown in Table 1, the six retrofitted buildings generally performed well during the earthquake, with only one old building (D10, built in 1968) assigned a yellow placard. Ten buildings that had not been retrofitted performed poorly, with six buildings red-placarded and three yellow-placarded. One building complex (E11), comprising six buildings (A–F), all suffered varying degrees of damage, with buildings A and F allocated red placards and the other four buildings assigned yellow placards. The inspection of this building complex, E11, was focused on Buildings A and F; thus, a red placard was issued for this complex in Table 1 and Figure 4 below. This building complex had a prolonged construction period: beginning in 1991 and completed in 1998, with construction suspended several times due to legal disputes between the

developer and the bank. Another building (A03) was assigned a yellow placard after the main shock and later received a red placard after the subsequent aftershocks.

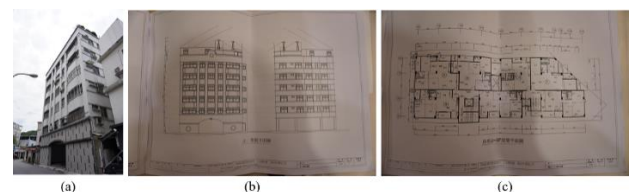
Figure 6: (a) street view, (b) elevation view, and (c) plan view of Building S03.

Building S03 is a six-storey residential building, constructed in 1993. The lateral load-bearing system of the building consists of RC moment-resisting frame (MRF) with unreinforced masonry (URM) infills. The residential complex has 36 units, and the building's first floor is used for car parking. The building has a total height of 25m, with a first-floor height of 3.9m and subsequent floors at 3m. The floor area of each storey is 935m². The building has 36 columns measuring 35cm by 60cm. The building was retrofitted in 2019 after it was damaged in the Mw 6.4 earthquake on February 6, 2018. The retrofit programme consisted of adding four 30 cm-thick RC walls and jacketing columns at the ground floor. Figures 6a–c respectively show the street view, elevation view, and plan view of the building.

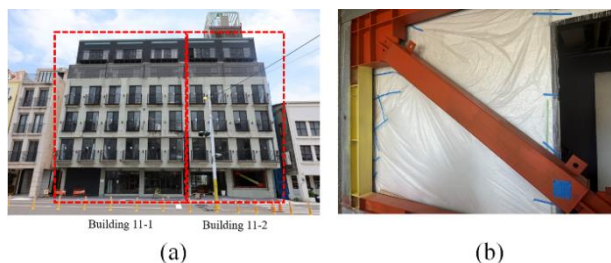
Figure 9: (a) street view of Building A11 and (b) BRB frame within the building.

Building A11 was a six-storey hotel (Hotel Les Champs Hualien) built in 1967. It has two buildings, A11-1 and A11-2, that were constructed adjacent to each other. Figure 9a shows the street view and the position of Buildings A11-1 and A11-2. The lateral load-bearing systems of these RC buildings were RC walls. The building had been retrofitted after the Mw 6.4

earthquake on February 6, 2018. The retrofit programme was self-funded and consisted of installing BRBs, as shown in Figure 9b. The building had a total height of 18m, with the first floor at 3.8m and the other floors at 3.2m. Figure shows the elevation view of this building from all directions. The plan dimensions of the building were 23.9m by 13.6m, and the typical floor area per storey was 325m². Figure 11 shows the plan view of this building.

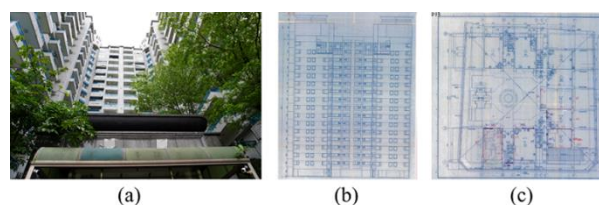
Figure 13: (a) street view, (b) elevation view, and (c) plan view of Building D13.

Building D13 was a U-shaped, seventeen-storey high-rise building constructed in 1996, with a large courtyard. The building had a mixed occupancy: the ground floor had commercial use, and the upper floors had residential use. The lateral systems of the building consisted of RC MRFs and RC shear walls. The building's total height was 50m, with the first floor at 3.2m and the other storeys at 2.9m. The floor area was 904m². Figure 13a–c present the street, elevation, and plan view of the building. The building had a large shear wall in the courtyard with visible reinforcement in a diagonal configuration. The concrete walls appeared thin and singly reinforced. Some walls had a large number of pipes running through them. There were several large-sized columns as well. There appeared to be soil subsidence due to liquefaction around the building, due to the proximity to the Meilun River. Relative settlement suggested the building was founded on piles.

The experienced PGA at the building's location was recorded as 0.4g. The reconnaissance data suggest that the building showed poor structural and non-structural seismic performance. A yellow placard was officially placed. The majority of the 128 household residents had moved out by the time of the visit.

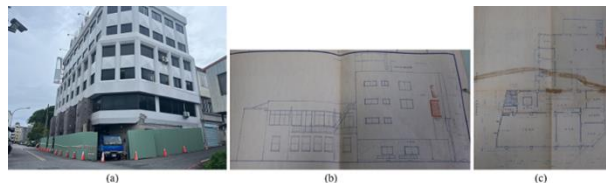
Figure 15: (a) street view, (b) elevation view, and (c) plan view of Building D10.

Building D10 was a six-storey office building for a news agency constructed in 1968. The lateral load-bearing system consisted of RC MRF and RC shear walls. The ground floor of the building had been retrofitted before the earthquake. The height of the building was 18m, where the height of the two bottom floors was 3.3m and 3.2m respectively, and a floor height of 3m for the other storeys. The floor area was 650m². RC shear walls had short spans along the x-axis. Figure 15a–c presents the street view, elevation view, and plan view of Building D10.

The PGA experienced at the building's location was recorded as 0.44g. The building was occupied after the earthquake, and at the time of reconnaissance, despite slight to moderate structural damage being observed. The building was officially assigned a yellow placard. As shown in Figure 16, shear failure of one column was observed. There were visible cracks in the masonry infill walls, especially around the south corner of the building. There were also visible cracks at the base of columns around openings of the RC shear walls along the y-axis.

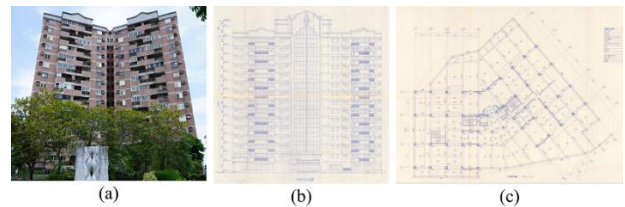
Figure 19: (a) street view, (b) elevation view, and (c) plan view of Building O67.

Building O67 was a 15-storey building constructed in 1994. The building consisted of two identical buildings separated by a seismic gap. The building's occupancy was mixed, with the ground floor used for commercial shops and the upper floors for residential use. The lateral load-bearing system of the building consisted of RC MRF with URM infills and RC walls. The building had a total height of 46m, with the first floor 3.6m high and the other storeys 3m high. The floor area was 432 m². Figure 19a–c illustrates the street, elevation, and plan view of the building.

The PGA experienced at the building's location was recorded as 0.41g. Building O67 showed a poor seismic performance following the earthquake. It was assigned a red placard. All 118 households had vacated the building. As shown in Figure 20, structural damage included shear failure of an RC wall in the staircase, shear failure of beams, shear failure of RC exterior partition infill walls above the second floor, and shear failure of hanging walls with a horizontal reinforcement fracture. Damage to several non-structural elements included damage to interior suspended ceiling panels. There were large diagonal cracks in the exterior tiles due to damage to the exterior concrete infills, creating a considerable falling hazard. The building manager had shut down power and water, but there was no reported disruption to the utility supply.

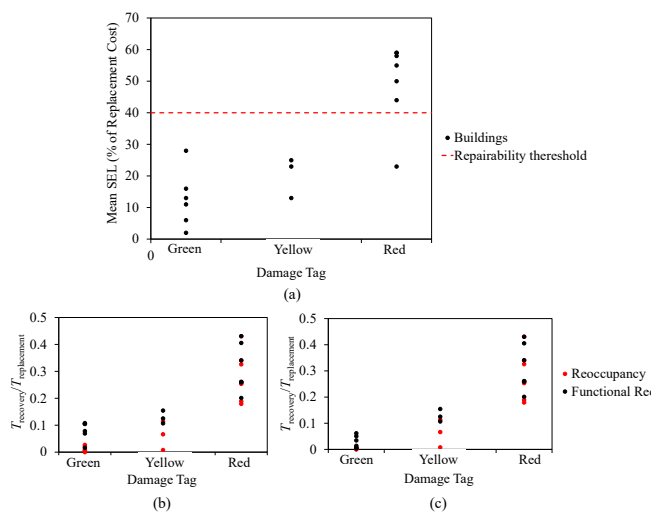
Figure 21: Benchmarking outputs for all the buildings in terms of: (a) mean SEL; normalised recovery time with (b) default SP3 assumptions and (c) better-quality non-structural components for slightly damaged buildings.

Figure 21a shows that almost all the buildings with red placards had a predicted SEL of over 40%. According to the FEMA P-58 framework [3], the building repairability threshold is set at a repair-to-replacement cost ratio of 40%. In other words, it is estimated that repairing a damaged building would be economically justifiable only if the cost is less than 40% of its replacement cost. SP3 appears to have accurately predicted which buildings need to be demolished and replaced following the earthquake, with a predicted SEL of above 40%. Data on repair costs for many buildings were unavailable at the time of reconnaissance. A longitudinal recovery reconnaissance is needed to collect repair cost data so that the prediction of repair costs using FEMA P-58 can be further benchmarked, as in previous studies such as the 1994 Northridge Earthquake [25], the 2009 L'Aquila Earthquake [24], and the 2010/2011 Canterbury Earthquake sequence [23].

As shown in Figure 21b, the recovery time required for buildings with red placards appears consistent between the observed data and SP3 predictions. Moreover, Figure 21c shows that for buildings that received no placard, SP3's predictions of damage and functionality match the observed building performance, with non-structural components such as HVAC units and elevators remaining functional. The discrepancy between the observed and the predicted performance is resolved in Figure 21c, where local conditions and higher quality and anchorage of non-structural elements are considered. In contrast, the buildings with a red placard are predicted to have a poor structural performance, and their long recovery time is mainly due to their extensive structural damage, even if better-quality non-structural components were used.
