PERFORMANCE EVALUATION AND COST ASSESSMENT OF WEAK-STORY RETROFITS IN RC BUILDINGS SURVEYED AFTER THE 2024 HUALIEN EARTHQUAKE

Jonathan Monical¹, Alex Shegay², Tomomi Suzuki³,
Tsung Chih Chiou⁴, H. Huseyin Aydoğdu⁵, Lucas S. Hogan⁶,
Zhuoran Yi⁷, Julian Benito⁸, Julian Rincon⁹ and Min Lang Lin¹⁰

ABSTRACT

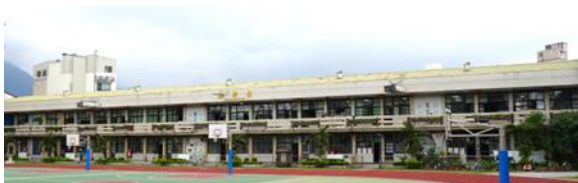
Figure 12: Building C43 with retrofitting.

General information of the school buildings compared in Case Study 1 is given in Table 2 and additional details are included in the Appendix. The two school buildings surveyed in Hualien City were low-rise structures with regular plans and prior to retrofitting each had no full-height walls oriented in the x-direction. Building S01 had no retrofitting and was demolished after the earthquake due to severe damage (Figure 11). Building C43 had retrofits applied in 2010 (before the 2024 Hualien Earthquake) and suffered minor damage after the earthquake (Figure 12).

Building S01 suffered severe earthquake damage while Building C43 suffered only minor damage. Building S01 had shear failures with subsequent axial failures in most columns located next to windows (captive columns) as seen in Figure 20. Building C43 was observed to have much less damage consisting of small, inclined cracking in RC shear walls (Figure 21).

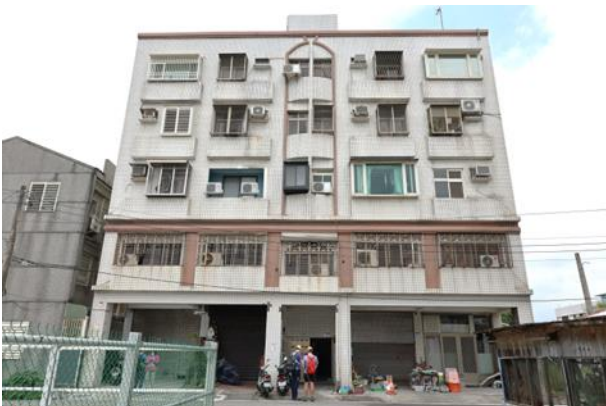
Figure 22: Building C05 without retrofitting.

Parameters of the residential and hotel buildings compared in Case Study 2 are summarized in Table 4. These two buildings surveyed in Hualien city were low-rise structures with regular plans and prior to retrofitting had few full-height walls oriented in the x-direction. Building C05 had no retrofitting, suffered moderate structural damage, and building functionality was disrupted after the earthquake including temporary displacement of tenants (Figure 22). Building A11 consisted of two similar buildings side by side (A11-1 and A11-2) separated by a seismic expansion joint. Both A11 Buildings had retrofits applied in 2013 and each suffered minor structural damage (Figure 23).

In the weaker and more flexible x-direction of Building C05, shear failure occurred in the single RC shear wall (Figure 28). This wall was located adjacent to a door opening increasing its vulnerability. In the stronger y-direction of the building, small, inclined cracks were observed in RC shear walls and minor concrete spalling occurred at joints of stairs. Masonry infill walls in the y-direction had moderate to severe damage but did not collapse (Figure 29).

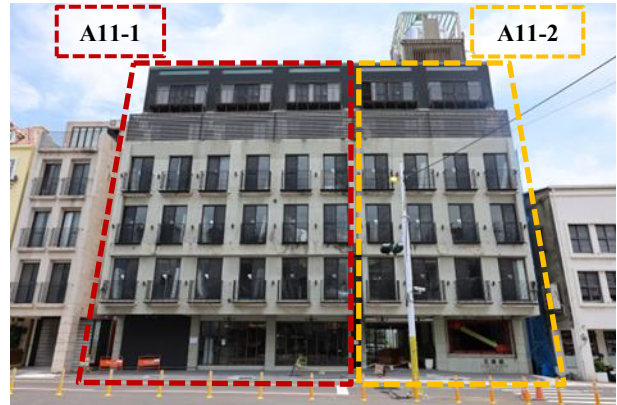
Figure 23: Building A11 with retrofitting.

Building A11 was observed to have minor damage consisting of small, inclined cracking on exterior columns (Figure 30). Additional cracking and damage at the seismic joint may have been caused by pounding between Buildings A11-1 and A11-2 (Figure 31).

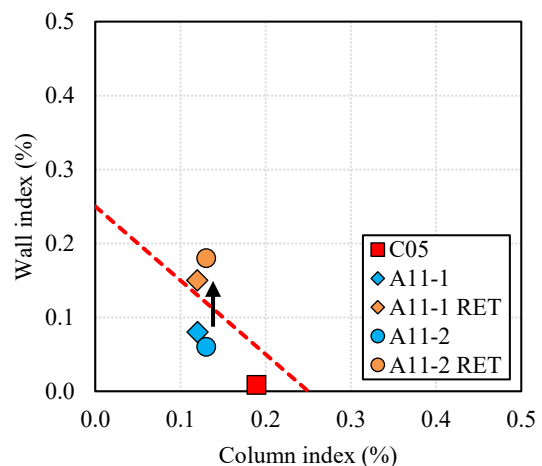
Building C05 had a relatively large column index of nearly 0.2% but the minimum wall index of 0.01% was observed to be small because of a single RC shear wall oriented along the x-axis (Figure 27) producing a Hassan index below the safety boundary indicating seismic vulnerability. Prior to retrofitting, Building A11 had column indices between 0.12-0.13% and wall indices between 0.06-0.15% producing Hassan indices near the safety boundary indicating small to moderate seismic vulnerability. After retrofitting, steel braces transformed into equivalent shear walls (estimated using Eqs. 4-8) increased minimum wall indices to values between 0.15-0.30%. Refer to the Appendix for additional information about column and wall indices.

Figure 27: Case Study 2 - Hassan indices.

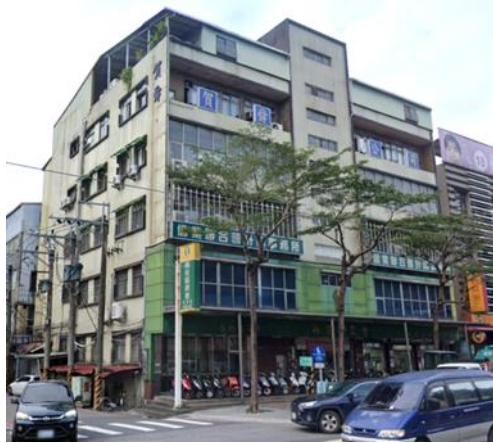
Figure 32: Building E35 without retrofitting.

After the earthquake, Building E35 had one column with axial failure and two columns with shear failures (Figure 41). Steel columns were used to shore the soffit of the second level floor slab around the column with axial failure which showed signs of severe corrosion and significant section loss for both longitudinal and transverse reinforcement. Masonry infill walls were observed to have inclined cracks wider than 1 mm. The building was evacuated except for the bank located on the first floor which operated one hour in the morning and one hour in the afternoon.

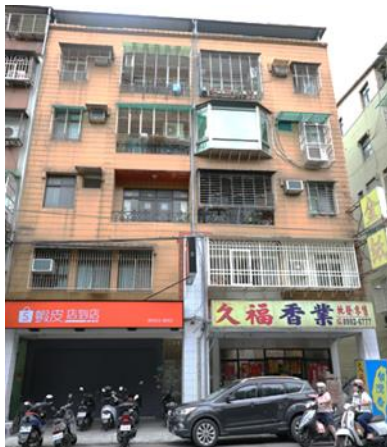
Figure 33: Building E36 with retrofitting.

Building E36 was observed to have minor damage consisting of 0.5-mm wide inclined cracks observed in columns with RC jacketing serving as boundary columns for the retrofitted shear wall in the first story (Figure 42). No disruption to commercial or residential units was observed or reported.

The two retrofits which addressed serviceability issues consisted of encasing exterior columns with steel plates to reduce rate of corrosion affecting column longitudinal bars and adding steel beams to soffit of second level floor slab in y-direction to reduce vertical deformations. Both retrofits were designed to increase the service life of structure.

The structural retrofitting cost for Building E36 was nearly 50% of total project cost (Table 9). But the amount which increased stiffness and strength (RC column jacketing, RC shear walls, and larger foundations) was smaller than 20% of total project cost. The remaining structural retrofitting cost was aimed at addressing serviceability issues including encasing exterior columns with steel plates to reduce effects of weathering, installing steel beams under the second-floor slab to prevent excessive deflections, and other fees such as temporary lavatories, temporary openings in walls, and restoration of openings after retrofit completion. Based on these data, it is plausible that installing additional RC shear walls in the weak direction of the building to double the wall index (y-axis of Figure 36) could be financed by increasing the total project cost by no more than 5% (based on the 4% value for RC shear wall retrofits indicated in Table 9).

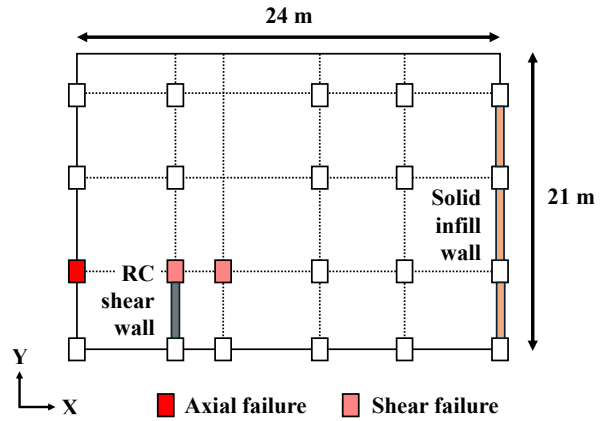
Building E35 was a 5-story structure with 4 spans in the x-direction and 3 spans in the y-direction (Figure 35). Typical column sizes were 35×60 cm. A single RC shear wall and full-height infill walls were oriented along the y-direction and no walls were oriented along the x-direction.

Figure 35: Building E35 structural plan.

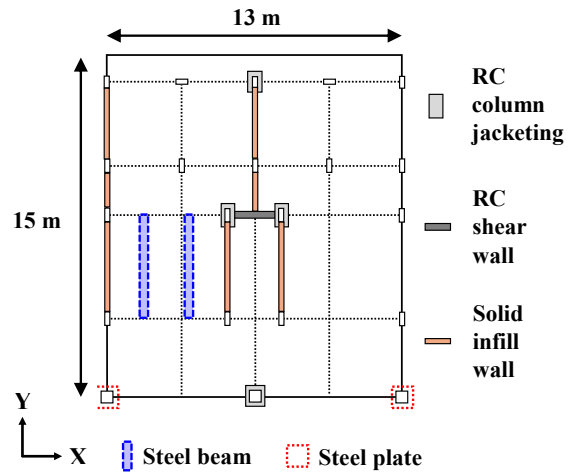
Building E36 was a 5-story structure with 2 to 4 spans in the x-direction and 4 spans in the y-direction (Figure 36). Typical column sizes were 18×50 cm and 18×60 cm. Full-height masonry infill walls were oriented along the y-direction and no walls were oriented along the x-direction.

Figure 36: Building E36 structural plan.

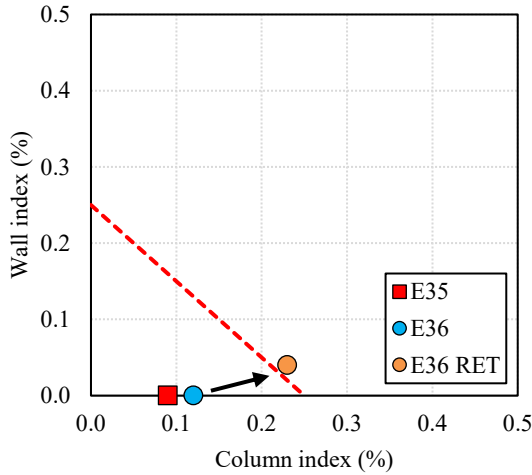
Prior to retrofitting, Buildings E35 and E36 had column indices of approximately 0.1% and no walls in the y-direction, indicating significant seismic vulnerability (Figure 40). After retrofitting, column indices of Building E36 more than doubled and the minimum wall index increased to 0.04% resulting in a Hassan index just above the safety boundary. Refer to the Appendix for additional information about column and wall indices.

Figure 40: Case Study 3 - Hassan Indices.
