IMPACTS OF SURFACE FAULT RUPTURE ON RESIDENTIAL STRUCTURES DURING THE 2016 M_w 7.8 KAIKŌURA EARTHQUAKE, NEW ZEALAND

Russ J. Van Dissen¹, Timothy Stahl², Andrew King³, Jarg R. Pettinga⁴, Clark Fenton⁵, Timothy A. Little⁶, Nicola J. Litchfield⁷, Mark W. Stirling⁸, Robert M. Langridge⁹, Andrew Nicol¹⁰, Jesse Kears¹¹, David J. A. Barrell¹² and Pillar Villamor¹³

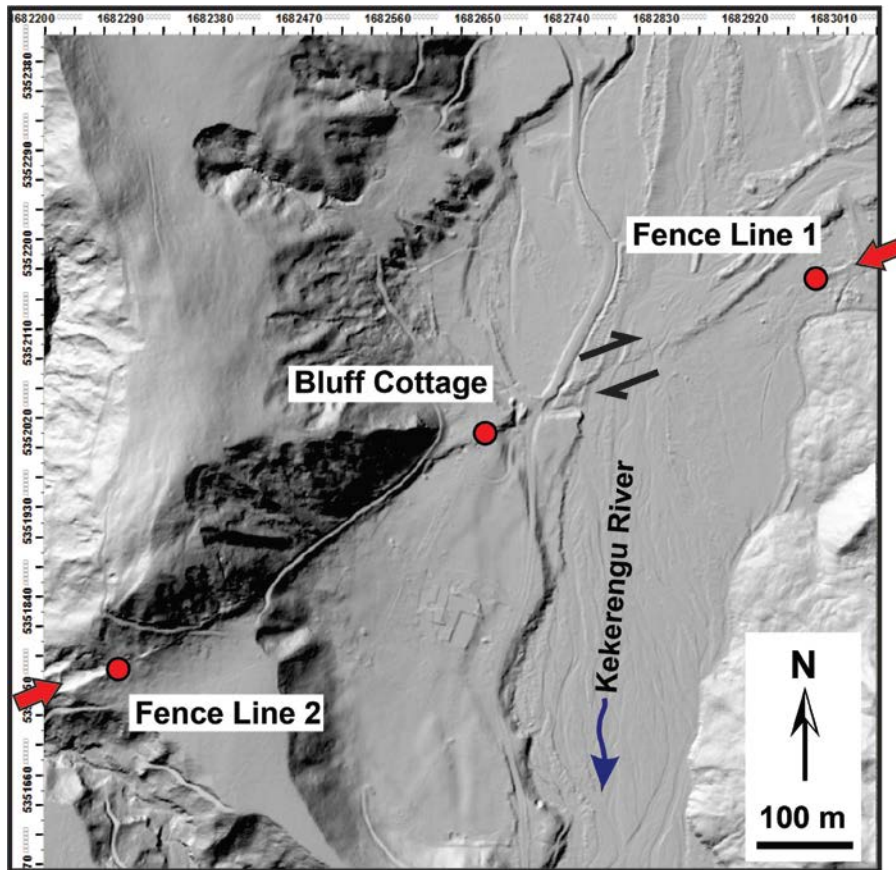
Figure 2: 2016 post-earthquake LiDAR hill shade DEM illuminated from the NW showing location of surface rupture trace of the Kekerengu Fault (red arrows), Bluff Cottage (Figure 3), the two offset fence lines depicted in Figure 4, and the sense of strike-slip on the Kekerengu Fault (black arrows). Though the size of Bluff Cottage portrayed in this figure is significantly exaggerated, its orientation is accurate. Coordinates are New Zealand Transvers Mercator 2000.
