## THE M8.8 CHILE EARTHQUAKE, 27 FEBRUARY 2010

### SUMMARY

This report summarises the observations of the NZSEE/EQC teams, supplemented by media updates on the Chilean reconstruction experience one year after the earthquake.

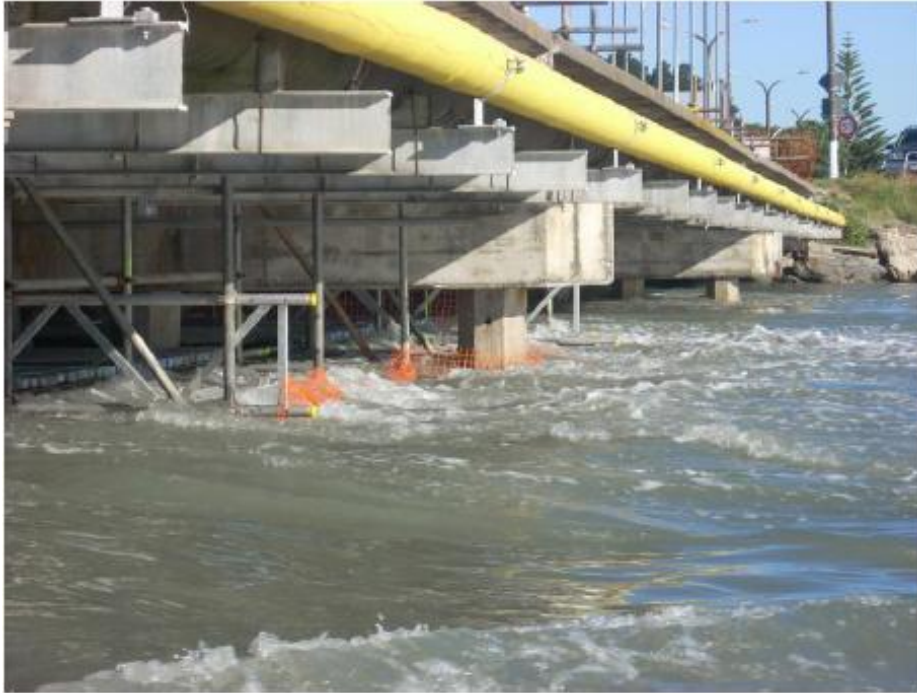
*Figure 2.2a: Strong currents from the Chilean tsunami move under the Westshore bridge, Napier (from Pearse, 2010).*

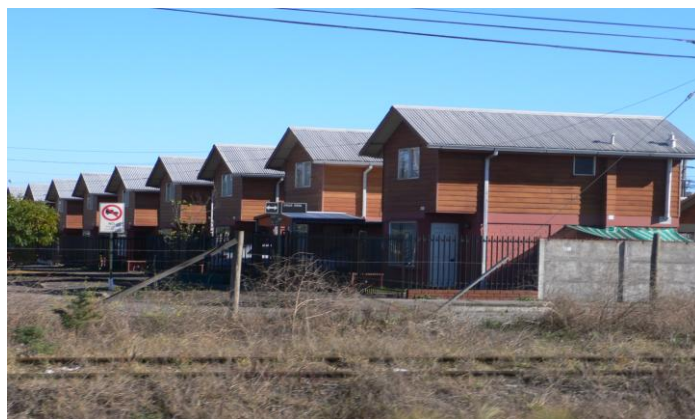
**Figure 5.1b:** *A typical residential subdivision in the Concepción region where no sign of damage was observed. (Photo: Graeme Beattie).*

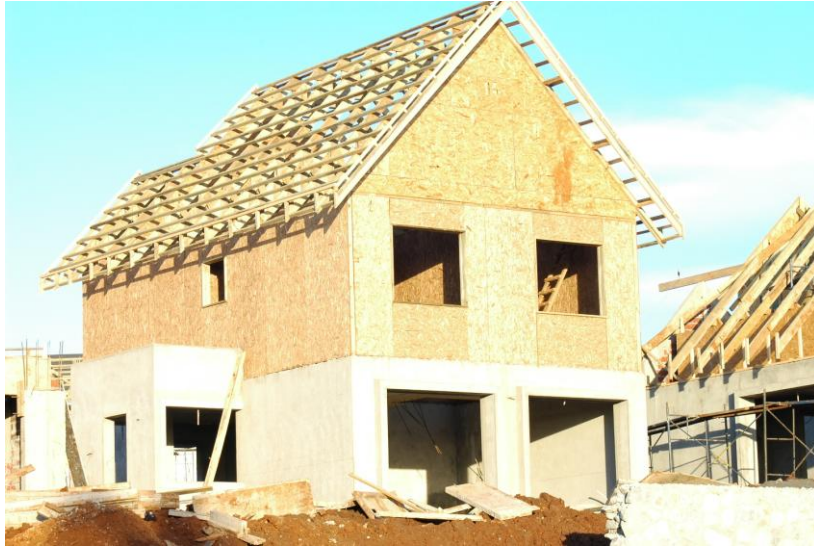
**Figure 5.1c:** Residential home in Concepción incorporating lower storey of reinforced masonry and upper storey of plywood and timber frame. (Photo: Hugh Cowan).

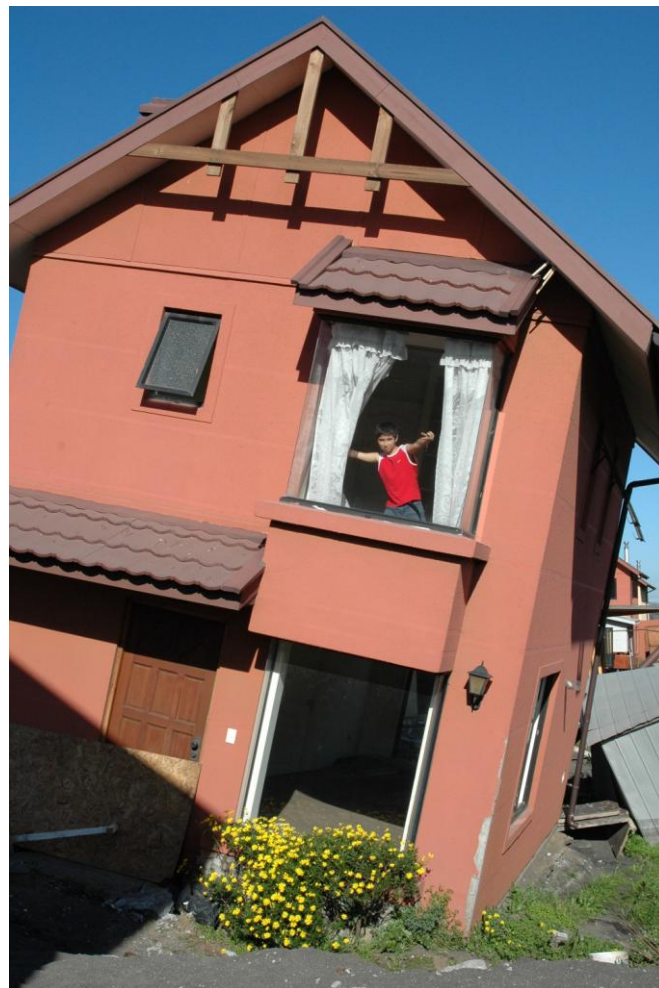
lower storey and light steel frame upper storey were observed to have performed well (Figure 5.1b). Similarly good performance was observed in up-market suburbs with reinforced concrete lower storey homes and timber-frame upper storeys (Figure 5.1c). Several homes situated adjacent to a minor waterways on the alluvial floodplain nearby, however, suffered severe deformation as a result of localised lateral spreading beneath the floor slab (Figure 5.1d) comparable to

**Figure 5.1d:** Severe deformation of a concrete floor slab and settlement of a two-storey home, constructed on soft soils in an area that experienced lateral spreading adjacent to a waterway near Concepción. (Photo: Hugh Cowan).

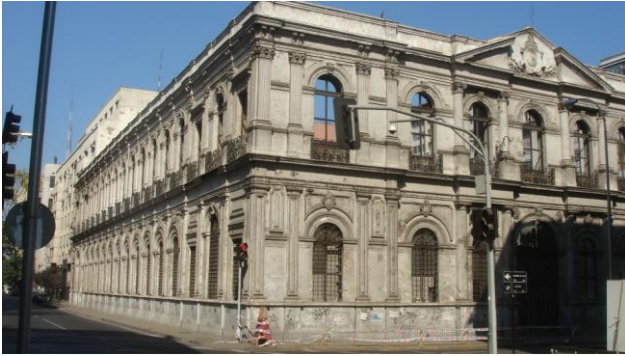
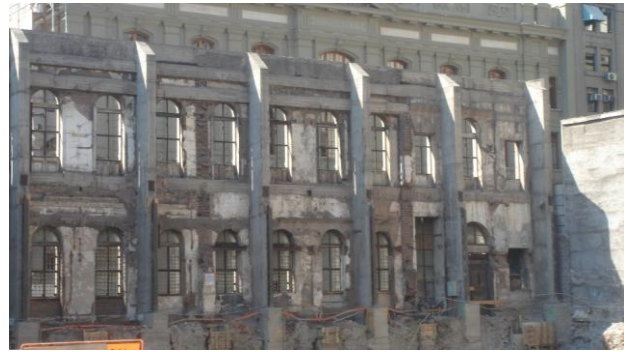
**Figure 5.2b (Photos: Peter Smith).**

The Chileans appreciate the ornate building facades of the older buildings and an example of the structural support of such a facade during re-development of a site was identified during the mission. The examples that were identified appeared to be robustly detailed utilizing substantial

reinforced concrete columns anchored to the face of the basement excavations and integrated with the temporary retaining system for the excavation. The system performed well during the earthquake, preserving the façade in an undamaged condition.

*Temporary support of Building façade in central Santiago.*

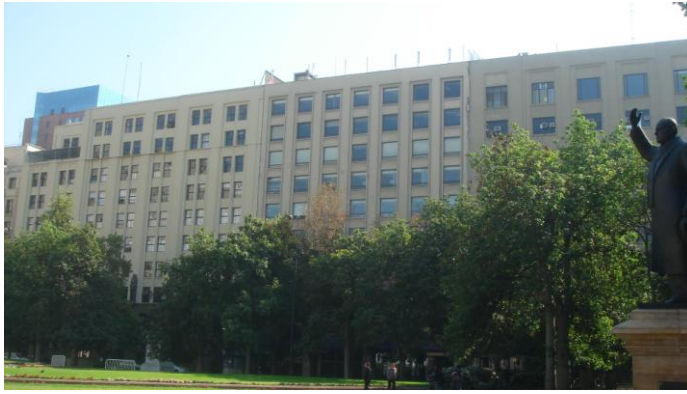
*Low rise commercial buildings in central Santiago.*

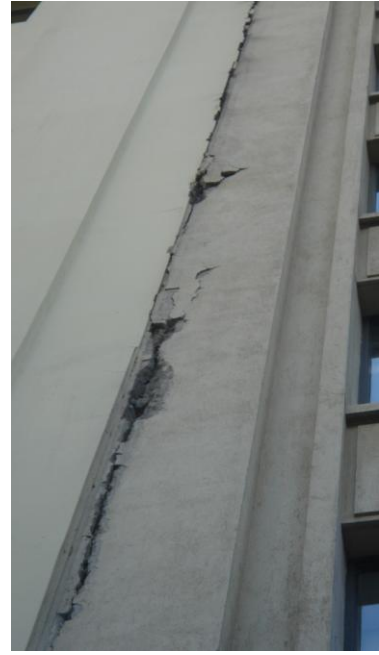
There were some exceptions where differences in the height of buildings and offsets between floor levels resulted in pounding which was detrimental to the structure of one or both buildings (Figure 5.2d).

*Pounding between buildings in central Santiago.*

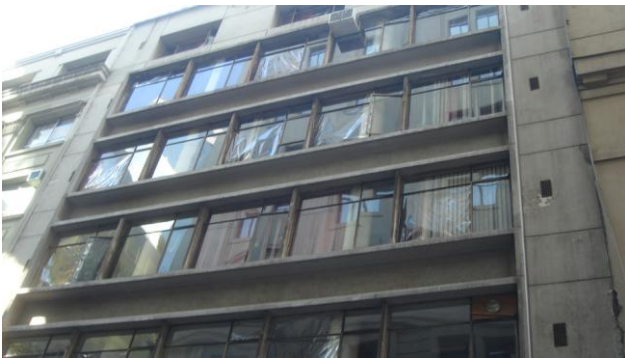
*Pounding between tower and podium of Direccion Regional Santiago Centro.*

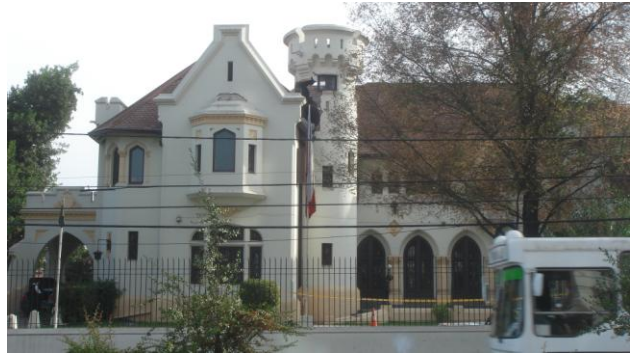
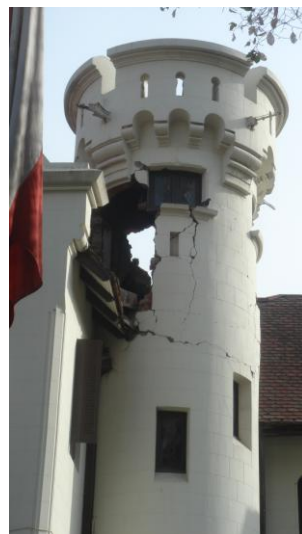
*Pounding between tower and dwelling in Santiago.*

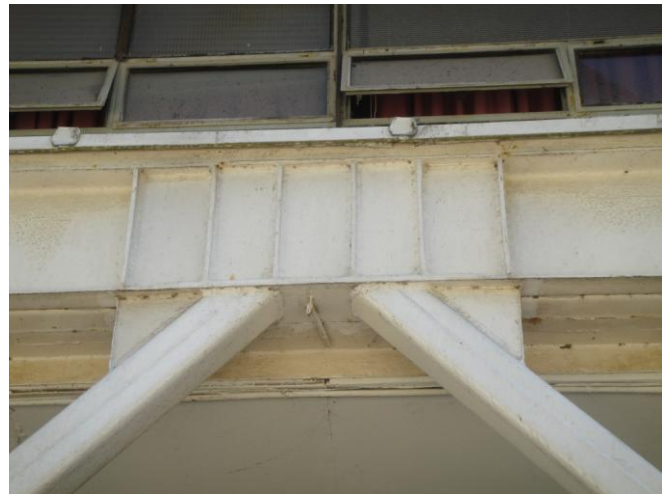
*Figure 5.2f (Photos: Peter Smith).*

Steel K braces had been used to retrofit two three storey buildings at the University of Concepción (Figure 5.2f).

*Unyielded steel active link in three-storey building at University of Concepción.*

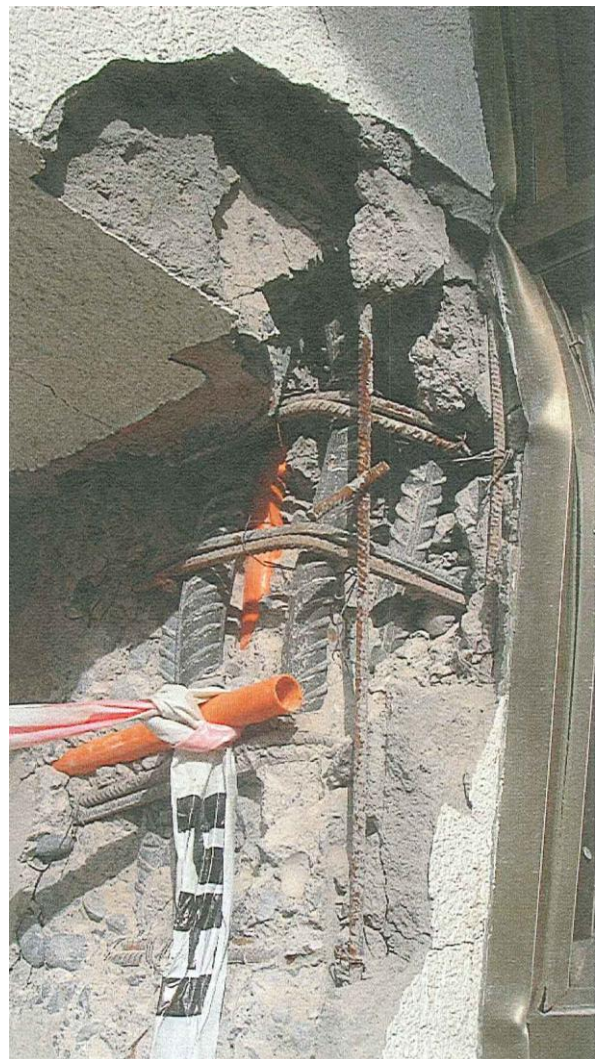
*Figure 5.3a (Photos: Peter Smith).*

*Lack of confinement to walls in Los Cerezos Apartment building.*

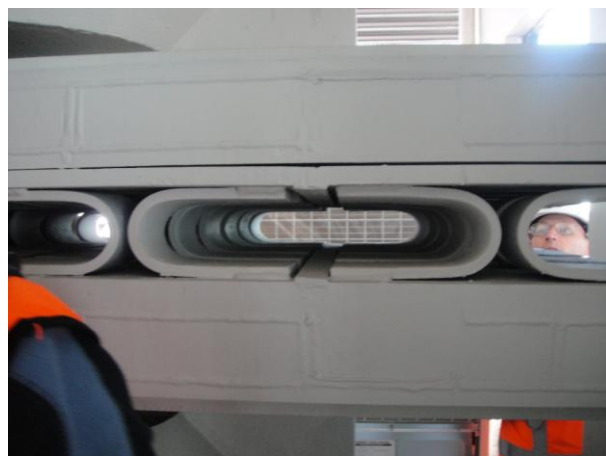
The building is of advanced design incorporating energy dissipaters, which are activated by the cumulative inter-storey drift over every three floors above level 15. Large steel cross braces are used to transfer deformations to the dissipaters at the ends of the building in the transverse direction while secondary shear walls are used for this purpose in the longitudinal direction. The dissipaters induce yielding in multiple U plates to dissipate energy (Figure 5.5a).

*Energy dissipaters Titanium Building, Santiago.*

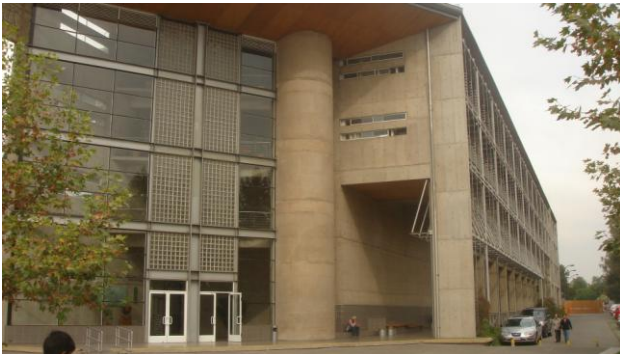
*Catholic University of Chile building.*

Several important buildings are base isolated. The Catholic University building in Santiago suffered very minor damage and had a permanent deformation in the lead rubber bearings (Figure 5.5b).

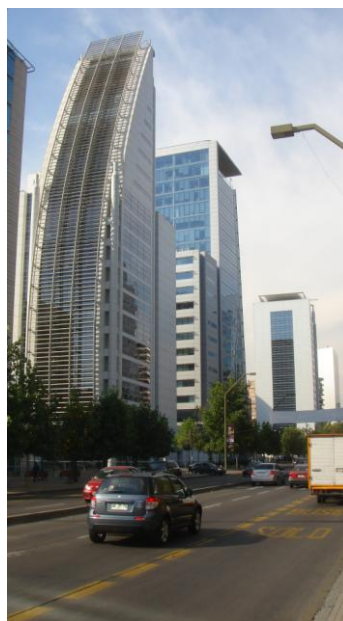
Most commercial buildings in Santiago appeared to have suffered little or no structural damage indicating that the design and construction of commercial buildings were to a higher standard than that adopted for apartment buildings (Figure 5.5c).

*Figure 5.5c: Undamaged commercial buildings in Central Santiago. (Photo: Peter Smith).*

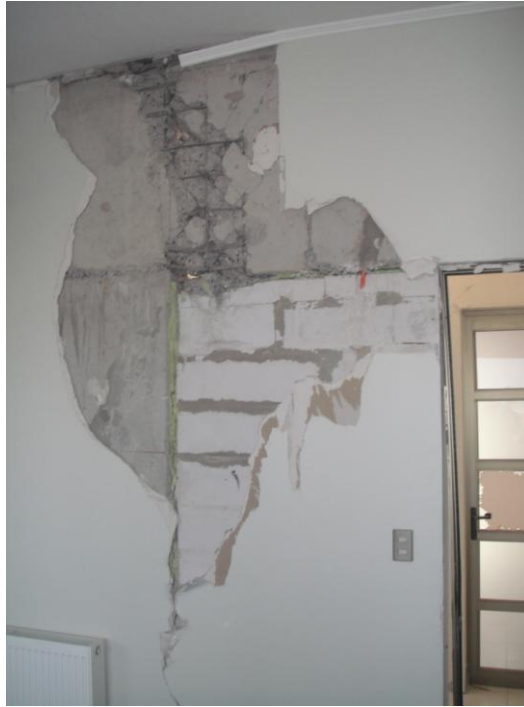
In one Concepción apartment building where masonry infill panels had been used, the seismic separation detail formed by

using extruded polystyrene resulted in very significant structural and non-structural change (Figure 5.8a).

*Figure 5.8a: Seismic separation. (Photo: Peter Smith).*

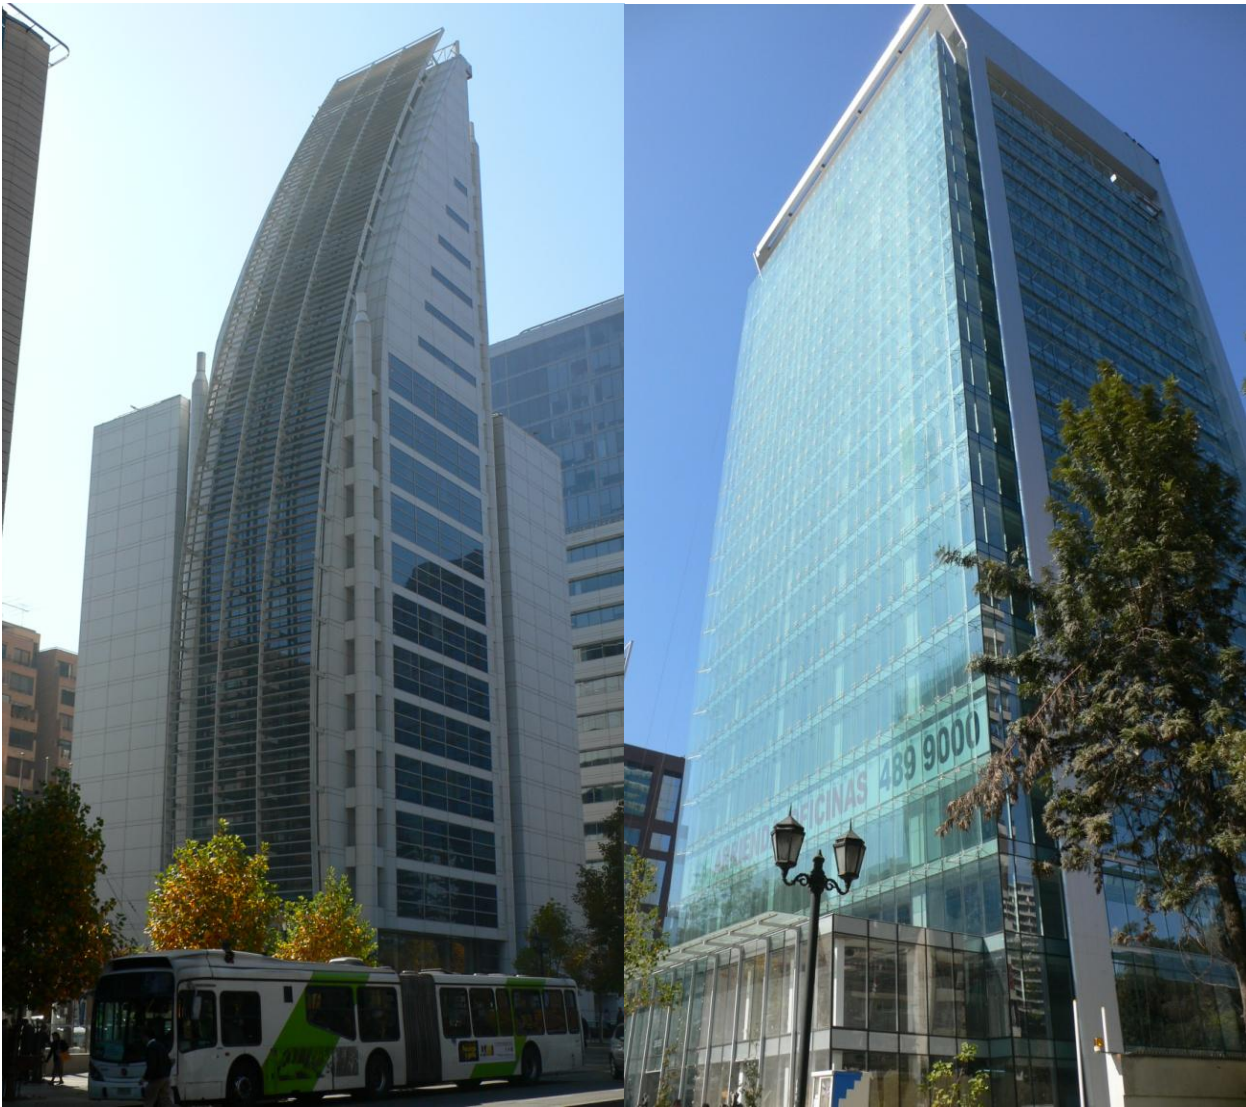
There are likely to be many older (1950s and 1960s) buildings in New Zealand of similar design that are likely to fare poorly in a major earthquake. These buildings may not yet have been identified as being likely to lose glass in a severe earthquake. The team's observations in both Concepción and Santiago were that curtain wall glazing systems on more modern buildings behaved very well (Figure 5.9b). This was corroborated by other foreign teams and by local engineers with whom we spoke.

*Figure 5.9b: Examples of curtain wall glazing that survived the earthquake with no damage in Santiago. (Photos: Graeme Beattie).*
