## GENERAL OBSERVATIONS OF EFFECTS OF THE 30th SEPTEMBER 2009 PADANG EARTHQUAKE, INDONESIA

**Jitendra Bothara<sup>1</sup>, Dick Beetham<sup>2</sup>, Dave Brunson<sup>3</sup>, Mike Stannard<sup>4</sup>, Roger Brown<sup>5</sup>, Clark Hyland<sup>6</sup>, Warren Lewis<sup>7</sup>, Scott Miller<sup>8</sup>, Rebecca Sanders<sup>9</sup> and Yakso Sulistio<sup>10</sup>**

### SUMMARY

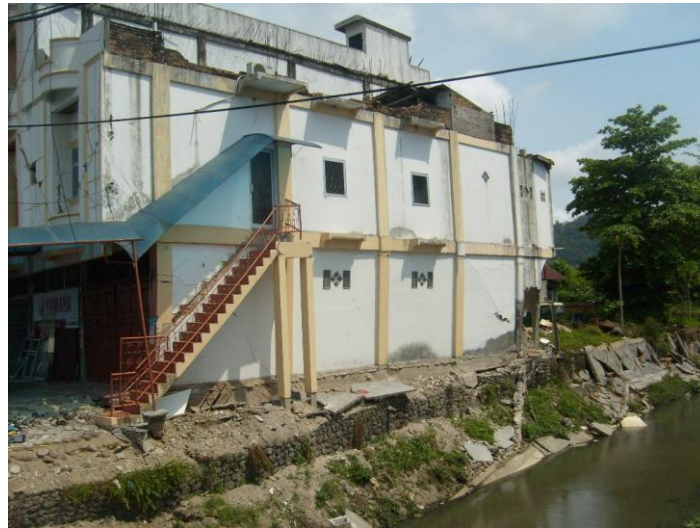
**Figure 3.4:** Settlement of ground surrounding a building due to lateral movement and rotation of a retaining wall.

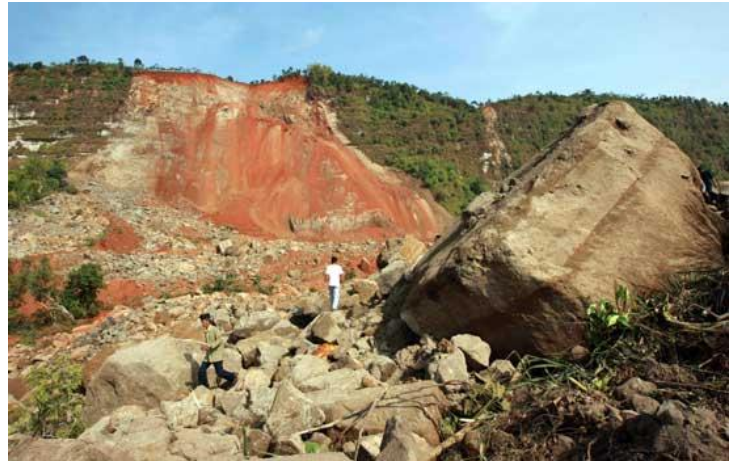
**Figure 3.7:** *Rock slides from part of the caldera rim which surrounds Lake Manijau.*

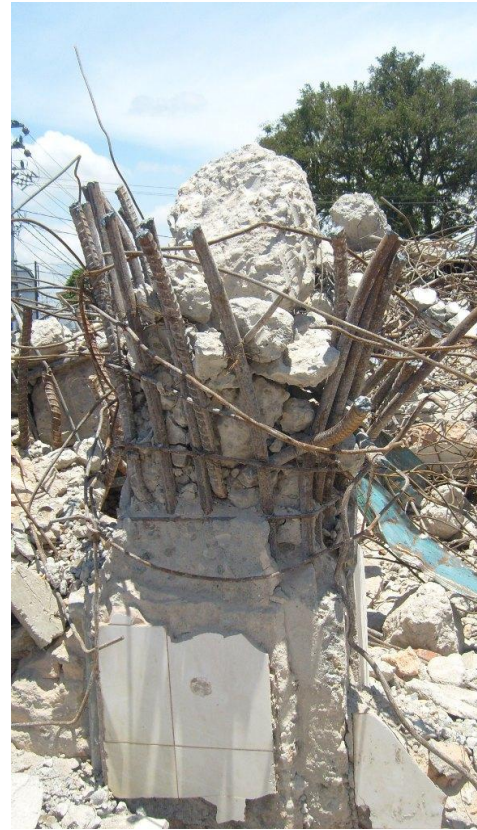
Use of plain bars, even up to 20 mm in diameter, for longitudinal reinforcement in columns and beams is common in the Padang area (Figure 5.3b). Mixing of deformed and plain bars is also common in the area (Figure 5.3c). In a number of cases, the reinforcement in columns (Figure 5.3d) were bent during construction—this led to reduction in tension capacity and often blew the concrete out when the bars tried to straighten, or came into compression during earthquake shaking. In a few cases, reinforcement splicing lengths were found to be about 20 diameters or even less for plain bars. Column bars are invariably lapped at the column base.

*c) Mixing of plain and deformed reinforcing bars.*

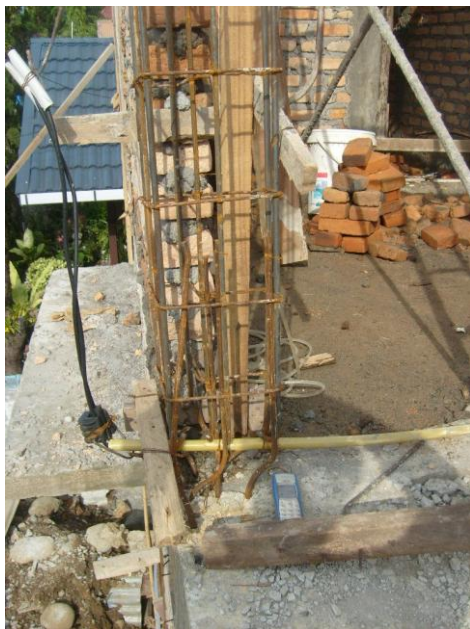
*d) Bent bars at the column base.*

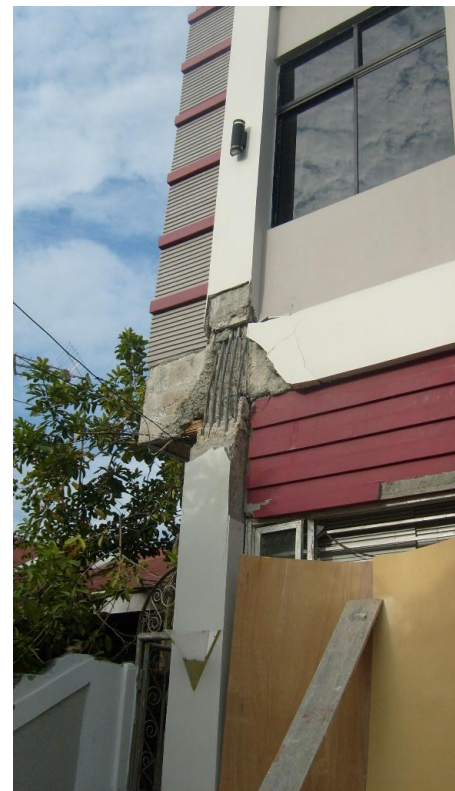
In detailing, stirrups were often observed at greater than 300 mm spacing throughout the column. It is not usual practice to provide stirrups in the beam-column joints (Figure 5.3e) and 90° hooks (Figure 5.4) are very common for stirrups, even in newer construction, although the seismic standard recommends 135° hooks. Ties are not used in columns.

*e) No stirrups in beam-column joint.*

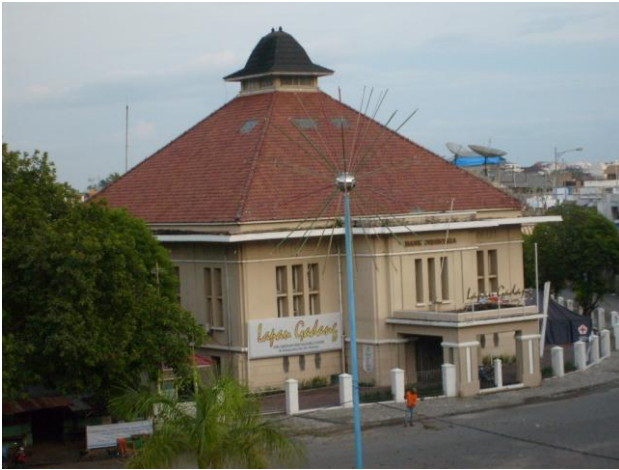
*a) Old Bank of Indonesia - a Dutch era building that survived without structural damage.*

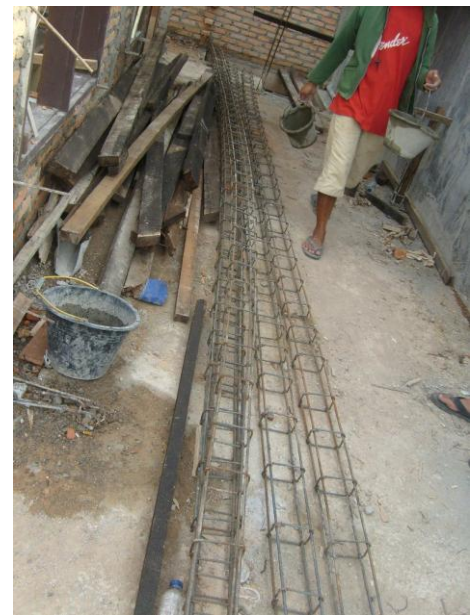
*c) Reinforcement ready for a practical beam. More stirrups would make a big improvement.*

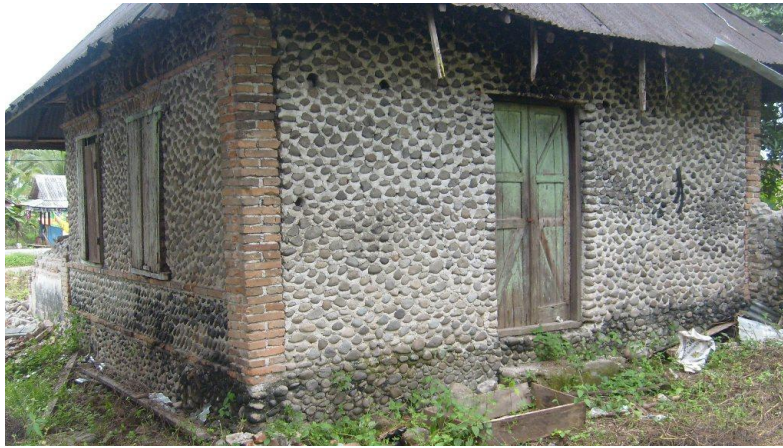
Many damaged or collapsed stone masonry buildings were observed in Sicincin village, one of the heavily damaged earthquake-affected areas. Typical stone masonry buildings were simple one- to two-storey dwellings. The walls of these buildings were constructed of river boulders (around 100 mm diameter) in a lime or cement-sand mortar. The typical thickness of these walls was of the order of 250 mm. The floors and roofs of these buildings were constructed of timber. One of the dwellings visited had corners constructed of bricks. During the shaking, the brick masonry separated from the stone masonry (Figure 6.15).

*Figure 6.15: A stone masonry building with unreinforced brick columns.*

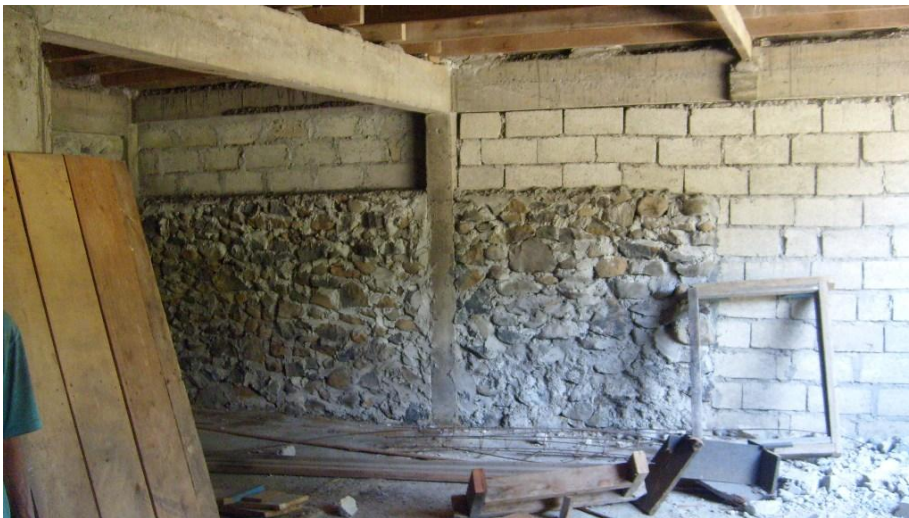
*b) Mixing of infill wall materials.*

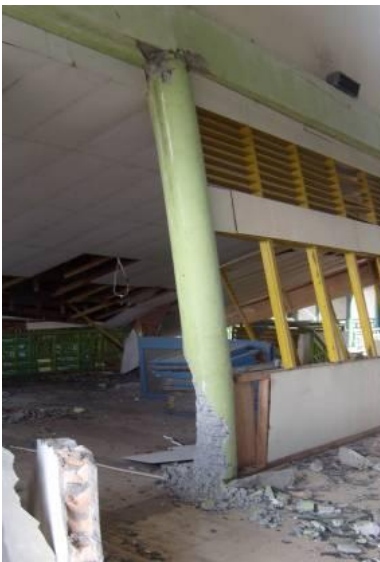
**Figure 6.21:** Excellent performance of a column with spiral stirrups in the bus terminal building.

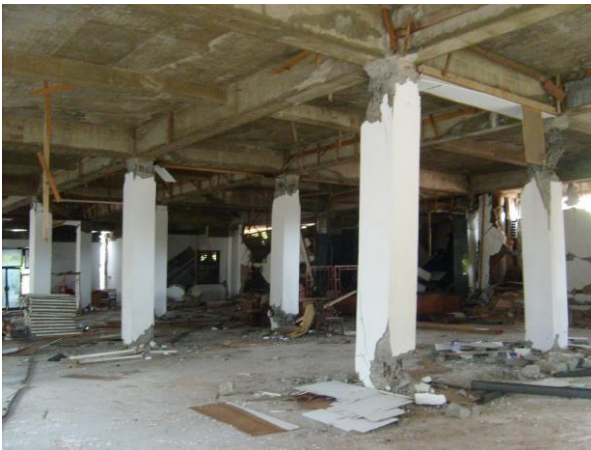
*b) Plastic hinging of columns of an open bottom storey.*

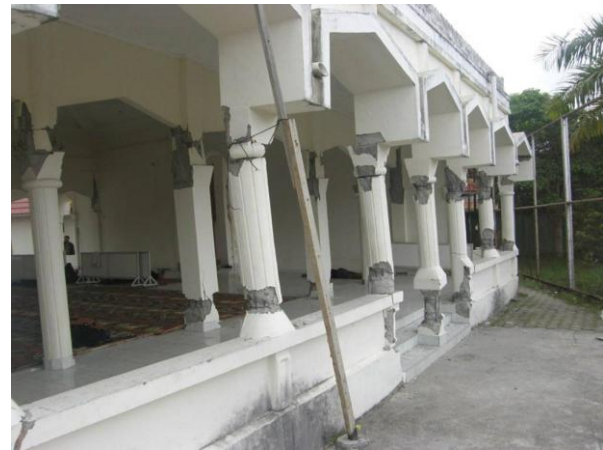
*c) Column hinging at top and bottom. The building survived due to the alternate gravity load-carrying system provided by the walls. Note the large rotation of columns imposed by shortening of columns due to the sill wall.*

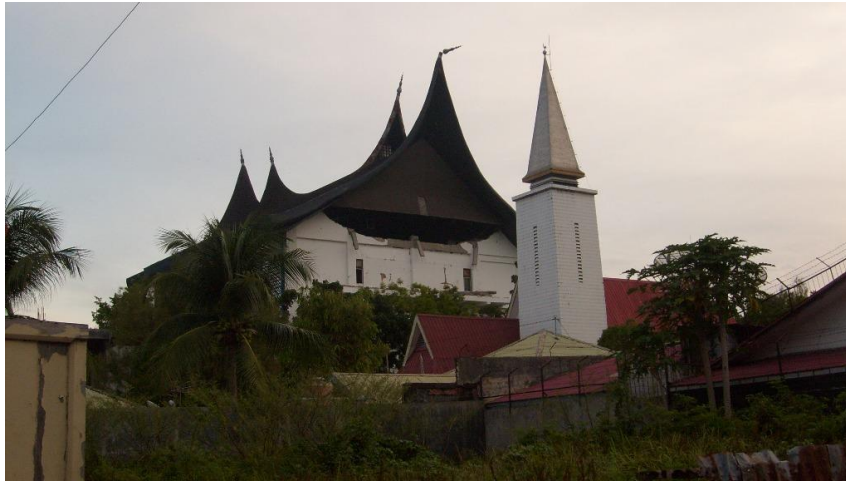
photographs showing non-structural damage. Figure 7.1 shows a museum that shed roof tiles due to shaking because tiles were not tied to the purlins. Figure 7.2 shows a “pinnacle” at the top of a building leaning on one side because of amplification of severe shaking. Damage to false ceilings was observed in many buildings (Figure 7.3) because of a lack of proper ties and detailing.

**Figure 7.2:** *Tilting “pinnacle” and toppled gable wall.*
