**THE PISCO (PERU) EARTHQUAKE OF 15 AUGUST 2007**  
**NZSEE Reconnaissance Report, June 2008**

**David Hopkins, Darrin Bell, Rafael Benites, James Burr,  
 Craig Hamilton and Rudolph Kotze**

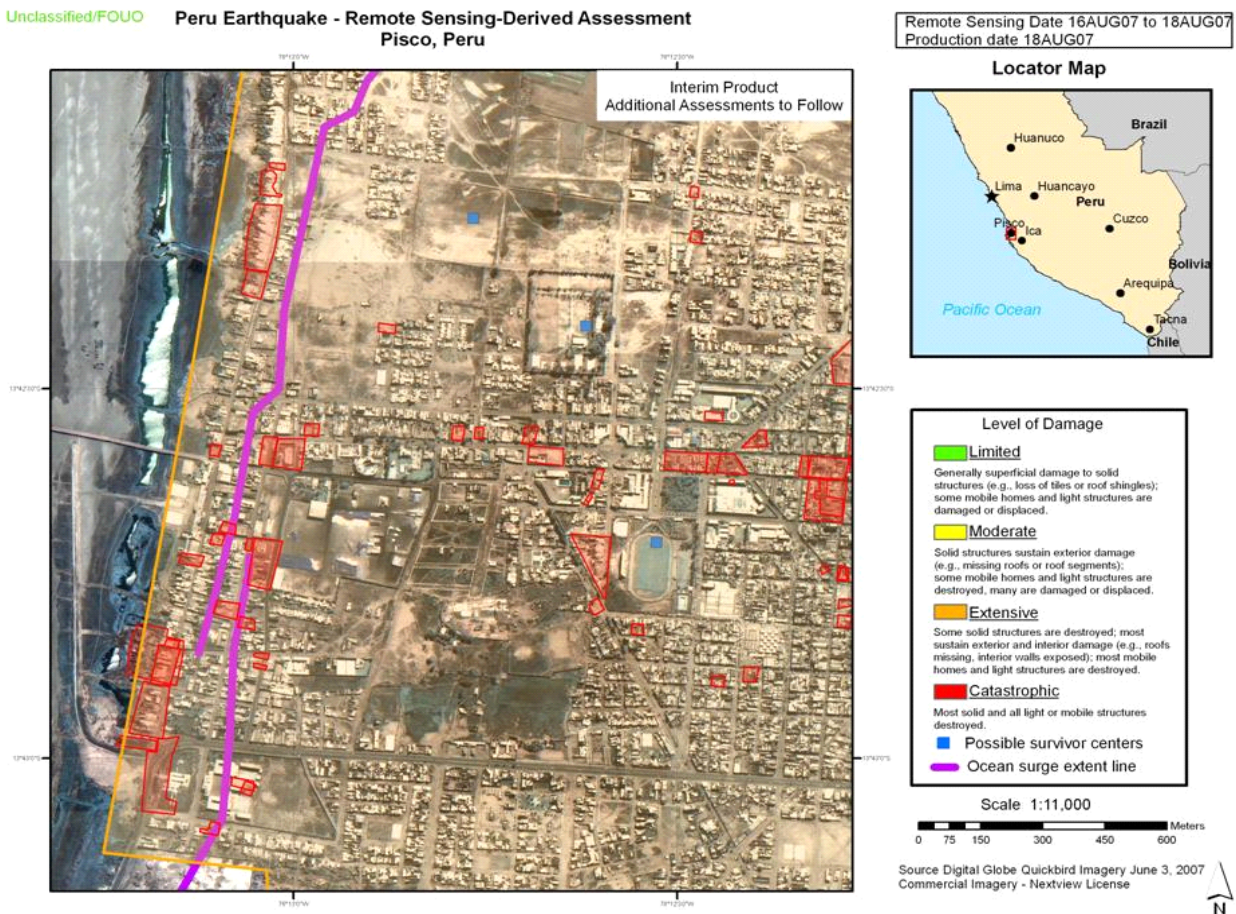
**Figure 11. Aerial view of Pisco showing worst-damaged areas**  
Photo courtesy INDECI Pisco

Figure 11 shows the impacted areas in Pisco with possible survivor centres and ocean surge extent lines. This shows how satellite technology can be overlaid with the intelligence gathered from aerial and ground reconnaissance.

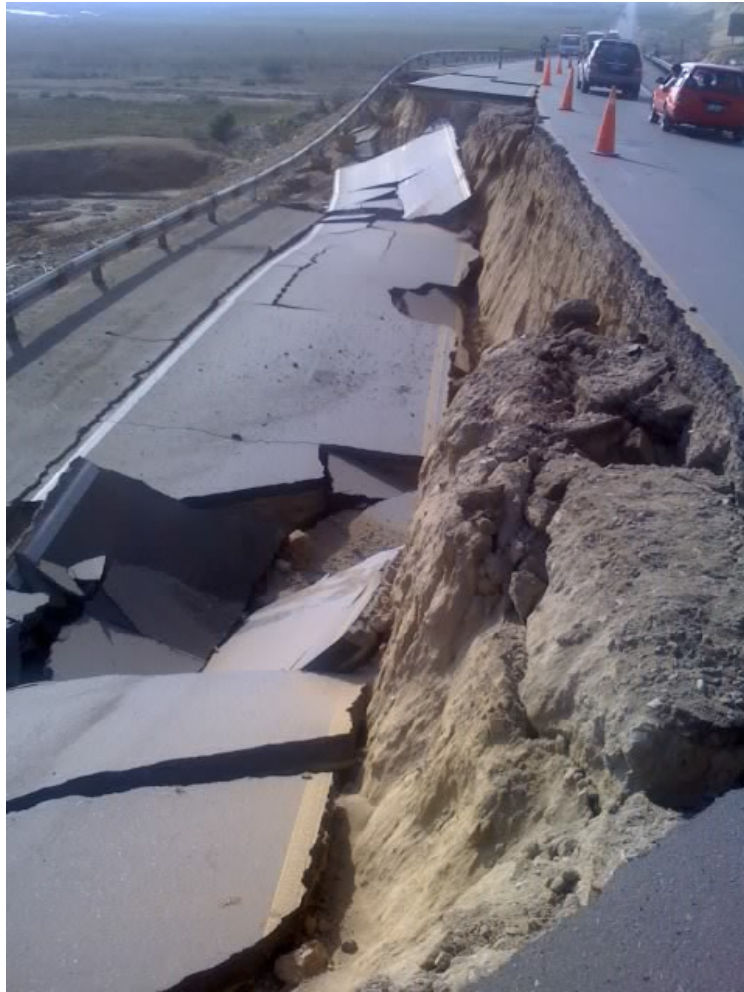
**Figure 24. Larger slip on Pan American Highway**  
 Photo – Ministry of Transport and Communications

The team briefly observed a larger scale slip located on the Pan American Highway north of Chincha Alta as the road drops to the coastal plain. The slip occurred in a fill embankment over a deep gully, took out one lane of the road and left a steep scarp along the centreline as shown in Figure 24.

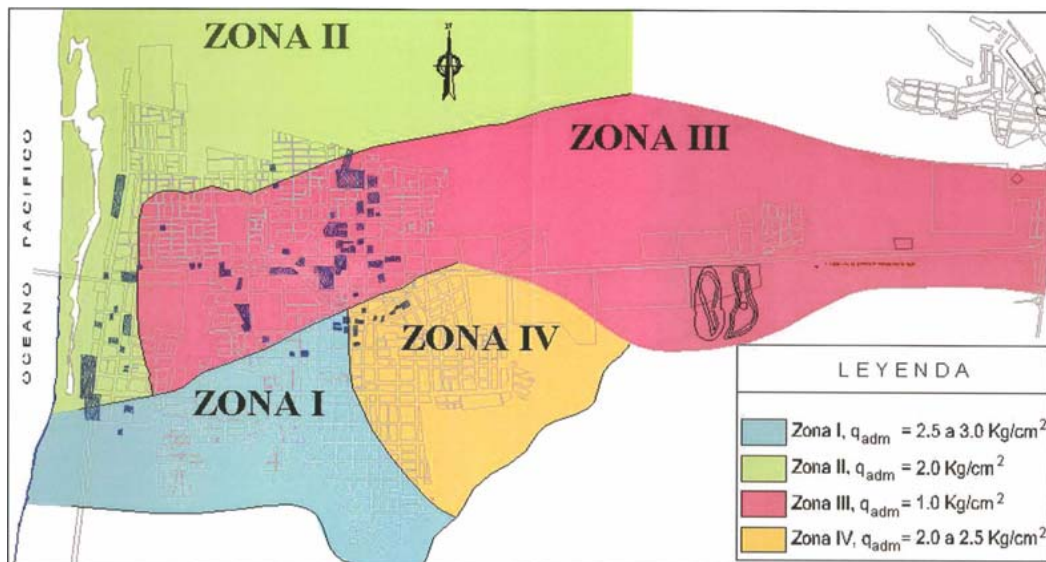
Figure 31. Microzonation map – Pisco

The Pisco map provides values from 1 to 3 kg/cm<sup>2</sup> (100 to 300 kPa) and the Ica map provides values of 0.5 to 2 kg/cm<sup>2</sup> (50 to 200 kPa). Superimposed on these microzonation maps are the areas of significant building damage in each town. The Pisco microzonation correlates well with damage - most of the affected buildings being within or adjacent to Zone III, the most susceptible to liquefaction. The damaged buildings in Zone II are near the coast and the damage here may be the result of higher groundwater levels and damage by the tsunami.

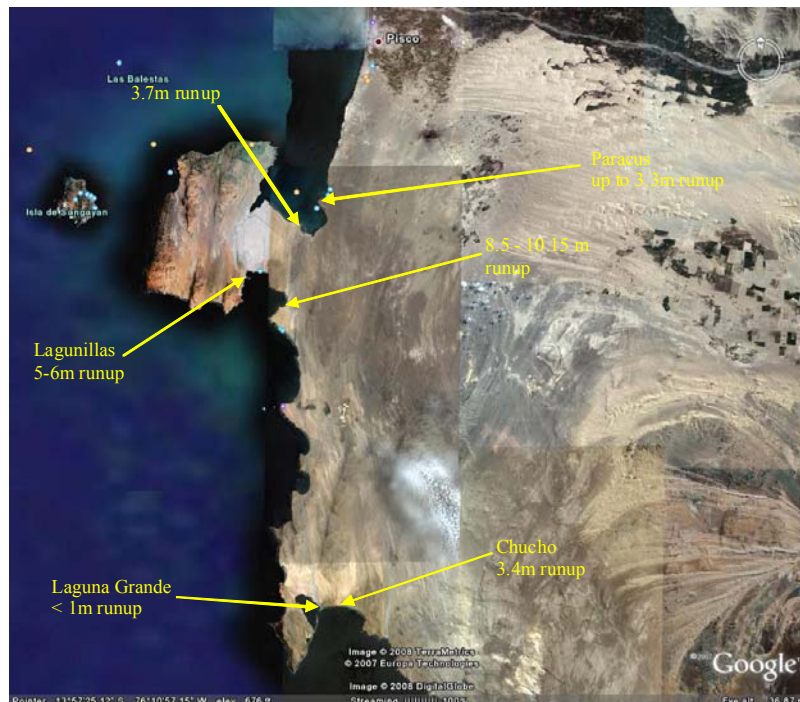
Figure 33. Tsunami run-up details

records from Dr Ronald Woodman of the Instituto Geofísico, who had made a special personal study of tsunami effects in the Paracas area. Refer Figure 33. In Cerro Azul a hotel had tsunami water over the patio area adjoining the beach and through the foyer, corresponding to a level of at least 2 m above mean sea level.

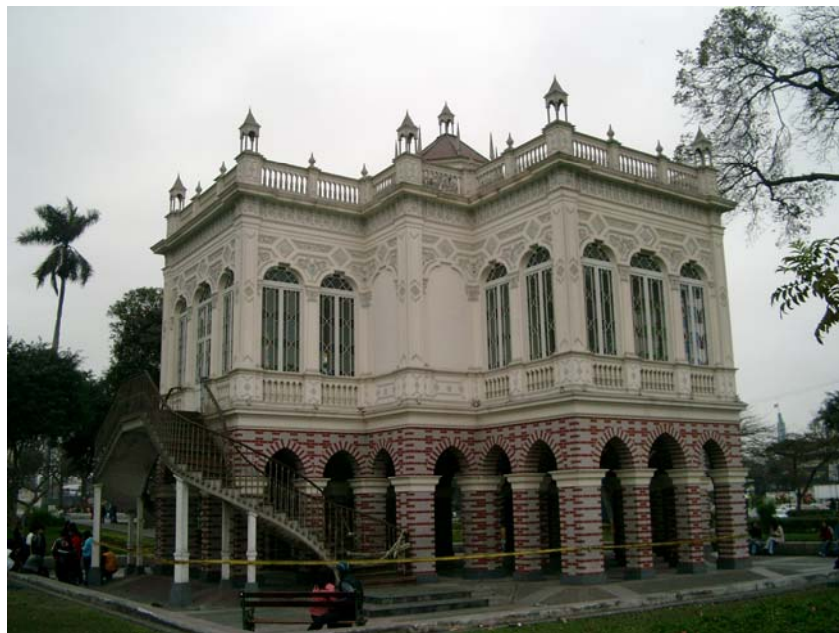
**Figure 44. Undamaged building Lima**

Generally there appeared to be minimal damage in Lima. General observations while travelling through Lima was that there was no visible damage, even in buildings which would generally be considered vulnerable to seismic motions ; historic structures, unreinforced masonry, buildings with a 'soft' first floor. Refer Figure 44.

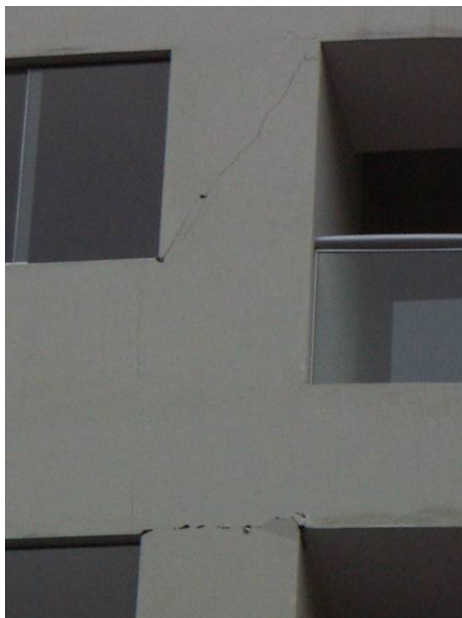
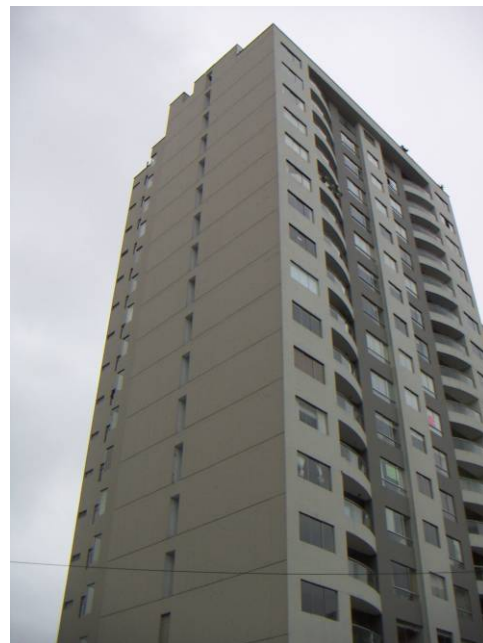
There were two observed instances of buildings with structural damage on the Avenida O. Benavides. A 17 storey apartment building had diagonal cracks in columns and beams on the front face for the bottom five floors. A nearby 18 storey apartment building had horizontal cracking in the side shear walls indicating the joint opening. There was also

corresponding cracking of beam column joints on the front face. Both buildings appeared to be new. Comparison with other buildings would suggest construction control or steel anchorage could have been contributing factors to the formation of cracks.

**Figure 48. Miraflores Apartment Buildings with diagonal creaking of columns**

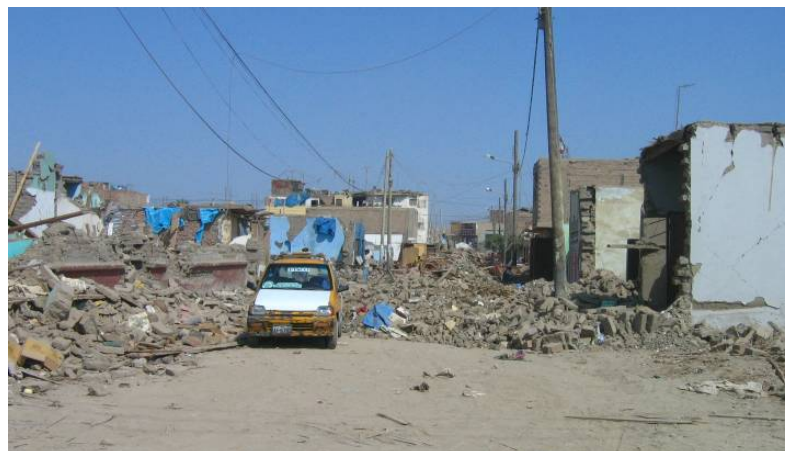
Damage was greatest in Pisco, possibly due to ground conditions (refer to geotechnical section). In Pisco many streets were full of rubble. Earthmoving equipment was present, and it was evident that many buildings had been demolished. While it is likely that ground shaking was the principal cause of damage in Pisco, ground subsidence and tsunami would also have been contributing factors, particularly along the waterfront. Houses in some streets in Pisco were relatively undamaged. This may have been because of the structural form, or location (ground conditions were better on the southern side of the town).

*Figure 50. Pisco Residential Street*

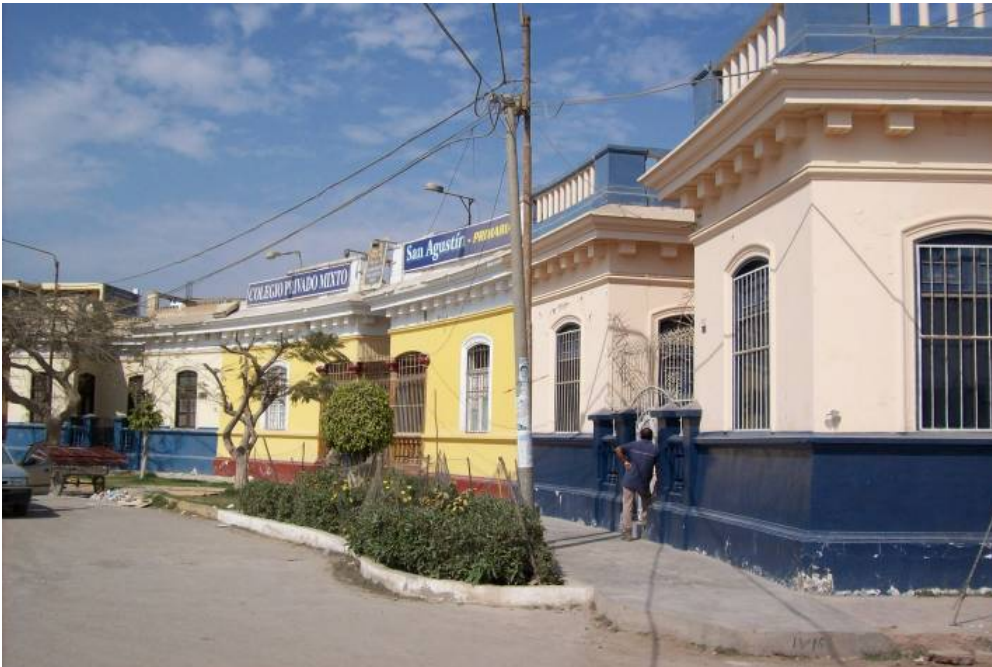
*Figure 52. Undamaged Buildings – Pisco*

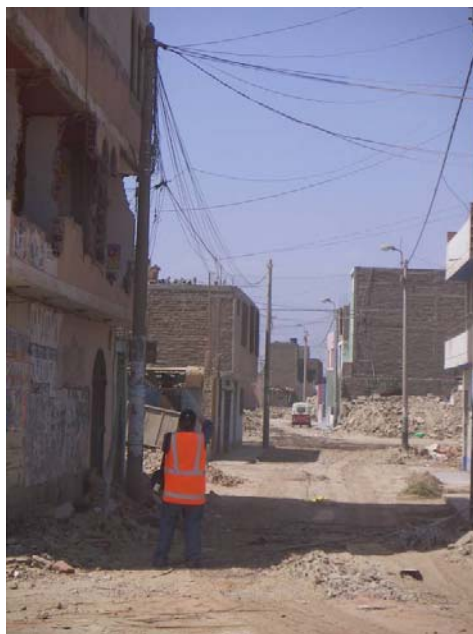
The team observed the collapse of damage to a significant number of residential adobe buildings in Ica. There was also damage to isolated public or commercial adobe buildings, with the most significant damage being to churches and school and hospital buildings.

**Figure 54. Street Damage - Ica**

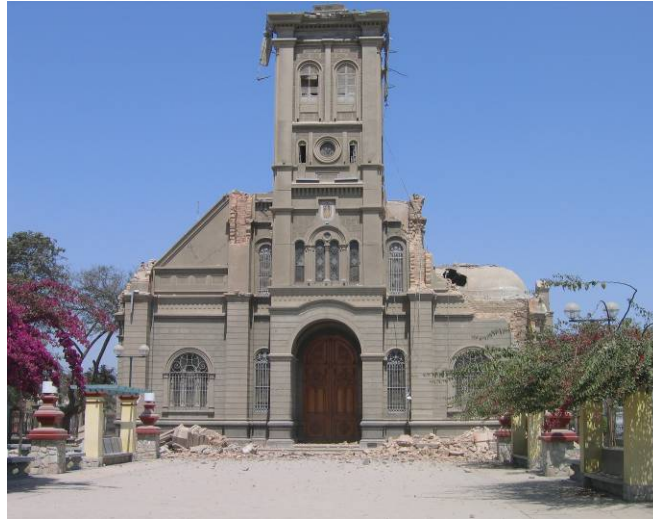
*Figure 55. Collapsed church roof - Ica*

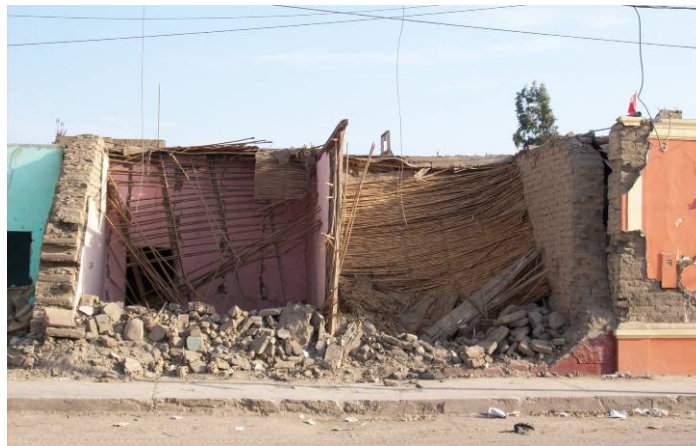
Typical adobe buildings were simple single storey dwellings. The majority of these adobe buildings in Pisco were seriously damaged. Large numbers were also damaged in Chincha and Ica. Out-of-plane failure of walls was common. There were a few isolated instances of diagonal cracking of walls indicating

in-plane failure. There were a number of more substantial adobe structures, including two storey commercial buildings and residences. Damage levels of these structures varied. From observation, typical adobe houses were not detailed for seismic actions and were constructed in soft soil zones.

*Figure 56. Typical Adobe House Damage*

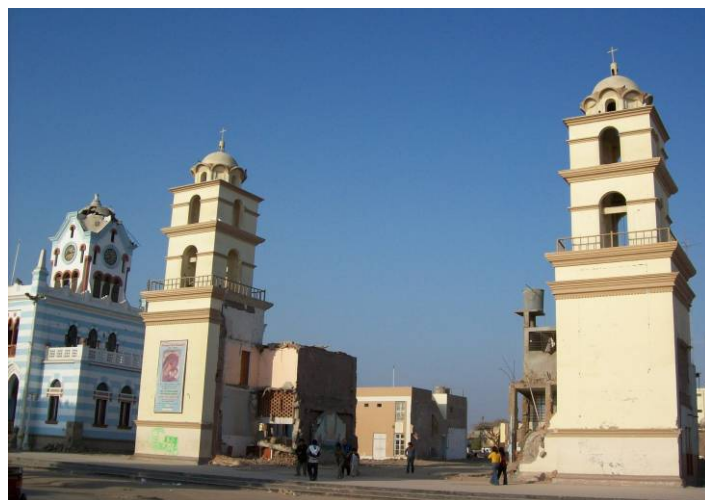
*Figure 60. Cathedral San Clemente after Earthquake*

The most significant casualty of the earthquake was the Cathedral San Clemente. The dome of the Cathedral collapsed, killing 148 people. The building was principally adobe construction. The corner towers, which had been reinforced with concrete, were the only parts of the church that remained.

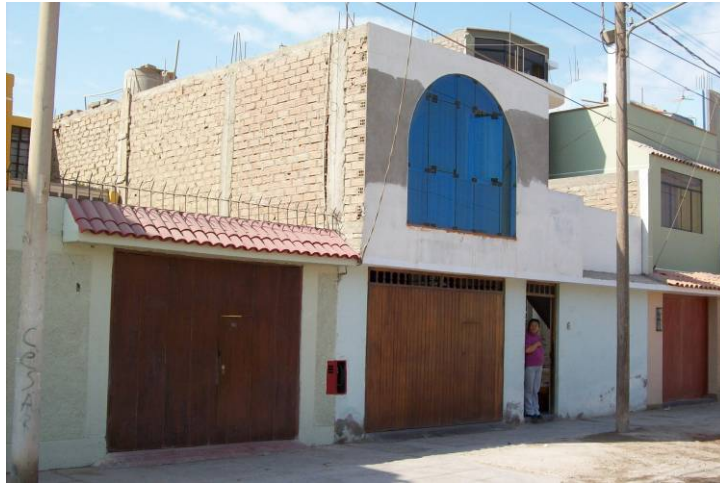
Confined masonry buildings observed were generally undamaged, including buildings that one might expect to be vulnerable to a large earthquake. There were isolated observed instances of out-of-plane toppling of cantilever walls and in-plane cracking and/or loss of masonry infill walls.

*Figure 61. Undamaged Confined Masonry Dwelling - Pisco*

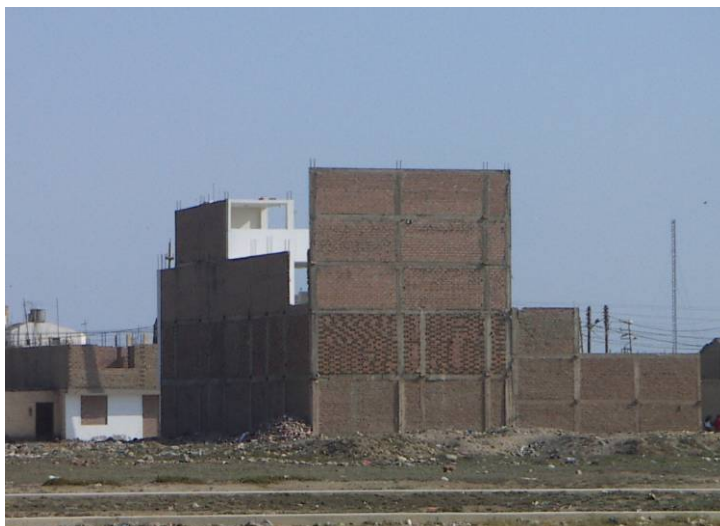
*Figure 62. Undamaged Engineered Confined Masonry Dwelling - Pisco*

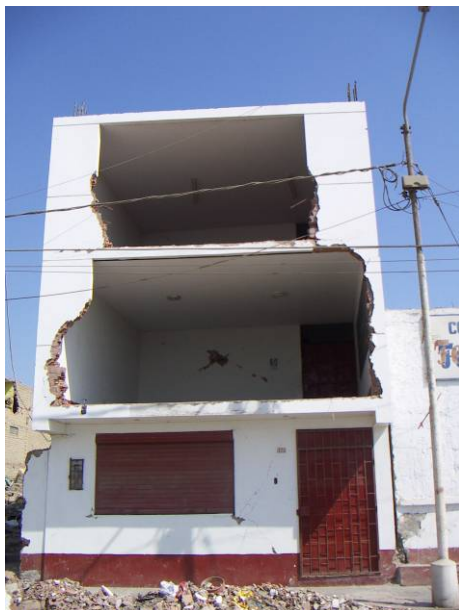
*Figure 63. Multistorey Confined Masonry Building - Pisco*

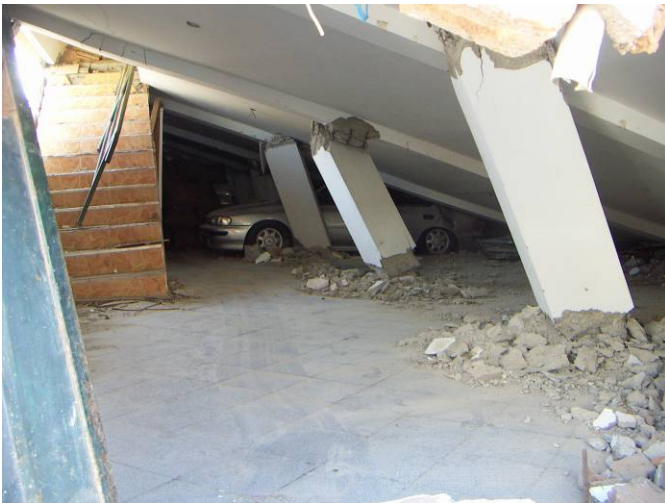
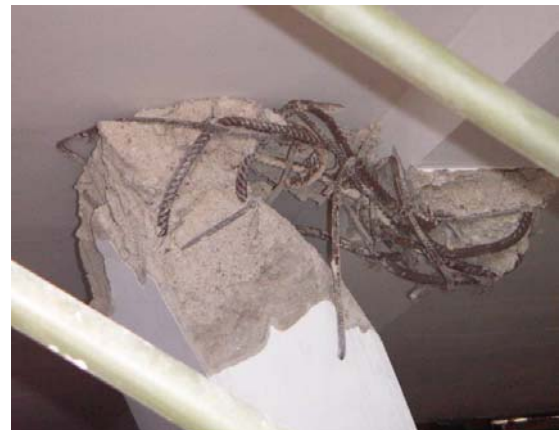
A four storey residential building, with a ground floor carpark and three levels of dwelling over. The structure supporting the front of the first floor had collapsed. The remaining floors were remarkably intact. A neighbour reported that during the earthquake she has observed a crack in the ground propagating

**Figure 68. Column Failure - Pisco Residential Building**

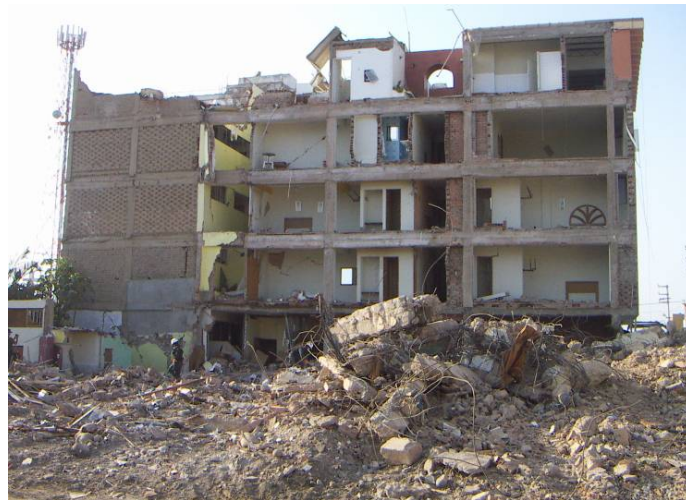
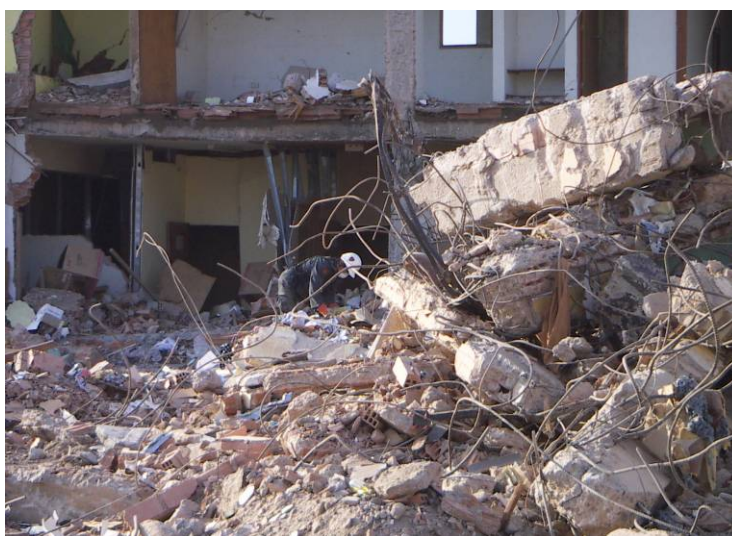
The 5-storey Embassy Hotel building collapsed and had been demolished. It was reported that 15 fatalities in this buildings. The building behind it, which appeared to be of similar structural form, had significant damage to brick walls

**Figure 70. Demolished Embassy Hotel – Pisco**

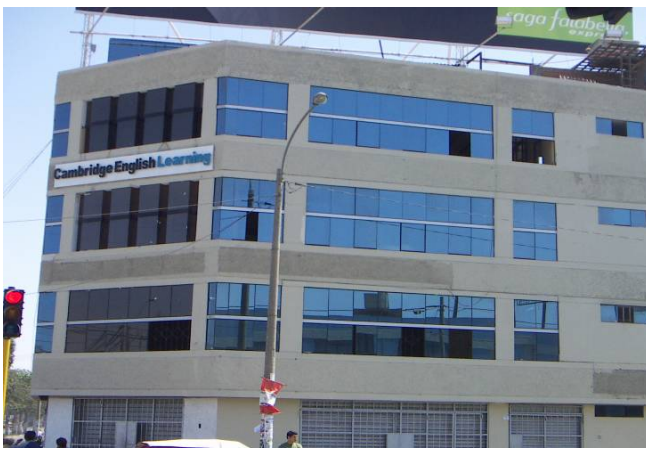
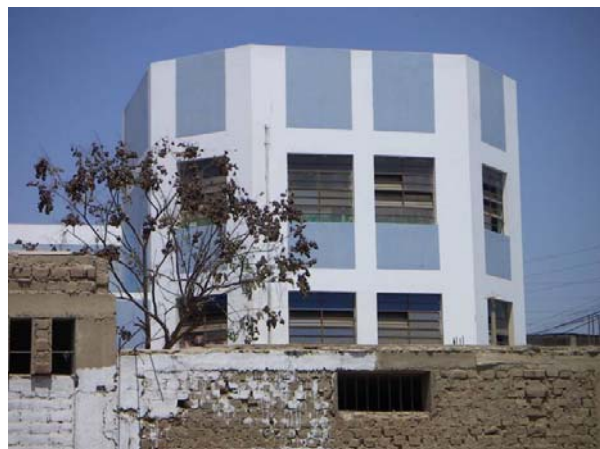
A number of school and hospital buildings could be regarded as reinforced concrete frame buildings with infill panels. There was damage of these buildings where critical structural weaknesses were present. (School and Hospital buildings are addressed separately in the following section.)

The few modern reinforced concrete buildings observed were undamaged, apart from those subject to ground subsidence.

*Figure 71. Commercial Buildings - Ica*

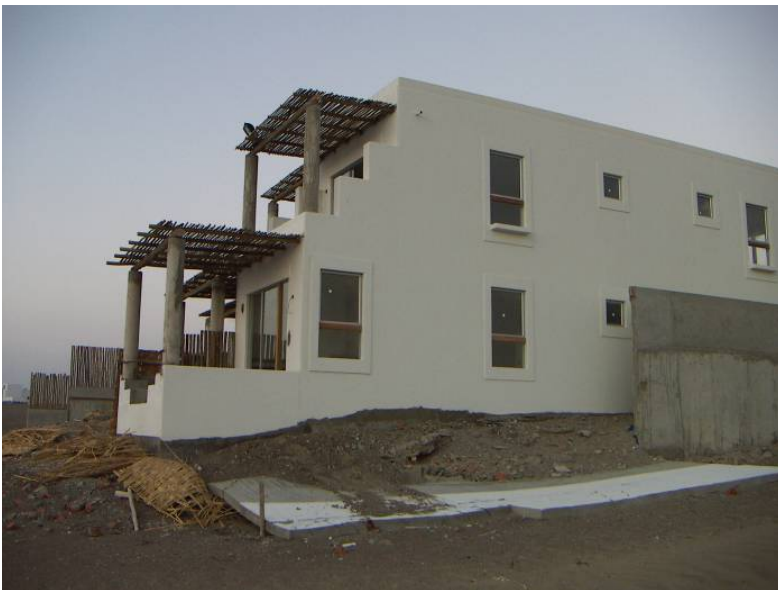
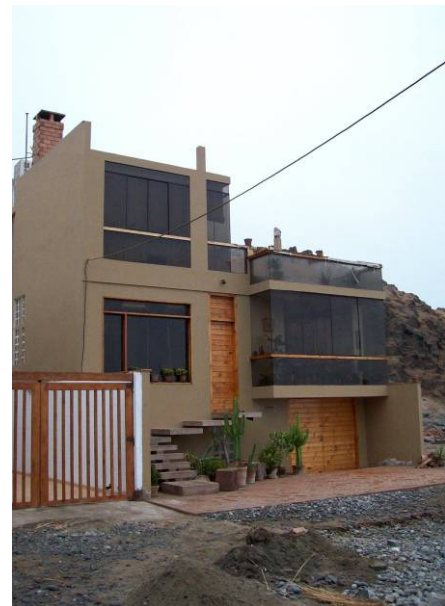
*Figure 72. Beach Houses – Paracas*

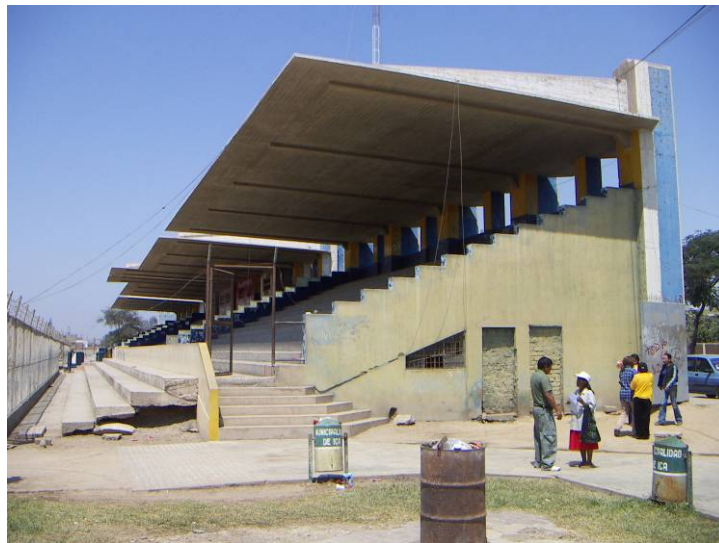
cracking of infill masonry panels. Damage of the Ica grandstand was limited to cracking at the base (due to differential movement) and minor infill panel cracking. There was no damage to the reinforced concrete columns and beams - not even a crack.

*Figure 74. Ica Grandstand*

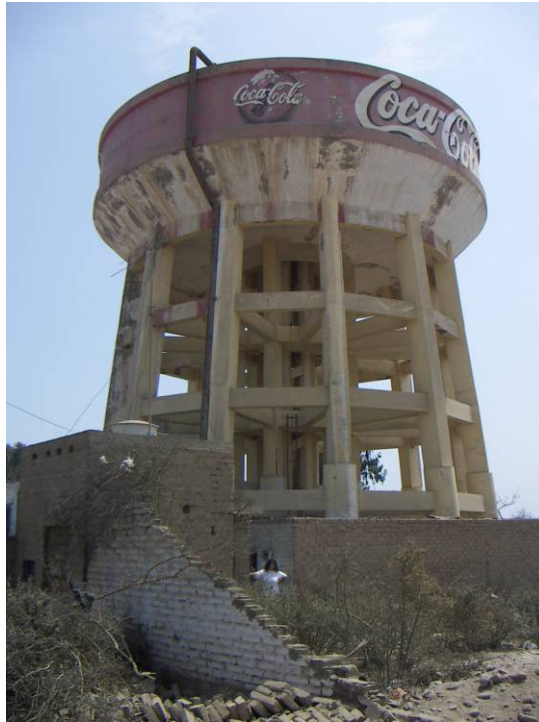
In Pisco there was a 1,200 cubic metre tank supported on a robust reinforced concrete frame. The tank was built in the 1960s and suffered damage to columns in a 1995 earthquake. These had been jacketed to about 6 m height. All columns were undamaged, but many of short tie beams between columns had significant cracks. A similar structure was

*Figure 75. Water Tower - Pisco*

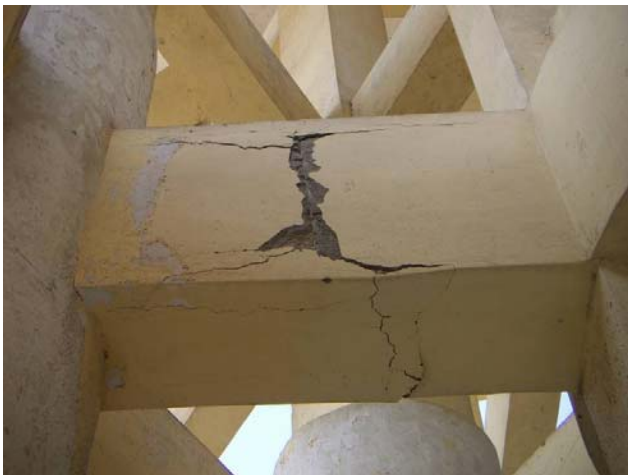
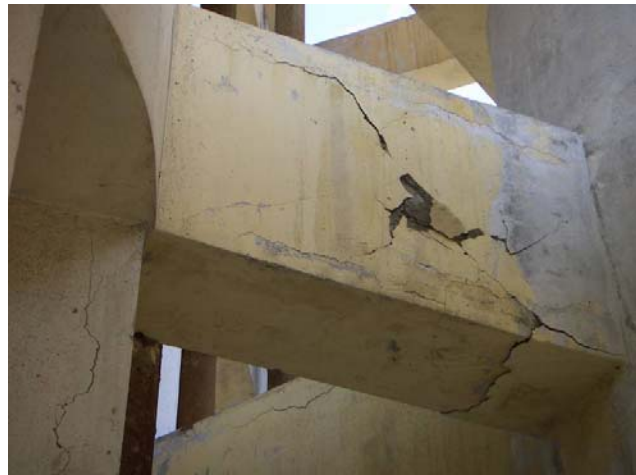
*Figure 76. Cracked Tie Beams - Pisco Water Tower*

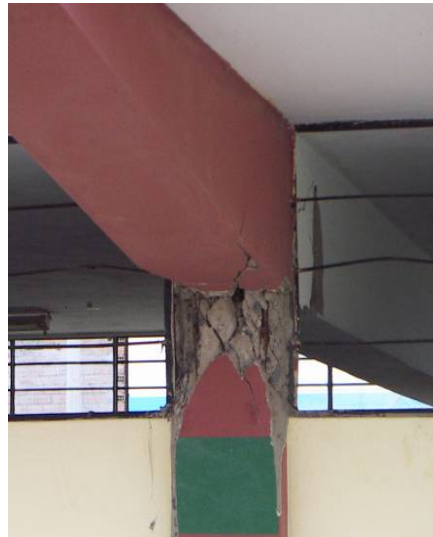
Damage was mostly superficial, but at two sites structural damage was observed. At a local school in Canete, there was shear failure of short columns, minor cracking of infill walls and minor impact damage from pounding of adjacent structures. A number of windows were cracked. At San Luis Gonzaga School, cracking of walls and spalling of concrete was sufficient to require repair. One column supporting a canopy had lost all concrete in the core, revealing that there

*Figure 78. Column Damage - Canete*

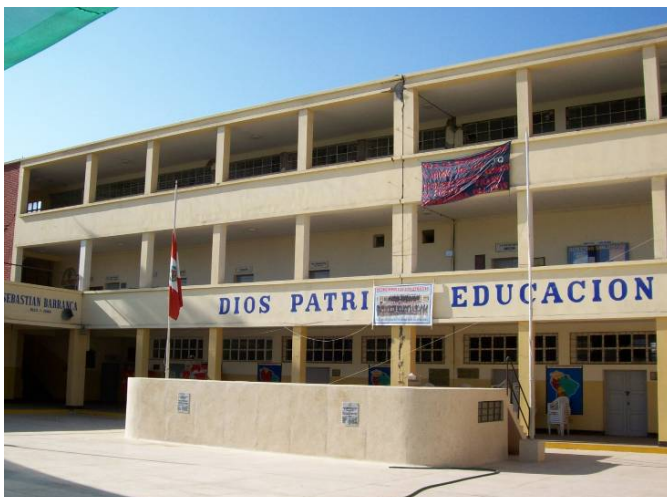
*Figure 79. Damaged School - Ica*

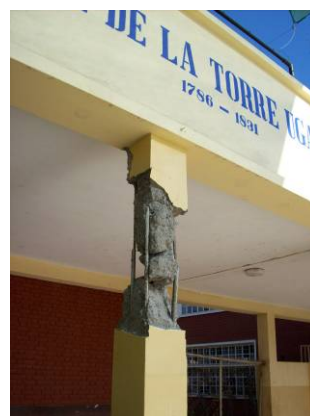
*Figure 80. Column Damage - Ica*

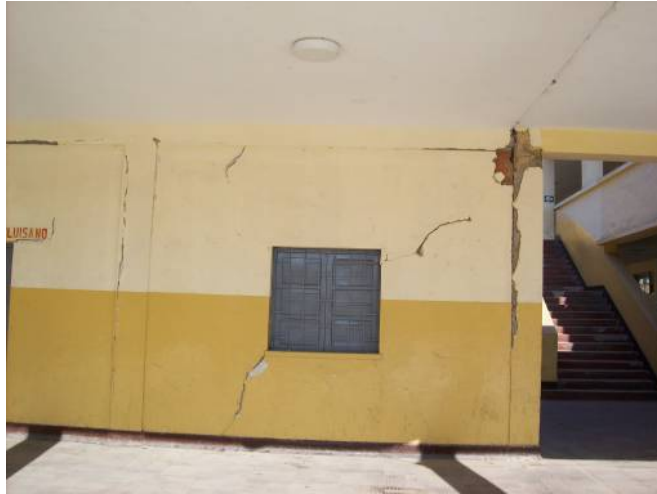
*Figure 81. Infill wall damage - Ica*

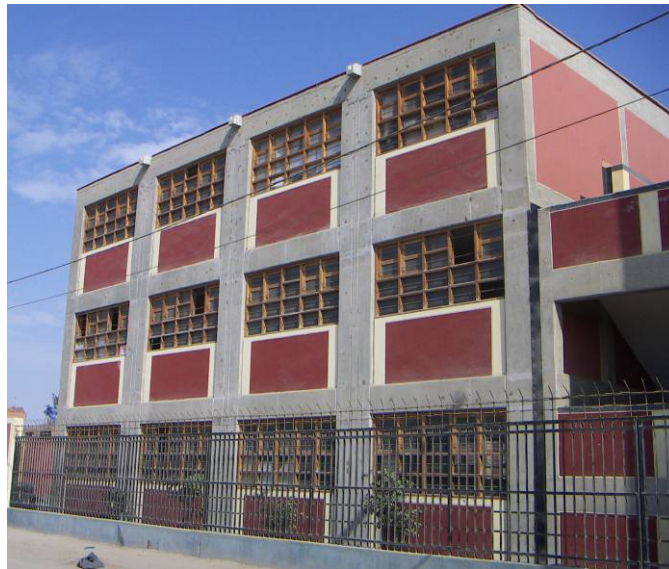
*Figure 82. School Constructed to New Standard - Pisco*

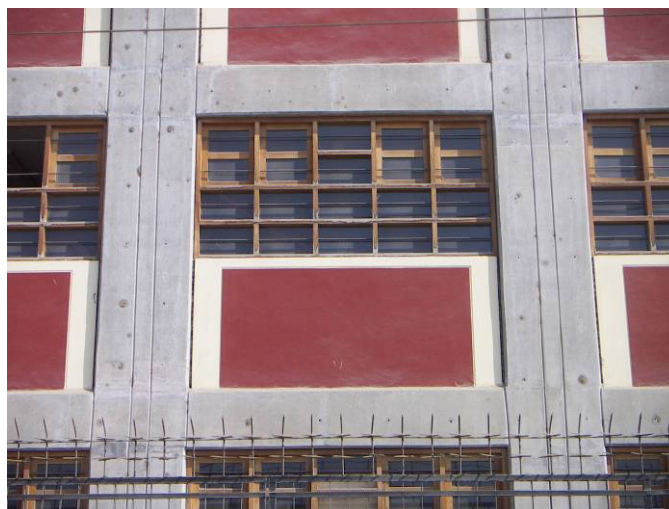
*Figure 83. New Standard School Detailing – Pisco*

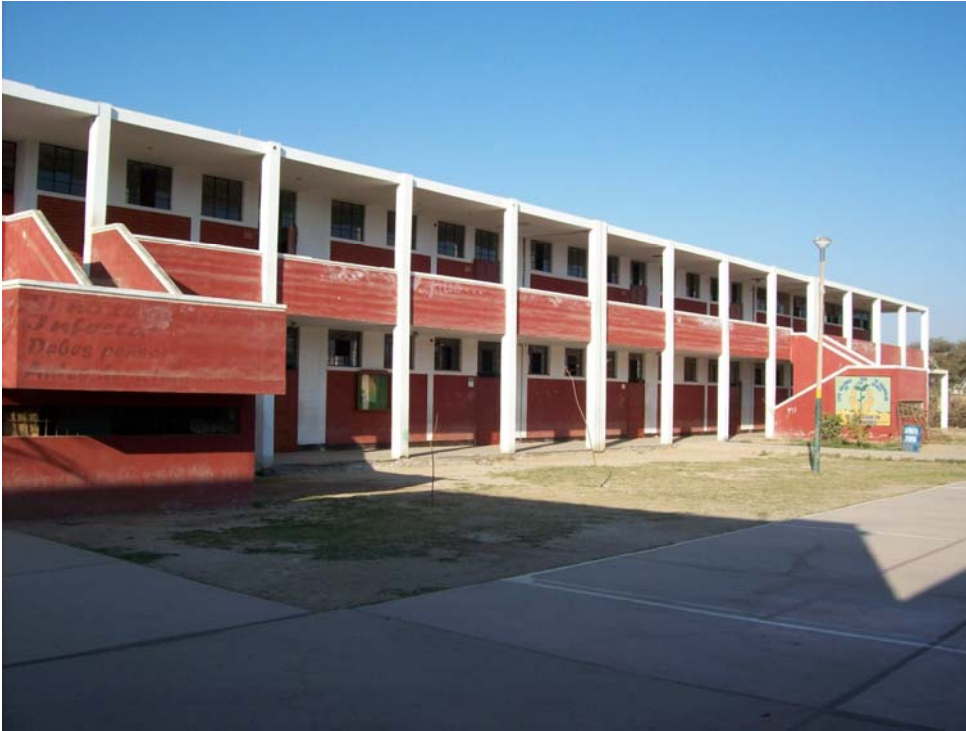
*Figure 86. Undamaged school – Ica*

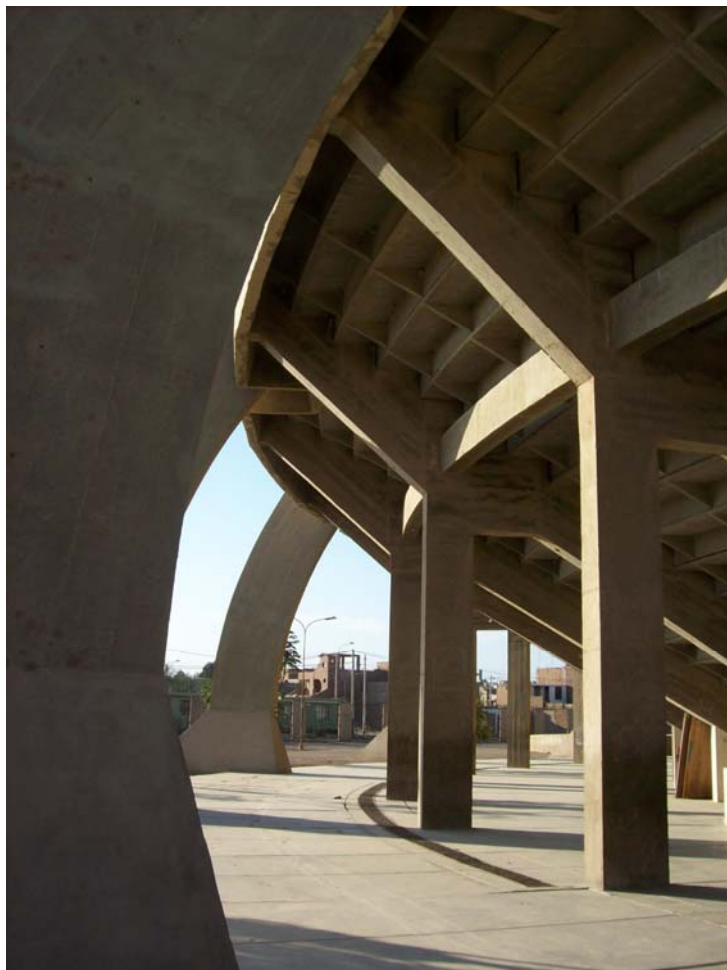
*Figure 87. University stadium Ica - no significant damage*

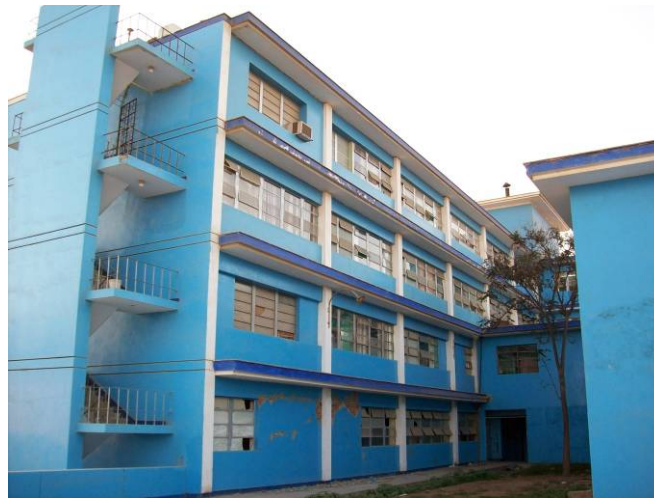
An inspection was made of the Regional Hospital in Ica. Building form and damage was similar to that of older schools. Characteristic buildings were storey reinforced concrete with infill panels featured short columns and deep spandrels. The site inspection showed extensive cracking of infill panels and a few instances of short-column failure. There was considerable damage to non-structural components; partitions, ceiling panels, un-braced contents and equipment. This made many rooms, including operating theatre suites, inoperable. Damage to building plant was also noted.

*Figure 88. Regional Hospital – Ica*

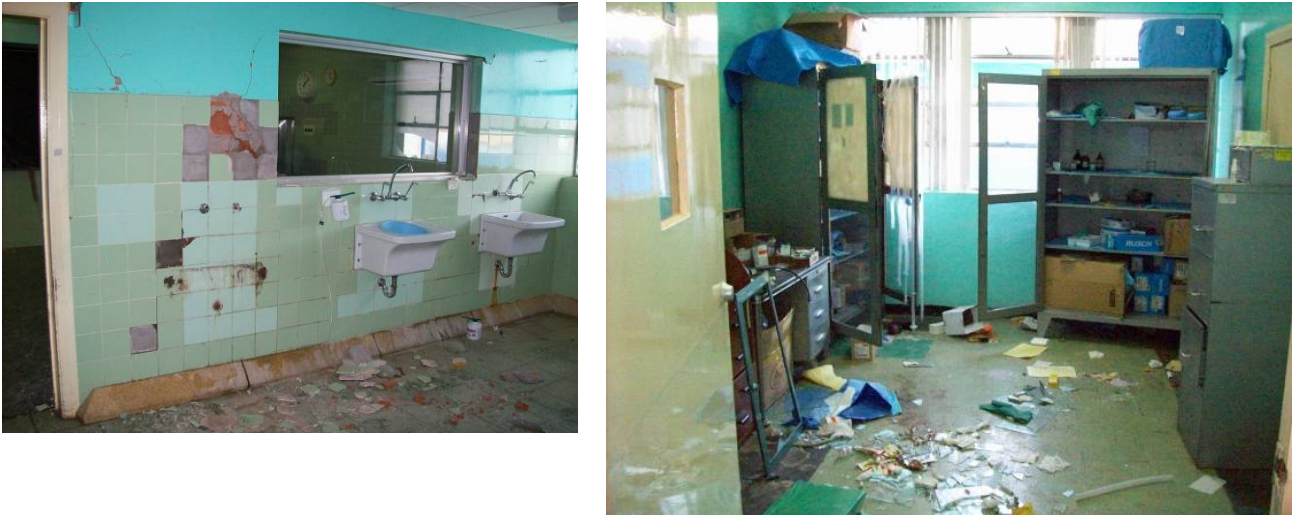
**Figure 90. Operation preparation areas - Ica Regional Hospital**

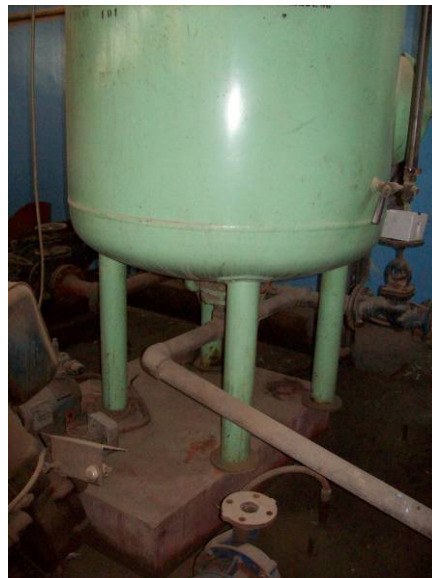
**Figure 91. Unsecured Building Plant - Ica Regional Hospital**

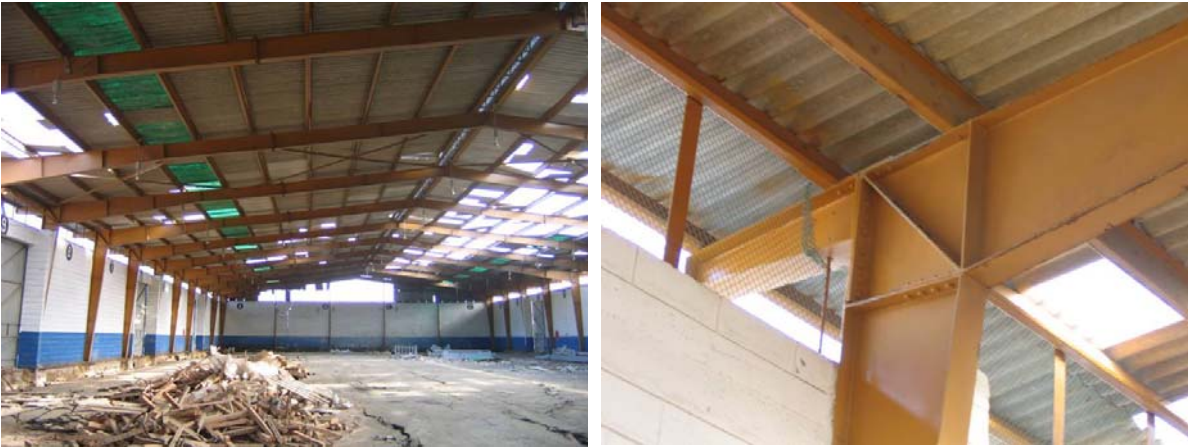
Steel portal frame warehouses adjacent wharf were supported by steel encased concrete piles with perimeter tie beam. Though the floor settlement was in the order of 1 m there was no visible damage to the superstructure. There was the loss of some cladding.

**Figure 99. Steel Portal Warehouse, Port of San Martin**

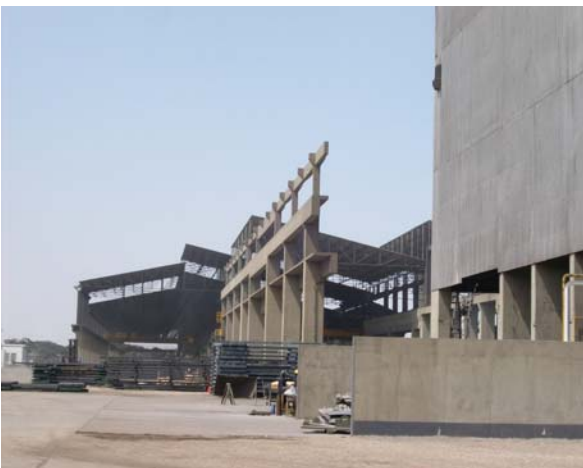
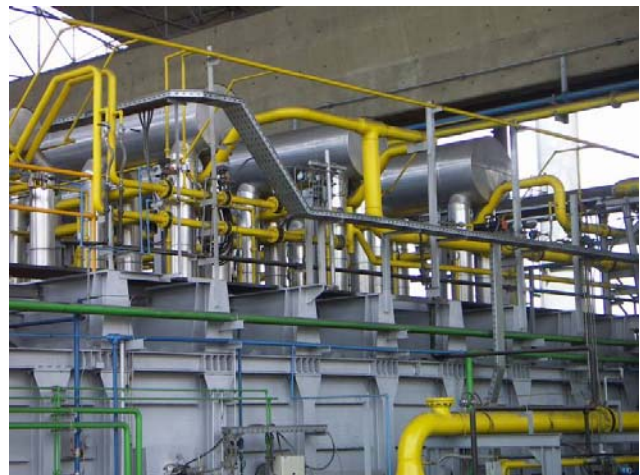
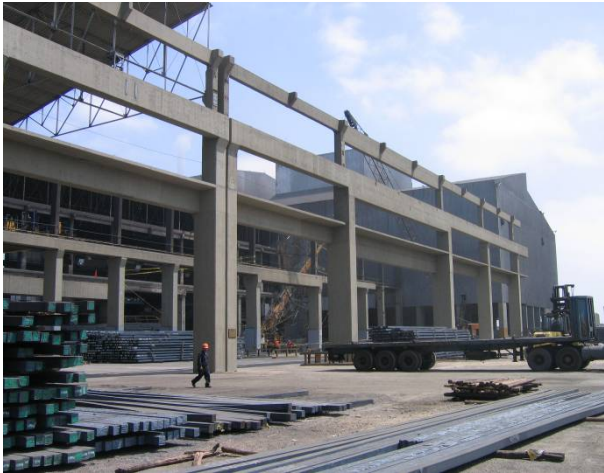
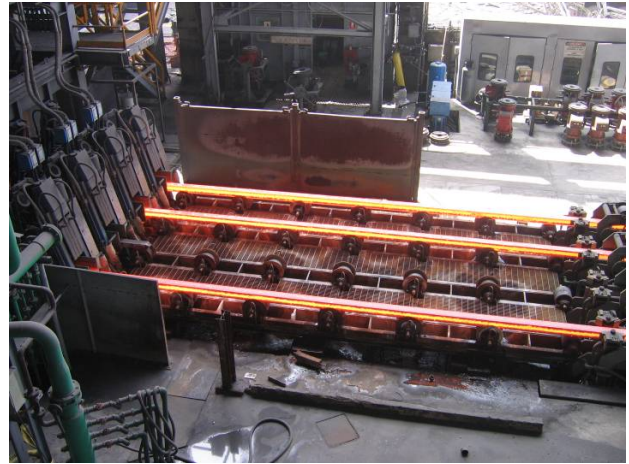
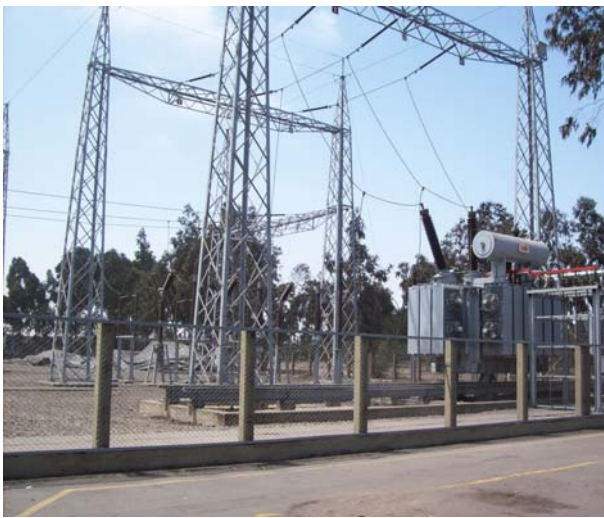
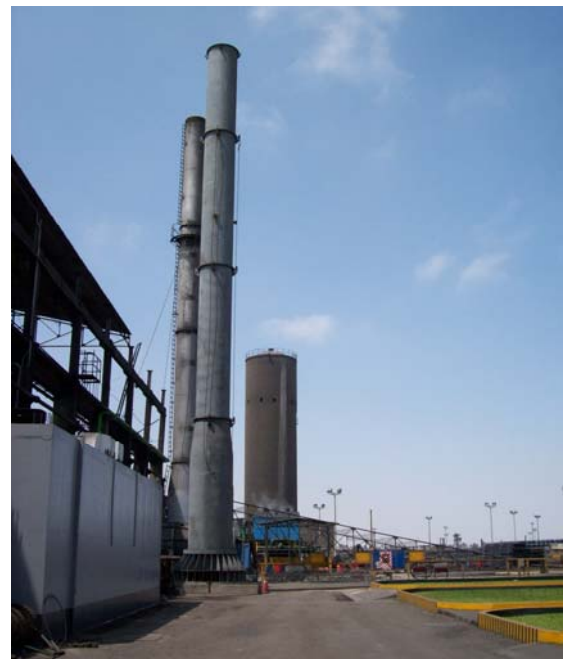
**Figure 100. Acero Arequipa Steel Plant**

The buildings had been designed by Eng. Antonio Blanco of Catholic University, based on a site specific study. Recently, some columns and foundations had been upgraded and jacketed to account for higher working loads. No special measures had been taken to tie cranes down from vertical movement. Transformers were on rails without tie-downs.

There was very little damage to the buildings and plant, typically minor cracking of infill panels. Two ladles of product needed to be discarded.

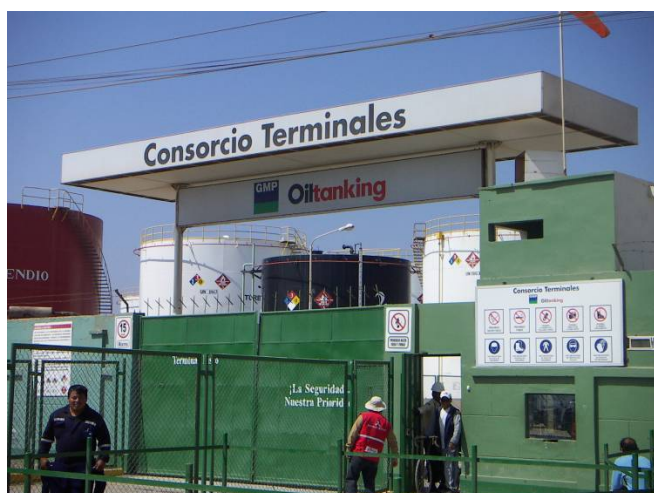
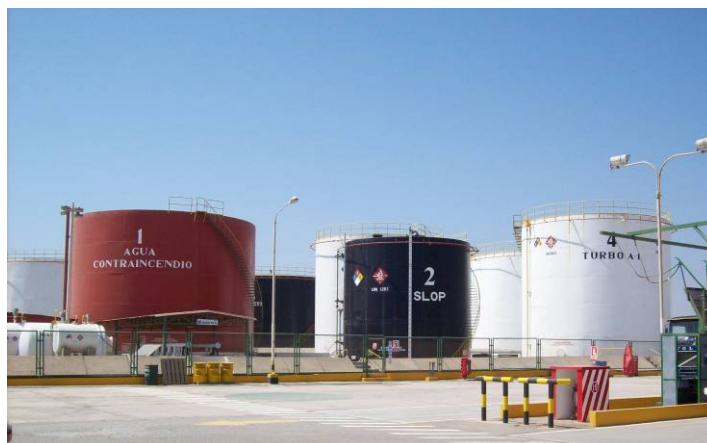
**Figure 102. Oil Terminal – Pisco**

This facility takes oil and gas pipelines from offshore platforms and stores it. A water tank had buckled and split at the bottom, but this was a rusted skirt only and no product was lost. There were no signs of sideways movement. All other tanks were undamaged.

A tsunami had demolished most of the perimeter fence and had reached halfway across the site. It was a gentle upwelling of water, not a wave, and had not gone above the bund.

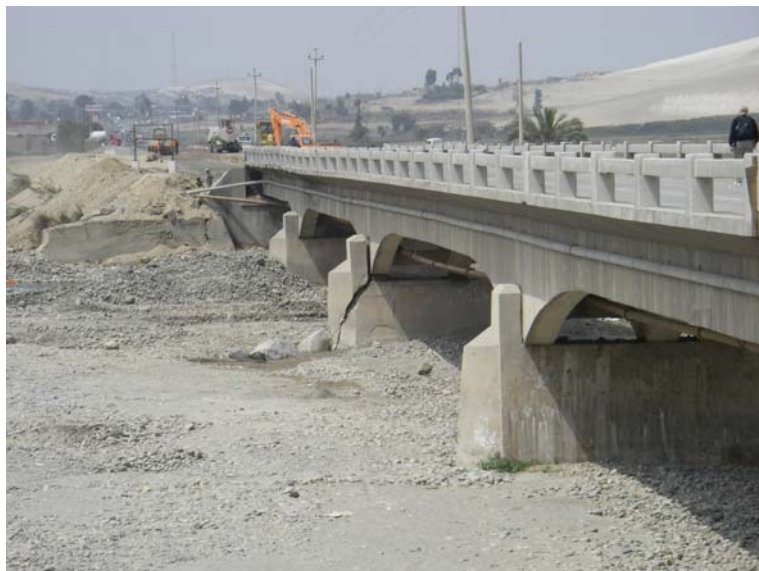
**Figure 104. Huamani Bridge on the Pan American Highway at San Clemente**

Generally, the bridges in the epicentre region performed well and the only bridge with notable damage was the Huamani Bridge on the Pan American Highway at San Clemente. Refer to Figure 104. The Huamani Bridge is approximately 60 years old and consists of a superstructure of 5 spans of reinforced concrete beam-and-slab construction. The total length of the bridge is approximately 100 m with average span lengths of

25 m. The superstructure is made up of a combination of continuous spans with cantilevered sections, which support two simply supported drop-in spans. The abutments and piers are of solid wall-type construction and indications are that the piers may be supported on short concrete piles. Movement joints (steel roller bearings) are provided at the abutments as well as one of the piers.

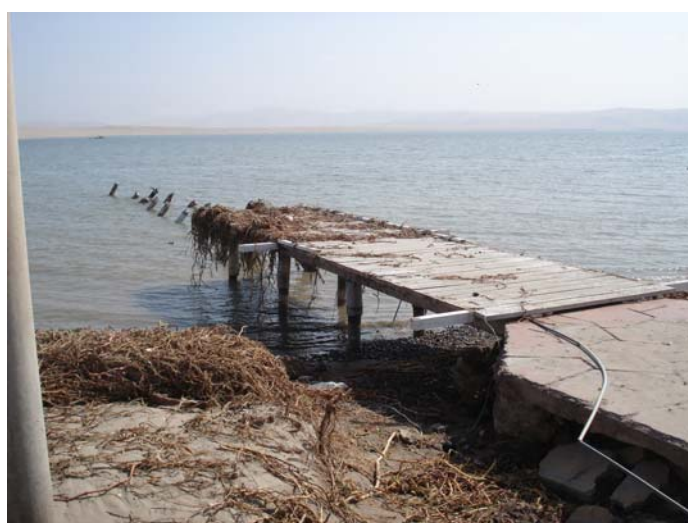
**Figure 108. Tsunami damage to pier on Paracas coast**  
Photo courtesy Alfonso Rey
