**THE PISCO (PERU) EARTHQUAKE OF 15 AUGUST 2007**  
**NZSEE Reconnaissance Report, June 2008**

**David Hopkins, Darrin Bell, Rafael Benites, James Burr,  
 Craig Hamilton and Rudolph Kotze**

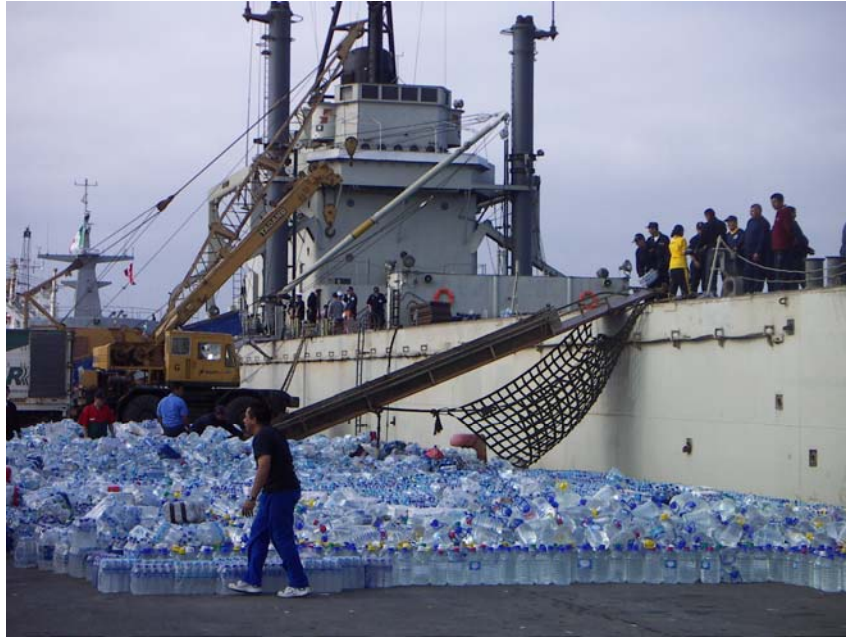
**Figure 113. Wharf operation delivering emergency supplies to Pisco area**

Damage to the port was caused mainly by liquefaction of the compacted fill behind the wharf. This resulted in damage to the settlement slabs and back walls on the wharf but, essentially, the wharf remained operational. The value of the port and wharf facility as a lifeline is obvious and at the time of our reconnaissance it was evident that the port performed a

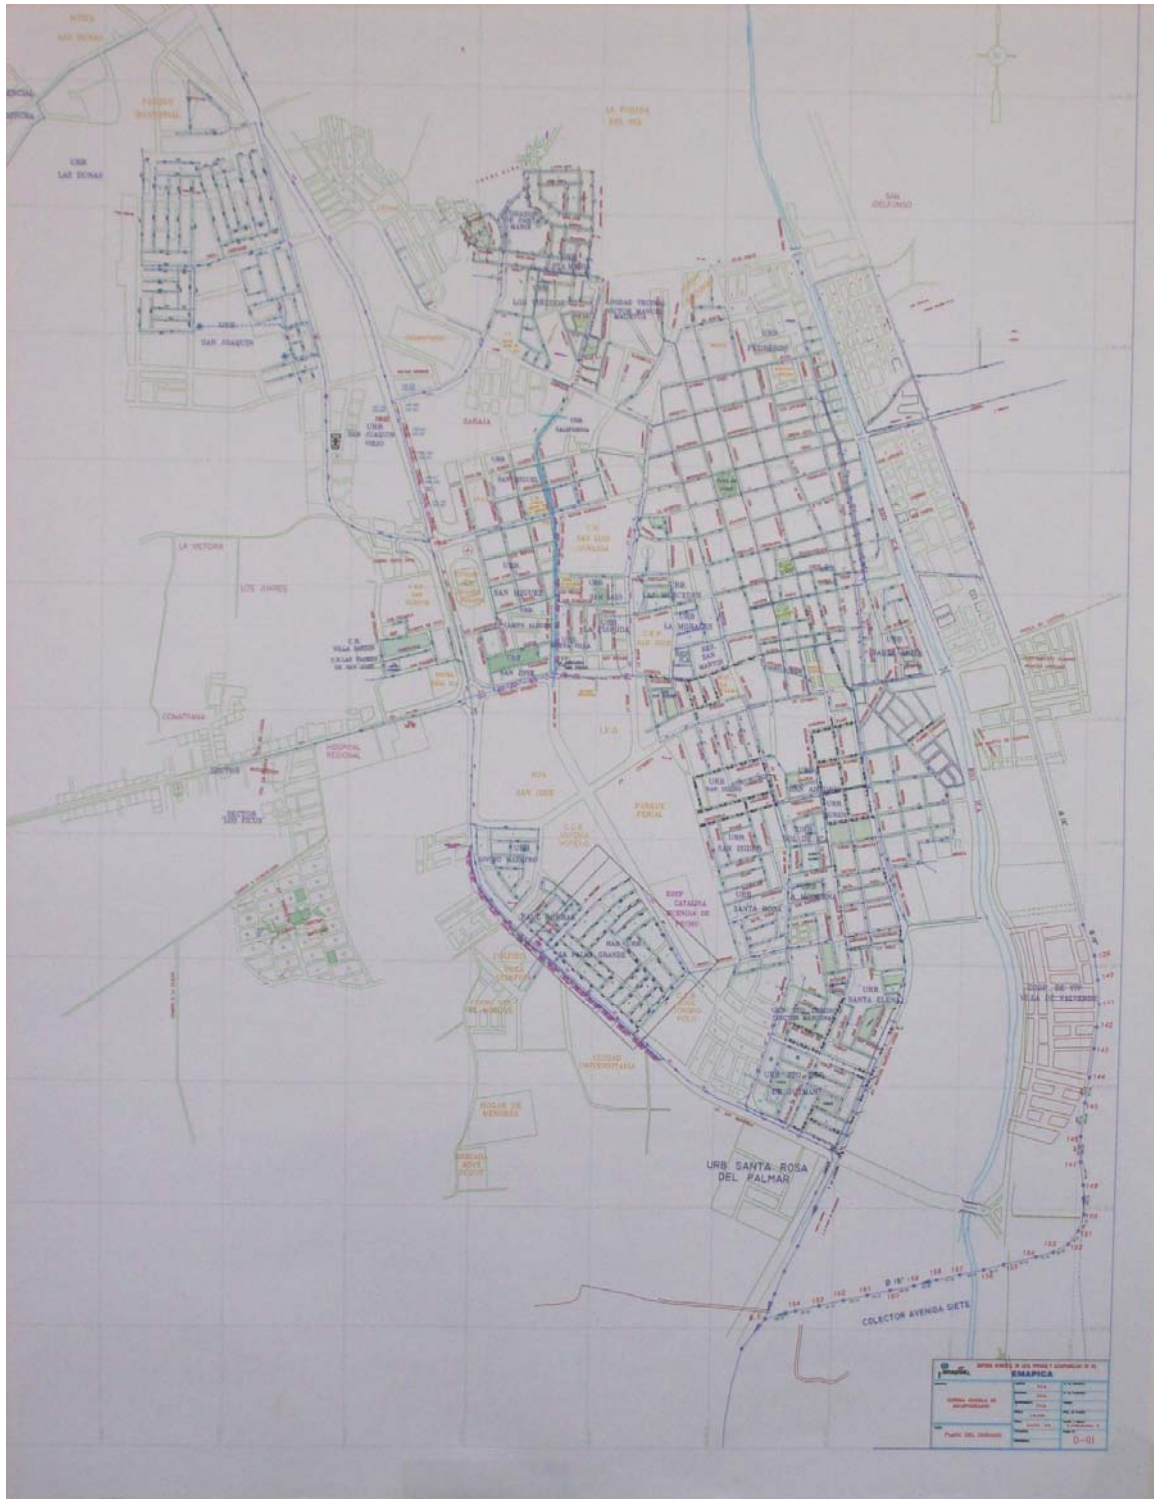
**Figure 114. Ica waste water network**

A section of 2 m diameter concrete sewer main collapsed in the earthquake, and was been repaired with PVC pipe. Some damage to pipes was caused by the heavy earthworking machinery used to clear up the debris from damaged buildings. Interestingly, the flows into the treatment station are now higher than before the earthquake. This may indicate that the replacement pipes have less leaks. The treatment ponds comprise 4 ponds, each 3.2 ha and 2.5 m deep, totalling 190,000 cubic metres. Damage to some sewers occurs on a

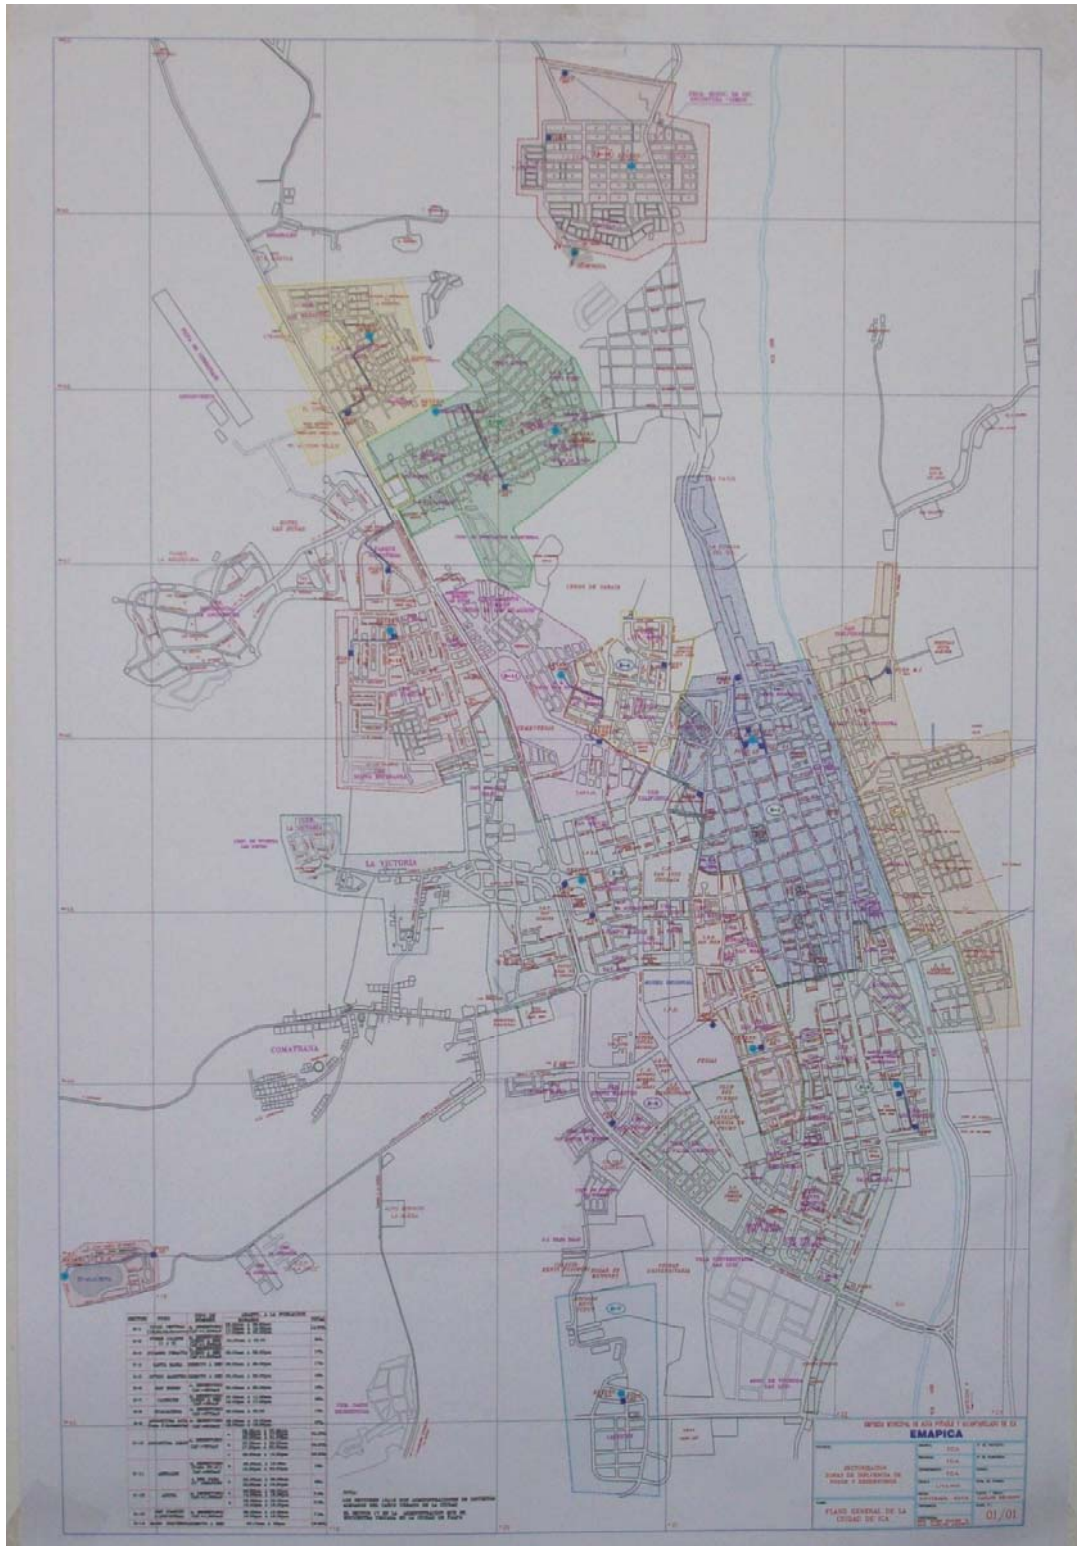
**Figure 115. Ica water supply zonation**

Figure 115 shows the water supply zones of Ica, each served by a separate, elevated reservoir. Damage to the distribution network was negligible, but some reservoirs suffered minor damage which resulted in them being emptied pending engineering evaluation. A reservoir similar to the one at Pisco suffered less damage.

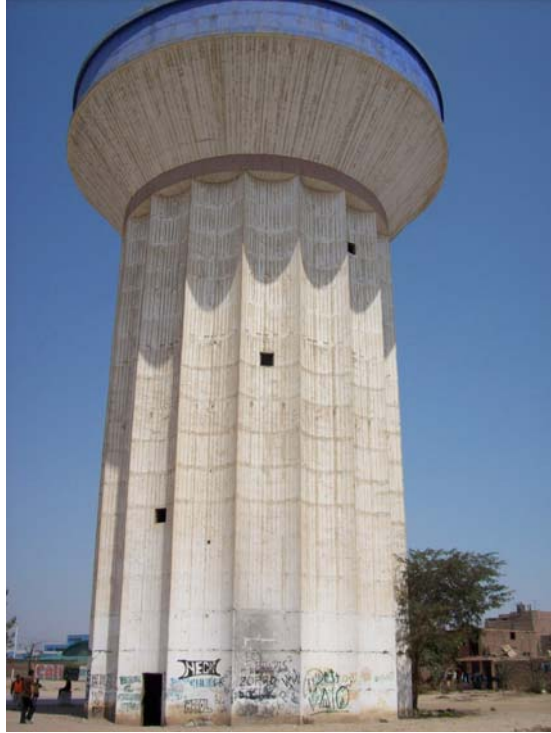
Water authority representatives took us to another large (1,200 m<sup>3</sup>) elevated reservoir which had been taken out of service. The reservoir (Figure 116) was supported on 200 mm thick doubly reinforced walls. Cracks were evident at about 3 m and 6 m up, matching the construction joints. Some minor spalling had occurred, with reinforcement exposed in one or two places. It was said that the structure had developed a lean during the earthquake, but this was difficult to detect. We were told that the tank was leaking quite badly and observed

what appeared to be cracks at construction joints in the tank structure itself. Peruvian engineers had recommended demolition of this structure, but it seemed capable of repair. We were told that the neighbours had long regarded the structure as a major visual intrusion and possibly a danger to them. It seemed that the earthquake was an opportunity to get the tank removed – a reminder that post-earthquake recovery is not driven solely by technical considerations.

**Figure 116.** 1,200 cubic metre reservoir in Ica

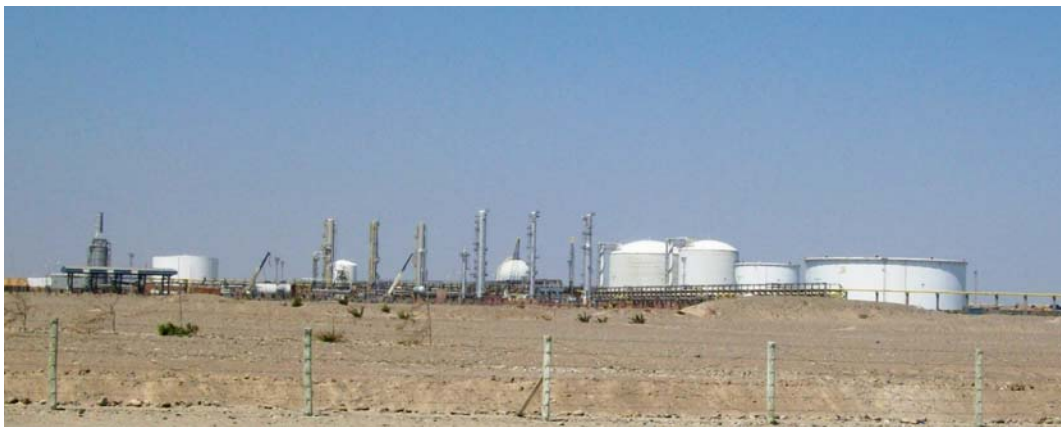
A gas liquefaction plant just north of Pisco (Figure 117) reported no damage due to the earthquake, but was not accessible for inspection. This facility processes natural gas for distribution within Peru and for export through a pipeline to an offshore loading platform. No damage was reported to the pipeline or platform.

**Figure 117.** Gas liquefaction plant near Pisco
