## EDGECOMBE EARTHQUAKE: RECONNAISSANCE REPORT

**M. J. Pender and T. W. Robertson\***

### SUMMARY

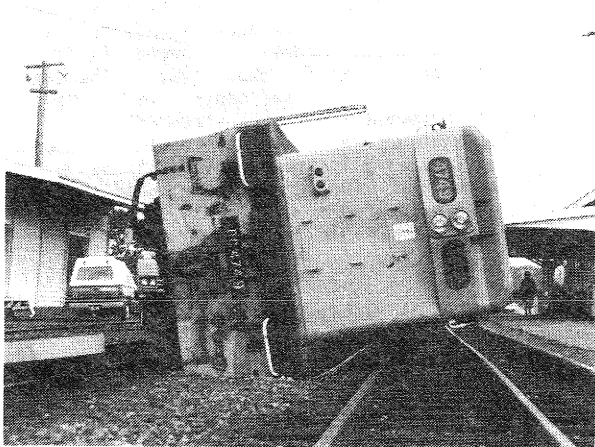
Fig. 2.7 : Overturned locomotive in the Edgcumbe railyard

(i) Figure 2.7 shows a NZR locomotive that was overturned in the railway yard at Edgumbe. In addition there were photographs in the newspapers of a loaded timber trailer and trucks overturned during the earthquake.

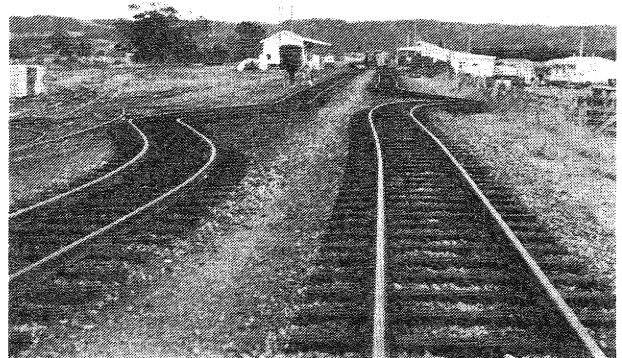
Fig. 2.9 : Compression of railway lines in the Edgcumbe railyard

(vi) Railway lines suffered numerous instances of compression buckling and sometimes fracture, Fig. 2.9. A similar effect was apparent in the streets in Edgumbe with the compression of the pavement and buckling of the footpath, Fig. 2.10. Both of these features suggest ground compression in the Edgumbe area.

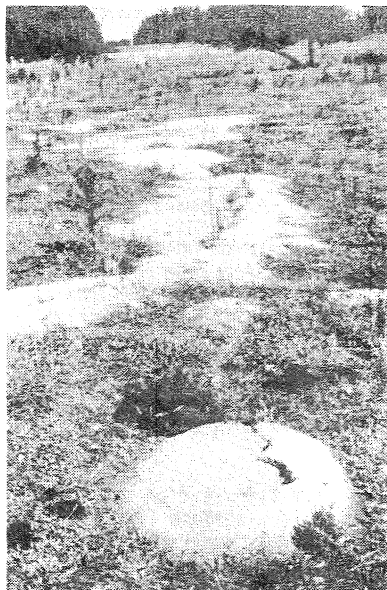
Fig. 3.4 : Close up of the ejected sand adjacent to the Whakatane Rvr.

A number of liquefaction related phenomena were observed across the Rangitaiki Plains. Figure 3.3 shows the locations of sand eruptions observed on aerial photographs of the plains taken a few days after the event; Grapes, Sissons and Wellman (1987). Figure 3.4 shows ejected sand adjacent to the west bank of the Whakatane River near the Landing Rd. bridge.

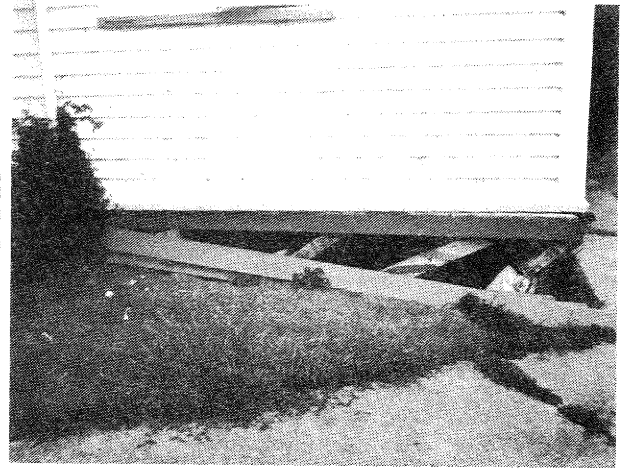
Figure 4.1.2 : Details from the right hand house in Figure 1.

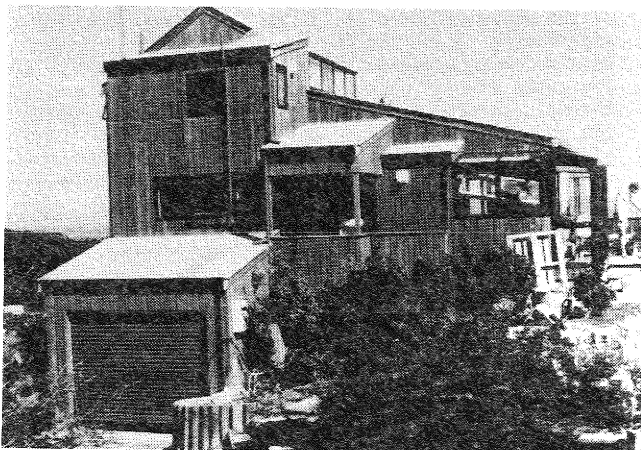
Figure 4.1.7 : A pole platform house of irregular shape

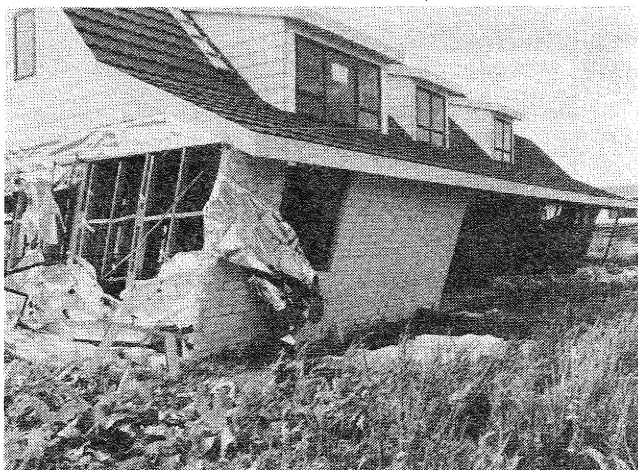
Figure 4.1.10 : House under construction

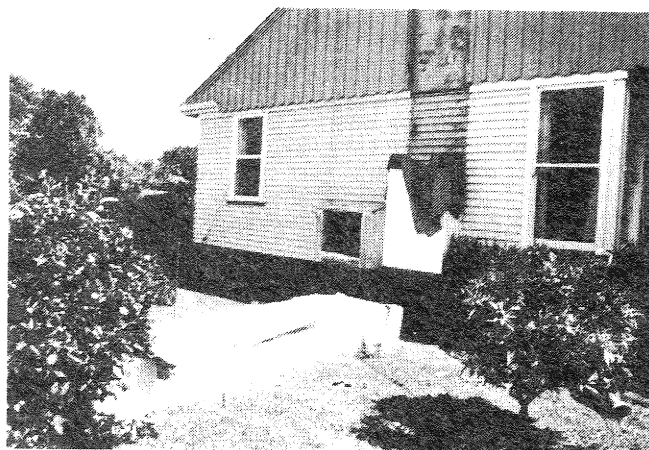
Fig. 4.1.12 : An unreinforced pumice concrete chimney

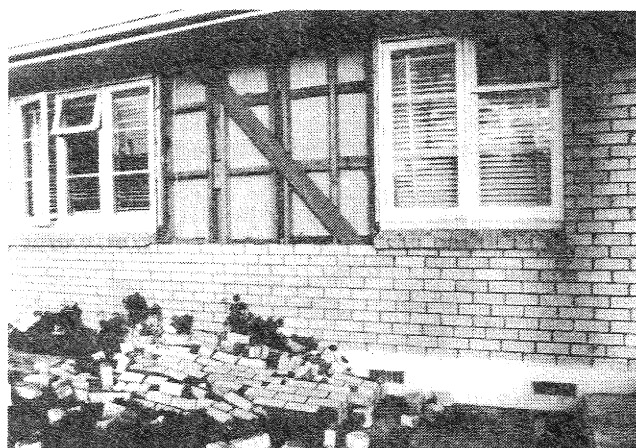
Fig. 4.1.14 : A collapsed panel of brick veneer

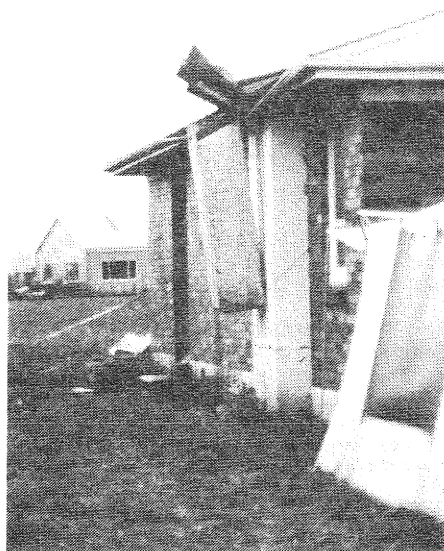
Fig. 4.1.13 : A reinforced pumice concrete chimney where the poorly grouted reinforced rods had partially withdrawn

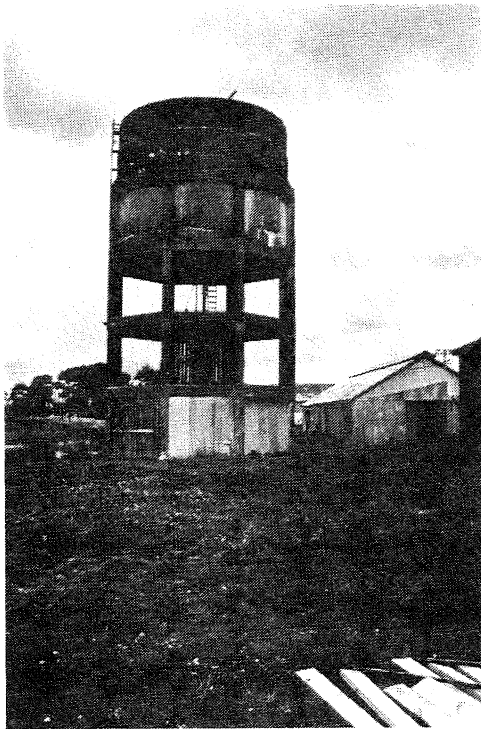
Fig. 4.2.6 : Timber Company water tower

This was an old structure comprising a reinforced concrete octagonal water tank supported on a three storey concrete frame with eight external columns and four internal columns, all interconnected by beams, Fig. 4.2.6. The water content at the time of the shake is unknown but reported to be "a reasonable quantity of water".

The support structure had behaved in almost textbook fashion, i.e. the inadequate, out of date details had behaved as theory would have predicted. Most columns showed column base hinging with significant spalling of cover concrete, Fig. 4.2.7. The plain steel reinforcing was not confined with consequential buckling of the column bars after yielding in tension. Several beam/column joints had failed in joint shear with reversal creating diagonal corner to corner cracking, Fig. 4.2.8. The amount of joint steel is unknown but judging from the age of the structure it is likely to be light to non-existent. One external beam had hinged considerably with large loss of concrete due to lack of confining stirrups. An internal beam column

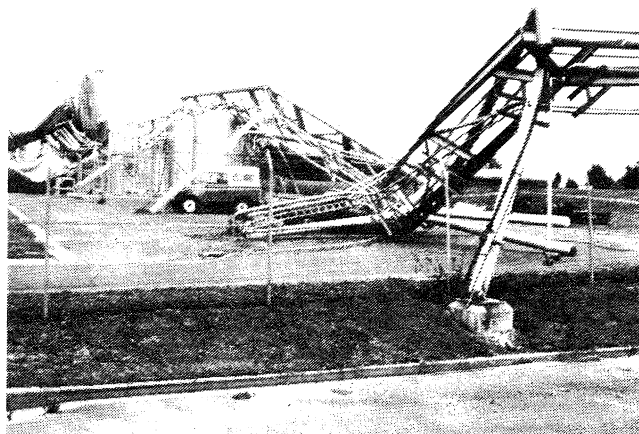
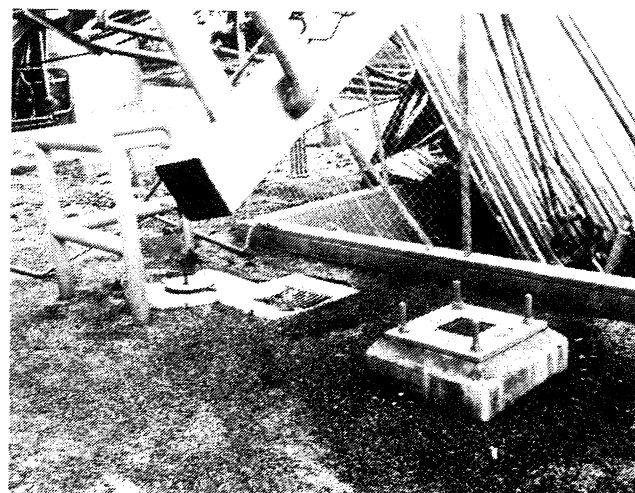
Fig. 4.2.12 : Pipe bridge - general view

An interesting collapse occurred with a particular pipe bridge within the milk treatment depot. Initial collapse occurred at a section where a tank fell upon it, which certainly would not come within a normal design loading. However, the longitudinal and lateral displacement thus induced brought about brittle failure of the welds at the base of the cantilever RHS stanchions well away from the point of impact. Had these behaved in a ductile manner, then consequential damage to the bridge and pipework would probably have been much less. The RHS posts were simply welded to the heavy base plates by fillet welds without gusset plates, stiffeners or the like. Although the base plates had been yielded, the welds had failed to generate the strength of the RHS and the welds tore progressively from a corner location without so much as distorting the RHS, Figs. 4.2.12 and 4.2.13.

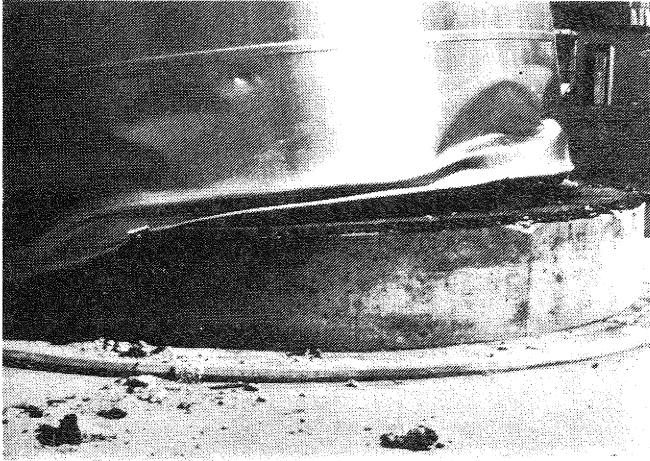
Fig. 4.4.1 : Typical tank pedestal

The support method for the large tanks was essentially the same with details varying from tank to tank. Each tank sat on a concrete pedestal (sloping to allow drainage), Fig. 4.4.1, which was part of a piled foundation slab. The floor edge of the tank was radiused upwards (formed by rolling) and butt welded to the wall; a skirt lapped onto

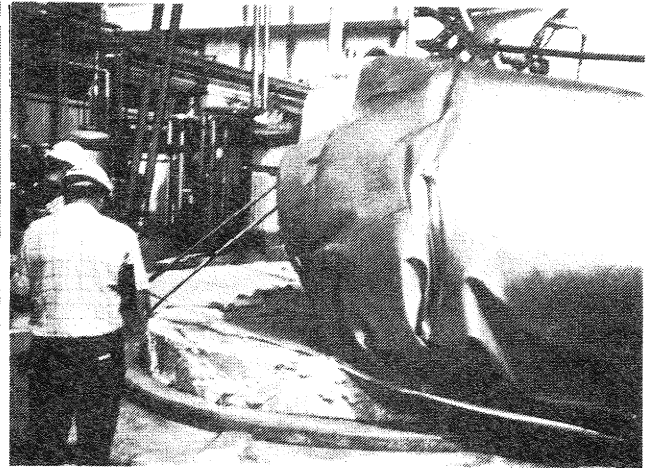
Fig. 4.4.2 : Pedestal with foam lining

the wall and extended down to the foundation pad. Usually there was some insulation material (cork or foam plastic) between the metal floor and the pedestal, Fig. 4.4.2. The skirt in turn was fastened to the foundation slab by holding down bolts, Fig. 4.4.3. There were usually about 9 No. 20 mm bolts for the larger tanks. These bolts acted through lugs that were welded to the skirt (a variety of details), and then fastened into the concrete. The bolts were made mainly of mild steel, but some of stainless steel were used. Some tanks had the bolts cast in-situ or grouted in while others used a "terrier type" fastening.

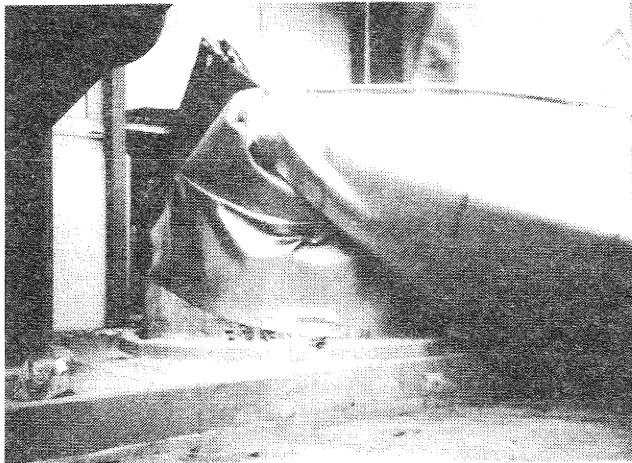
Fig. 4.4.12 : Cantilever collapse

The larger tanks, if they contained substantial fluid, collapsed; their behaviour during the earthquake being so violent that they often damaged nearby tanks and structure. Most of these tanks were lying on the ground, completely ripped off their bases with their contents lost, Figs. 4.4.6, 4.4.7, 4.4.8. Some were left standing, leaning on some supporting structure. It is difficult to categorize the sequence or primary cause of failure. For all tanks, the holding down detail had failed. It had failed in every possible way: the bolts (whether cast in-situ or of the "terrier" type) had been ripped from the foundation slab, the bolts had failed in tension and shear, there were cases of the nuts being pulled off the threads; the bolts had pulled through the hole in the lug, Fig. 4.4.9, ripped the lug hole open, Fig. 4.4.10, or pulled the lug completely from the tank (refer to Section 4.4.3 for more detail). Parts of the tank walls were buckled; quite frequently the tank base had unzipped from the wall along the weld, Fig. 4.4.11; in cases the tank walls were torn; or had buckled in a cantilever fashion, Fig 4.4.12.

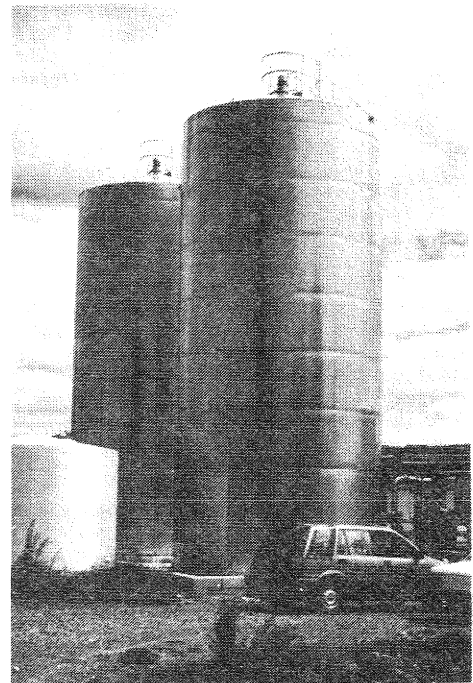
Fig. 4.4.13 : Omeheu Demonstration Farm tanks

Located approximately 4 km west of Edgecumbe, this farm used two silos which were similar to many observed at Bay Milk Products Ltd., Fig. 4.4.13. These were constructed of stainless steel and had a support configuration using a pedestal, skirt and holding down bolts similar in detail, to those as described previously. There was some damage to these silos but it was only superficial. There was a little cracking of the mortar around the holding down bolts and possibly a small amount of indentation at the base of the tank due to axial compression forces in the walls, Fig. 4.4.14. These tanks were approximately 40% full at the time, for which calculations indicate the base moment would be only 12-15% of that for the full tank.

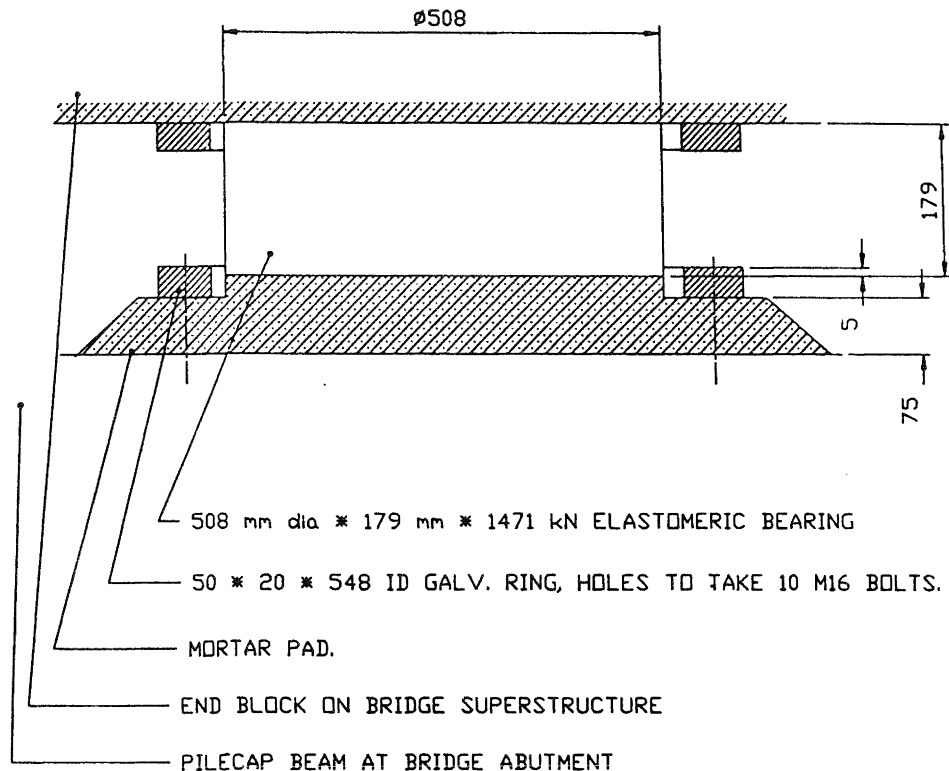
Fig. 5.2.1 : Te Teko bridge lead-rubber bearing - as installed

As constructed; a 10 mm to 15 mm upstand was included on the two mortar pads at the western abutment, as shown in the accompanying drawing, which reduced the effective height of the lower retaining rings to 5 mm to 10 mm, Fig. 5.2.1. The effective depth of retention was a little greater for the downstream bearing.

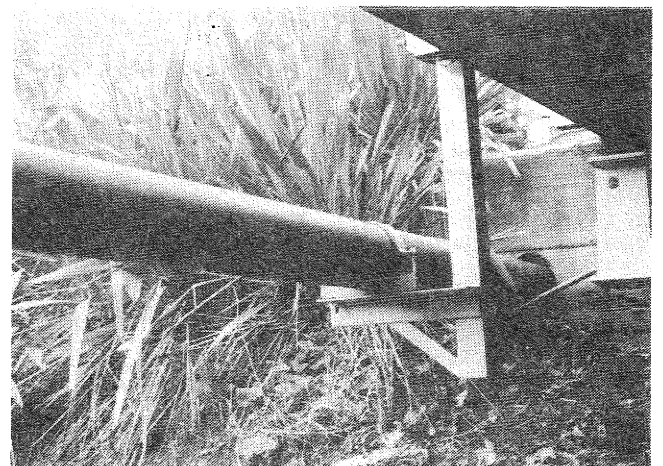
Fig. 6.2.5 : Sewer pipe on Kawerau Bridge

At Kawerau, the bridge over the Tarawera River adjacent to the Borough Works Depot suffered some damage to the services. The bridge deck appeared to have moved about 100 mm towards the left bank of the river. The 250 mm diameter steel water main underneath the bridge passed into a sleeved hole in the abutment. The movement of the deck taking the pipe with it has caused the pipe to jam on the top of the sleeve. Efforts were being made to enlarge the opening to reduce the loading on the pipe. Also on this bridge a 250 mm dia. steel sewer was suspended by angle brackets from the side of the bridge. The pipe was seated in shaped timber blocks, and was well secured in position. According to the workmen on the job, the end bracket was badly deformed and the pipe jammed against the sleeve. Repair work consisted of straightening the bracket, and reducing the height of the timber support block under the pipe by about 100 mm, while keeping the sewer in service, Fig. 6.2.5.

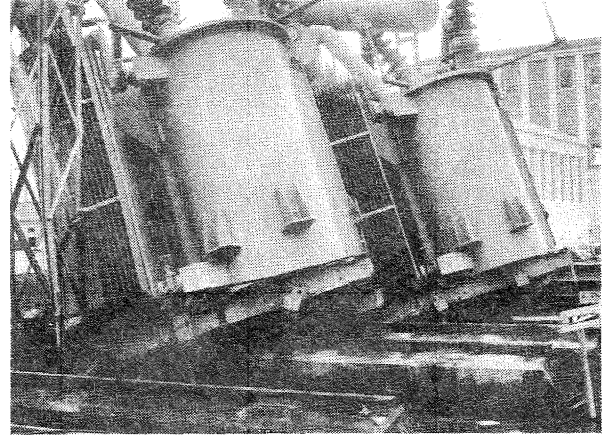
Fig. 7.1.5 : Two of the three Met-Vickers 110 kV 3333 MVA transformers. Note hold down bracket.

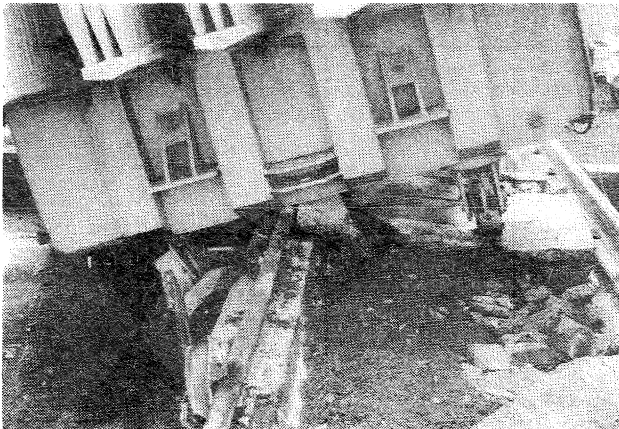
All three Savigliano transformers plus the spare came off the rails when the holding down arrangements failed completely. All of the 3/4" Whitworth studs securing the holding down brackets to the wheels failed in shear as shown in Fig. 7.1.3. The studs would have been subjected to very high shear loads under horizontal earthquake load in the direction of the rails because of the lever action of the relatively long bracket on the narrowly spaced studs, Fig. 7.1.4.

Fig. 7.1.3 : Close up view. Note twisted holding down bracket

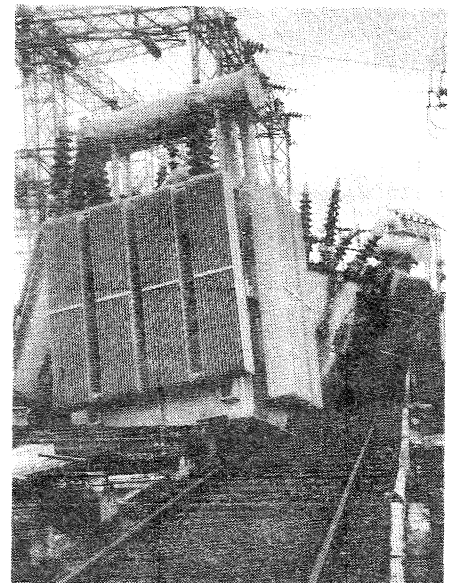
Fig. 7.1.6 : Spare transformers bank in the 110 kV yard. The Feranti in the foreground and the three Metropolitan Vickers in the background.

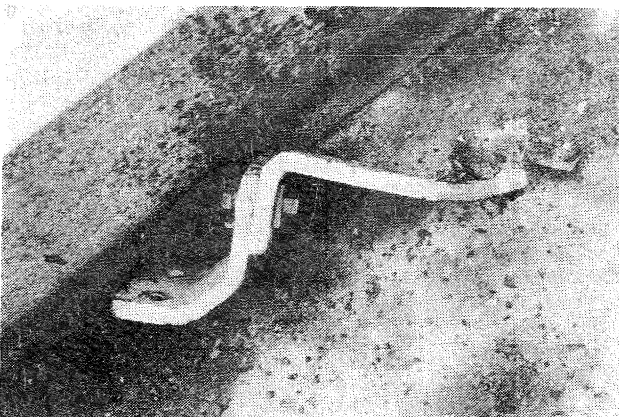
Fig. 7.1.4 : Holding down bracket shows evidence of prising of fixing bolts

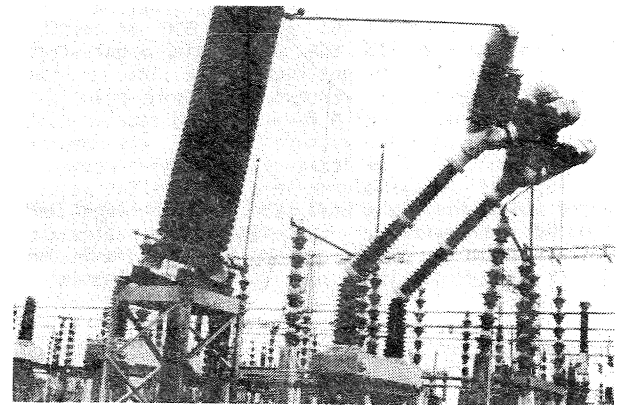
Fig. 7.1.7 : 220 kV Oreliken CB-Blue Phase. Red and yellow phases were on the ground.

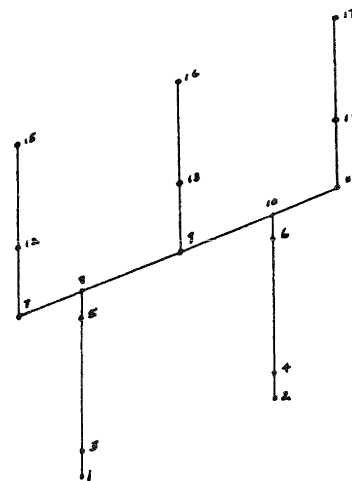
Fig. 7.3.2 : The computer model of the airbreak switch support used for the Strudl-Dynal dynamic analysis

The DSIR has reported that the earthquake at Matahina dam had a peak ground acceleration of 0.33 g and a form very similar to that of El Centro 1940. To determine the possible loadings during this earthquake, the concrete posts were computer modelled using the El Centro earthquake. On this basis the base bending moment on the concrete pillars at Kawerau may have just exceeded 22 kNm. Using the same model, Fig. 7.3.2, and a scaled El Centro earthquake, it was found that the ultimate bending moment of 26 kNm is only exceeded when the ground acceleration exceeds 0.43 g.
