Seismic Retrofitting of Low Strength Unreinforced Masonry Non-engineered School Buildings

J. K. Bothara¹, B. Pandey² and R. Guragain²

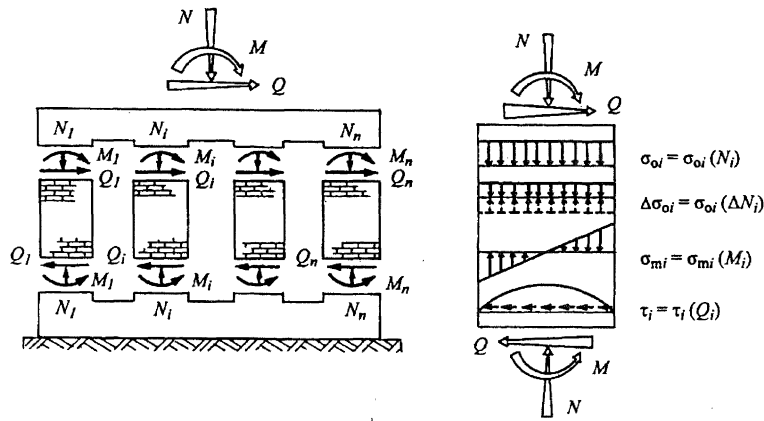
The lateral load analysis for in-plane loading was based on a simple static, lumped mass system. "Pier-only" (Arya, 1987) spanning between sill and lintel level (Figure 7), analysis was conducted to assess stresses in structural components during the in-plane action. This method is similar to the storey mechanism model applied by Tomazevic (1999). Lateral load was distributed to the piers according to their stiffness based on their geometry. No specific considerations were taken for strengthening in shear. Nevertheless, the splints and bandages (discussed later) will increase shearing strength of the walls and piers.

Figure 7: Forces and stresses in in-plane piers (Source: Tomazovic, 1999).
