# THE MAGNITUDE 8.3 JUNE 23 2001 SOUTHERN PERU EARTHQUAKE AND TSUNAMI: RECONNAISSANCE TEAM REPORT

Mark Stirling<sup>1</sup>, Robert Langridge<sup>2</sup>, Rafael Benites<sup>2</sup> and Hector Aleman<sup>3</sup>

## SUMMARY

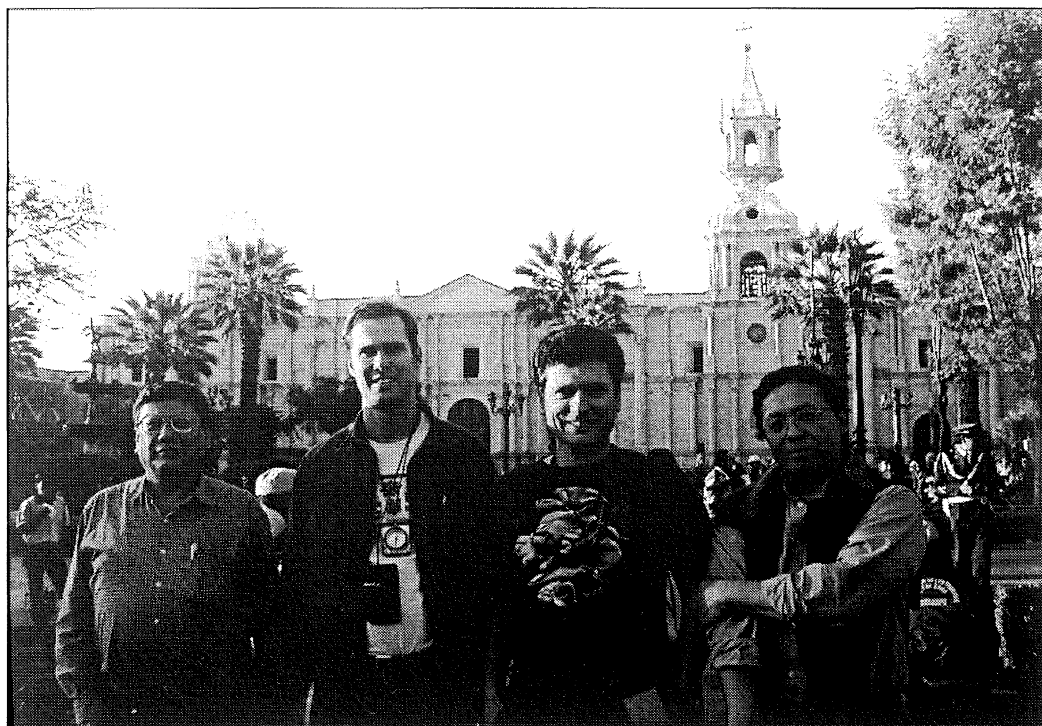
Figure 4. Reconnaissance team members. From left: Hector (Coco) Aleman (geophysicist), Robert Langridge (earthquake geologist), Mark Stirling (trip leader and seismic hazards scientist), and Rafael Benites (seismologist). The photograph also shows the damaged Arequipa cathedral in the background.

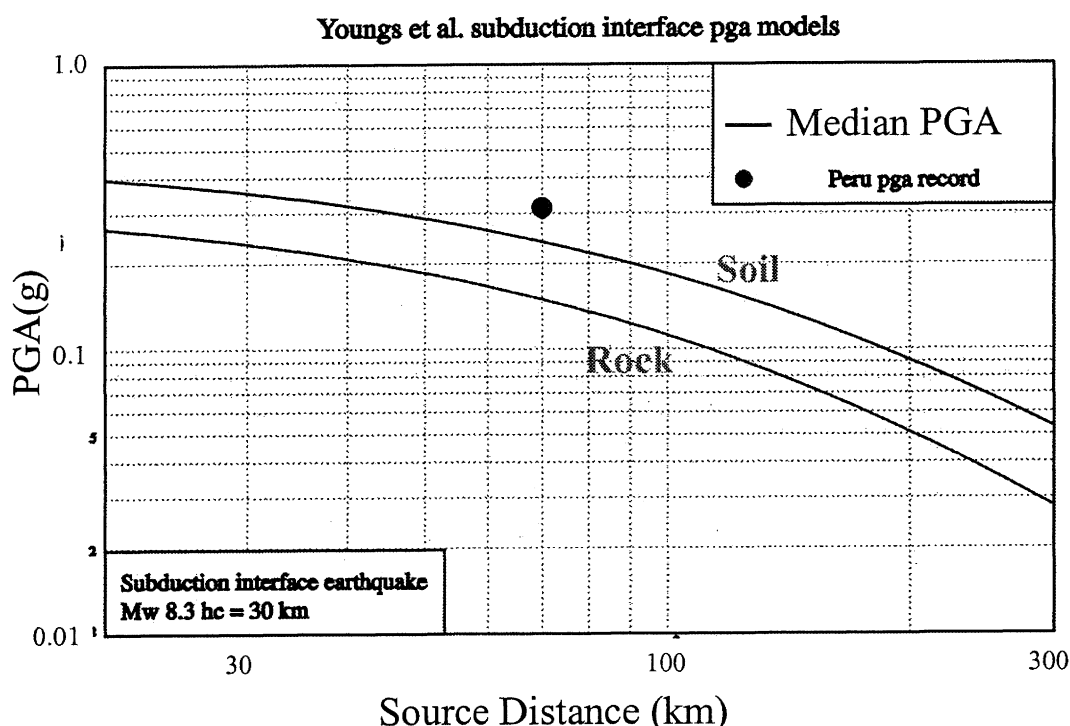
Figure 23. The Moquegua peak ground acceleration (soil site conditions) plotted on the graph of median ground motions predicted for the same size of earthquake from the Youngs et al (1997) subduction interface attenuation relationship.

- Establish the extent to which the ground motions of the southern Peru earthquake are typical of subduction-interface earthquakes on the Chile-Peru subduction zone and elsewhere in the world. The earthquake produced only “moderately strong” levels of shaking (PGA 0.3g on alluvium and considerably less on rock) which appear to be typical of the shaking levels measured in other subduction zone interface earthquakes. However, we recommend that this comparison should be the focus of further critical examination before the earthquake is formally used as a basis for hazard assessment in New Zealand. Analysis of the felt reports from other subduction zone earthquakes in similar settings to the southern Peru earthquake would be of considerable value in understanding the range of effects that could be produced in a future great Hikurangi subduction-zone earthquake.
