REINFORCED CONCRETE BUILDING PERFORMANCE IN THE M_w 7.8 1931 HAWKE'S BAY, NEW ZEALAND, EARTHQUAKE

G. van de Vorstenbosch¹, A.W. Charleson² and D.J. Dowrick³

SUMMARY

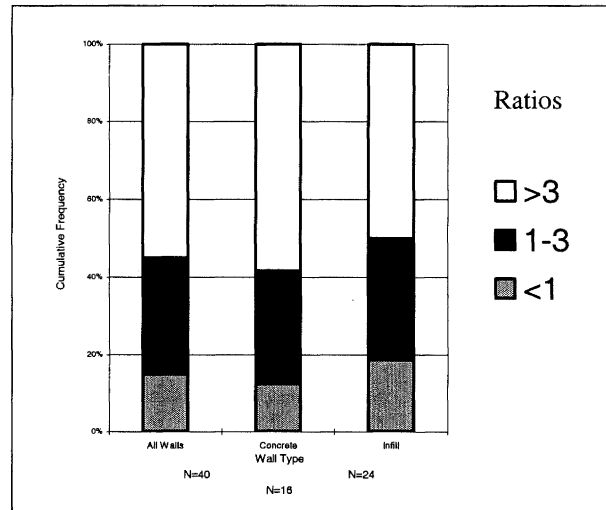
Figure 4. Cumulative frequency chart for ratios of wall overturning to restoring moments

Figure 4 shows the cumulative frequency of overturning to restoring moment ratios for all structural and infill walls using the calculated Hawke's Bay earthquake seismic load. Over 85 percent of all walls should have overturned or at least rocked (ie. ratio of overturning moment to resisting moment > 1). Over 50% of walls have ratios > 3 . If earthquake loads are reduced by ($m-\Phi$), all transverse walls and 50% of longitudinal walls should have rocked. Although

rocking or overturning of walls is not mentioned in any damage reports it is possible that rocking could have occurred without being apparent afterwards, especially given a probable unawareness of this form of dynamic response in the 1930s.

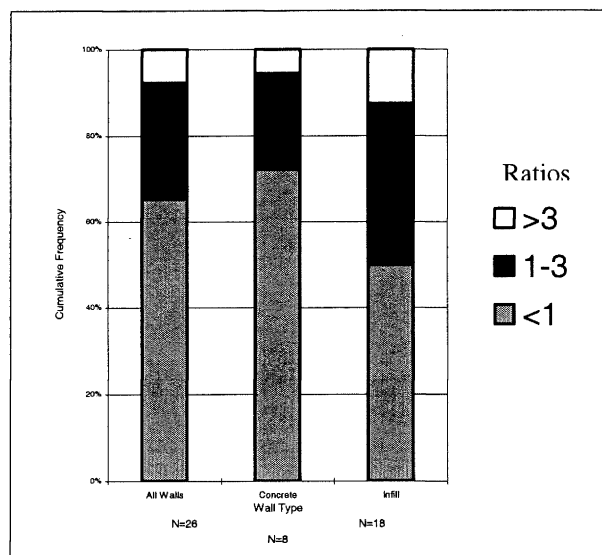
Figure 5. Cumulative frequency chart for ratios of applied shear force to probable wall shear strength.

Applied shear force to shear strength ratios for reinforced concrete structural walls and reinforced concrete frame masonry infill walls are summarised in Figure 5. The reinforced concrete walls have shear strengths that in 70% of cases was greater than the maximum shear forces. Assuming a ($m-\Phi$) reduction in load, a total of four walls would have been expected to suffer shear damage, however wall rocking is expected to have occurred well beforehand, reducing load levels.

Masonry infill panels exhibit three possible damage modes; horizontal sliding shear failure of the infill, diagonal tension and compression strut failure or sliding shear failure of adjacent reinforced concrete columns. For all infill walls where damage was expected to occur, five walls should have experienced horizontal sliding shear of the infill panel and three should have failed in diagonal tension. Diagonal tension failure does not necessarily equate to complete failure if tension forces can be redistributed to and resisted by diagonal compression struts. Sliding shear failure of adjacent column tops was found not to be critical.

The fact that both types of wall performed so well can first of all be attributed to several factors relevant to wall overturning that have already been discussed, namely that walls may have had their shear demand reduced by rocking.

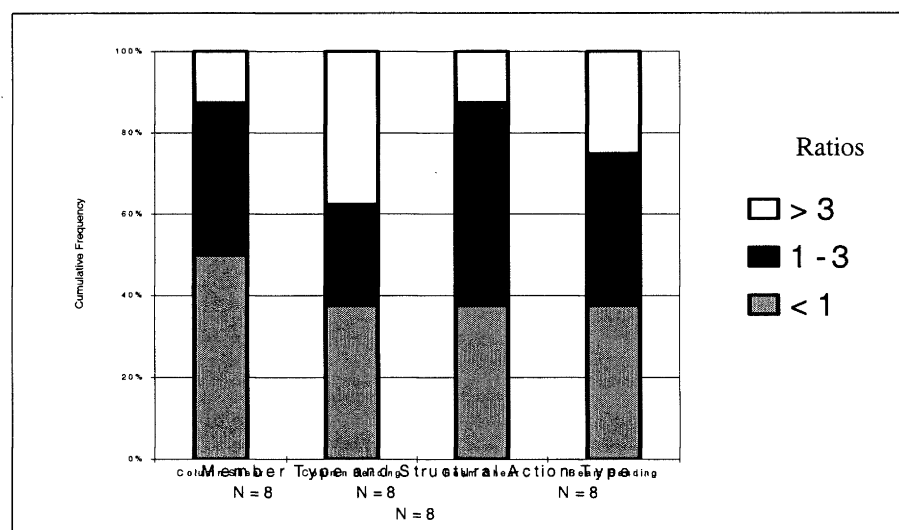
Figure 6. Cumulative frequency chart for ratios of applied shear force to shear strength and bending moment to bending strength of moment resisting frames.

The actual performance of frames was better than suggested by the analyses. Figure 6 summarises typical ratios of maximum shear force to probable shear strength, and maximum bending moment to probable bending strength for columns at ground floor level and beams at level 1 in open moment-resisting frames.

Approximately 50 percent of columns had their shear strength exceeded and 63 percent had their bending strength exceeded. Beam shear and bending ratios were exceeded in 60 percent of cases. If the $(m-\Phi)$ factor is applied, four column sets would be expected to yield in bending. In two cases, early flexural yielding would have prevented expected shear damage. However, apart from reports of column hair cracks in one frame, no structural damage to columns or beams was reported for these buildings. It must be recalled though, that for *all* frames (including many not in this study) it was observed that "*most of the damage.. .occurred in columns, and particularly ground floor columns*". The frames subject to this study clearly performed better during the earthquake than some others (since demolished).

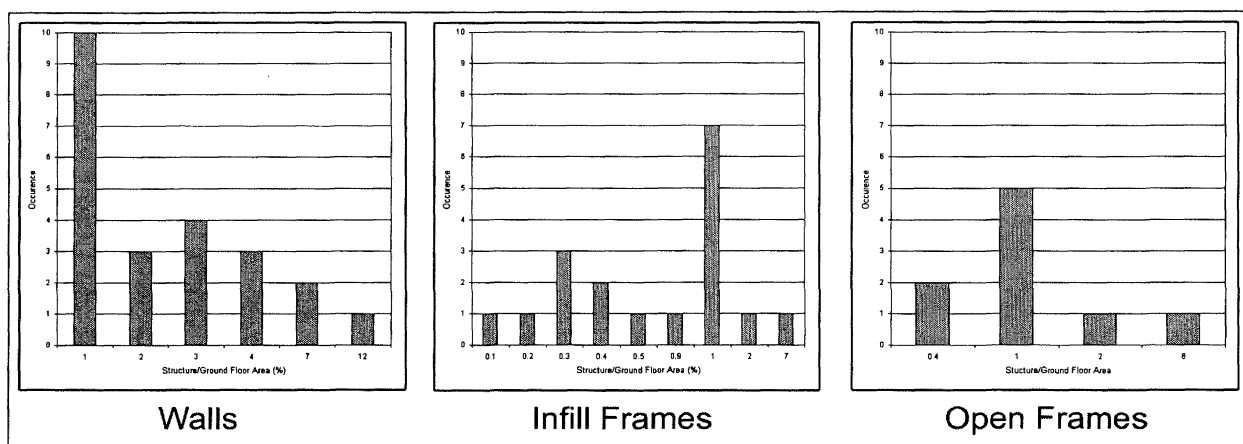
Figure 7. Percentages of structural footprints to ground floor areas.

Structural footprint areas expressed as a percentage of gross ground floor areas for all buildings studied as listed in Table 1 are presented graphically in Figure 7. Footprint percentages are calculated for each orthogonal direction separately.

The building with percentages of 0.1% and 0.2% (in each orthogonal direction, excluding the area of masonry infill) did experience minor structural damage. Infill frames of 0.3% (1.0% if the masonry area is included), performed well.

Frames with a structural footprint of 0.4 percent or greater performed well.
