THE 1942 WAIRARAPA, NEW ZEALAND, EARTHQUAKES: ANALYSIS OF OBSERVATIONAL AND INSTRUMENTAL DATA

G.L. Downes¹, D.J. Dowrick¹, R.J. Van Dissen¹, J.J. Taber²,
G.T. Hancox¹ and E.G.C. Smith²

ABSTRACT

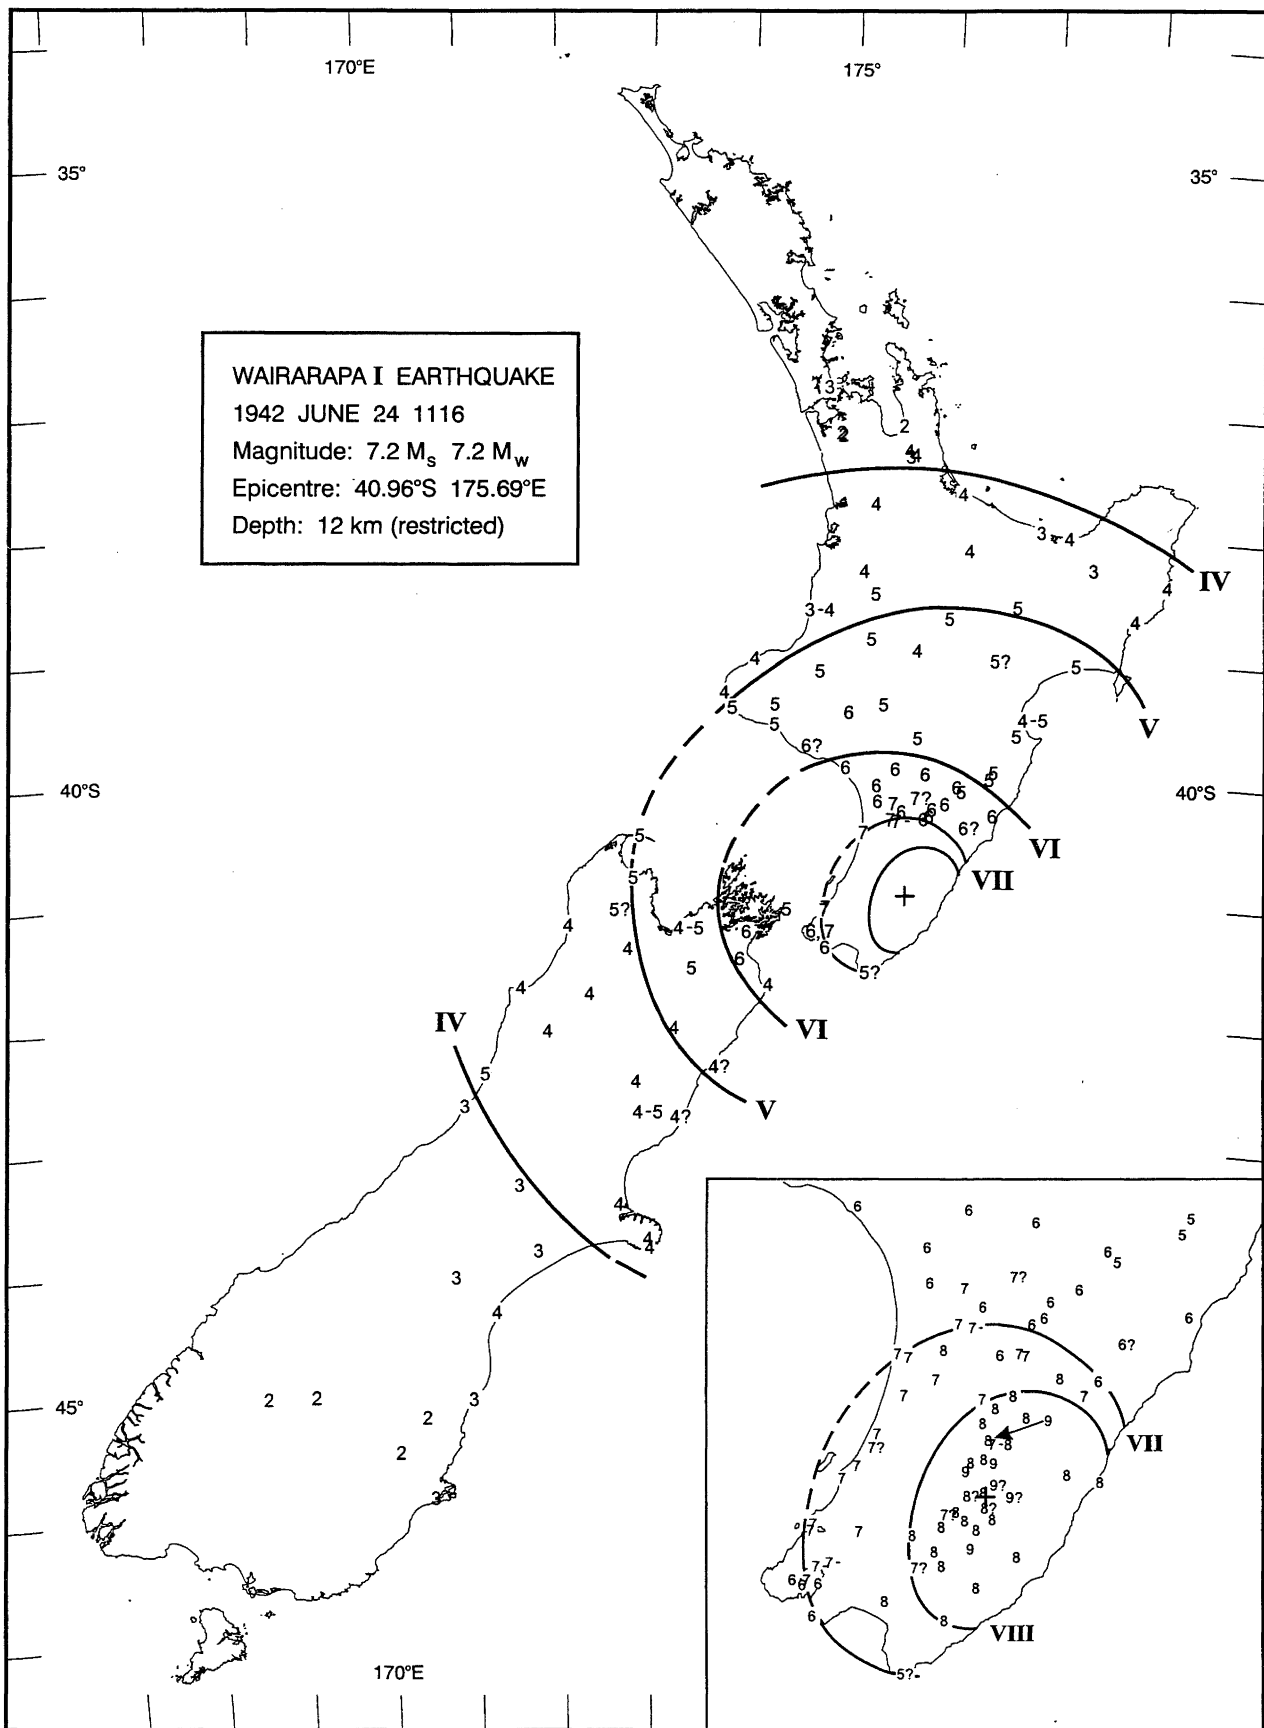
The earthquake of June 24 was shallow enough (centroid depth $h_c=12$ km) and, with a magnitude of $M_w 7.2$, large enough to cause considerable damage, despite being centred away from large cities. It was felt over a large part of the North and South Islands, from Auckland to Dunedin (Figure 3, Table 2). The zone of heaviest damage, inside the MM8 isoseismal, covered an area of about 4,000 km² and encompassed six small towns and a total population in 1942 of about 24,000 people. The intensity reached a maximum of MM9 at a few locations near Masterton.

Figure 3: Isoseismal map of the 1942 June 24 M_w 7.2 Wairarapa earthquake (Wairarapa I). Inset shows detail within the inner isoseismals. "+" denotes epicentre determined in this paper.

The railway line most strongly affected ran from Featherston via Masterton to Woodville, with about 80 km of the track lying within the MM8 isoseismal, including 30-40 km probably directly above the rupture zone (Figure 3). Peak ground accelerations probably ranged from 0.3-0.6g. Following the clearance of a small slip from the line in the Rimutaka Ranges south of Featherston, the train service between Masterton and Wellington operated normally the day after the main shock. North of Masterton, two bridges were damaged and a section of track was out of alignment. This damage was apparently not heavy, but sufficient to keep the line between Masterton and Eketahuna closed for several days.

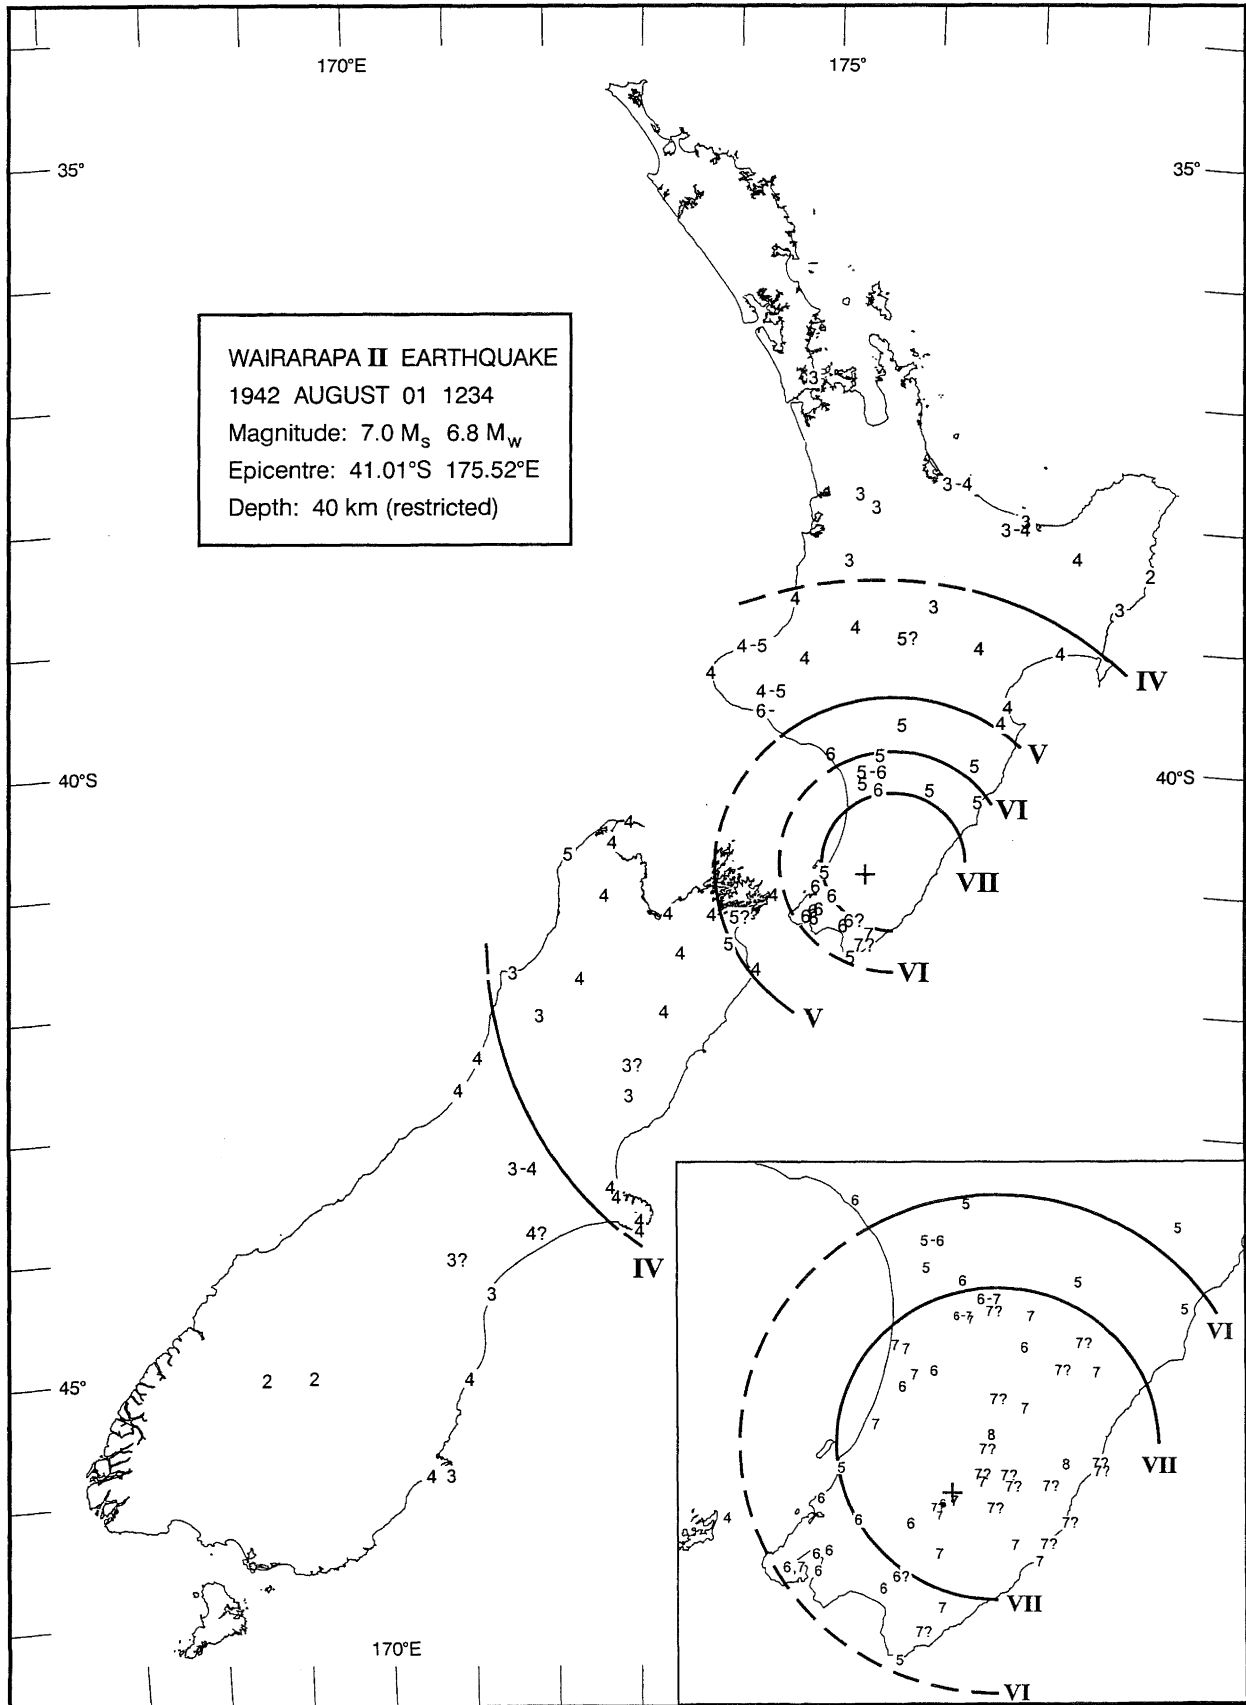
Figure 4: Isoseismal map of the 1942 August 1 (August 2 NZT) M_w 6.8 Wairarapa earthquake (Wairarapa II). Inset shows detail within the inner isoseismals. "+" denotes epicentre determined in this paper.

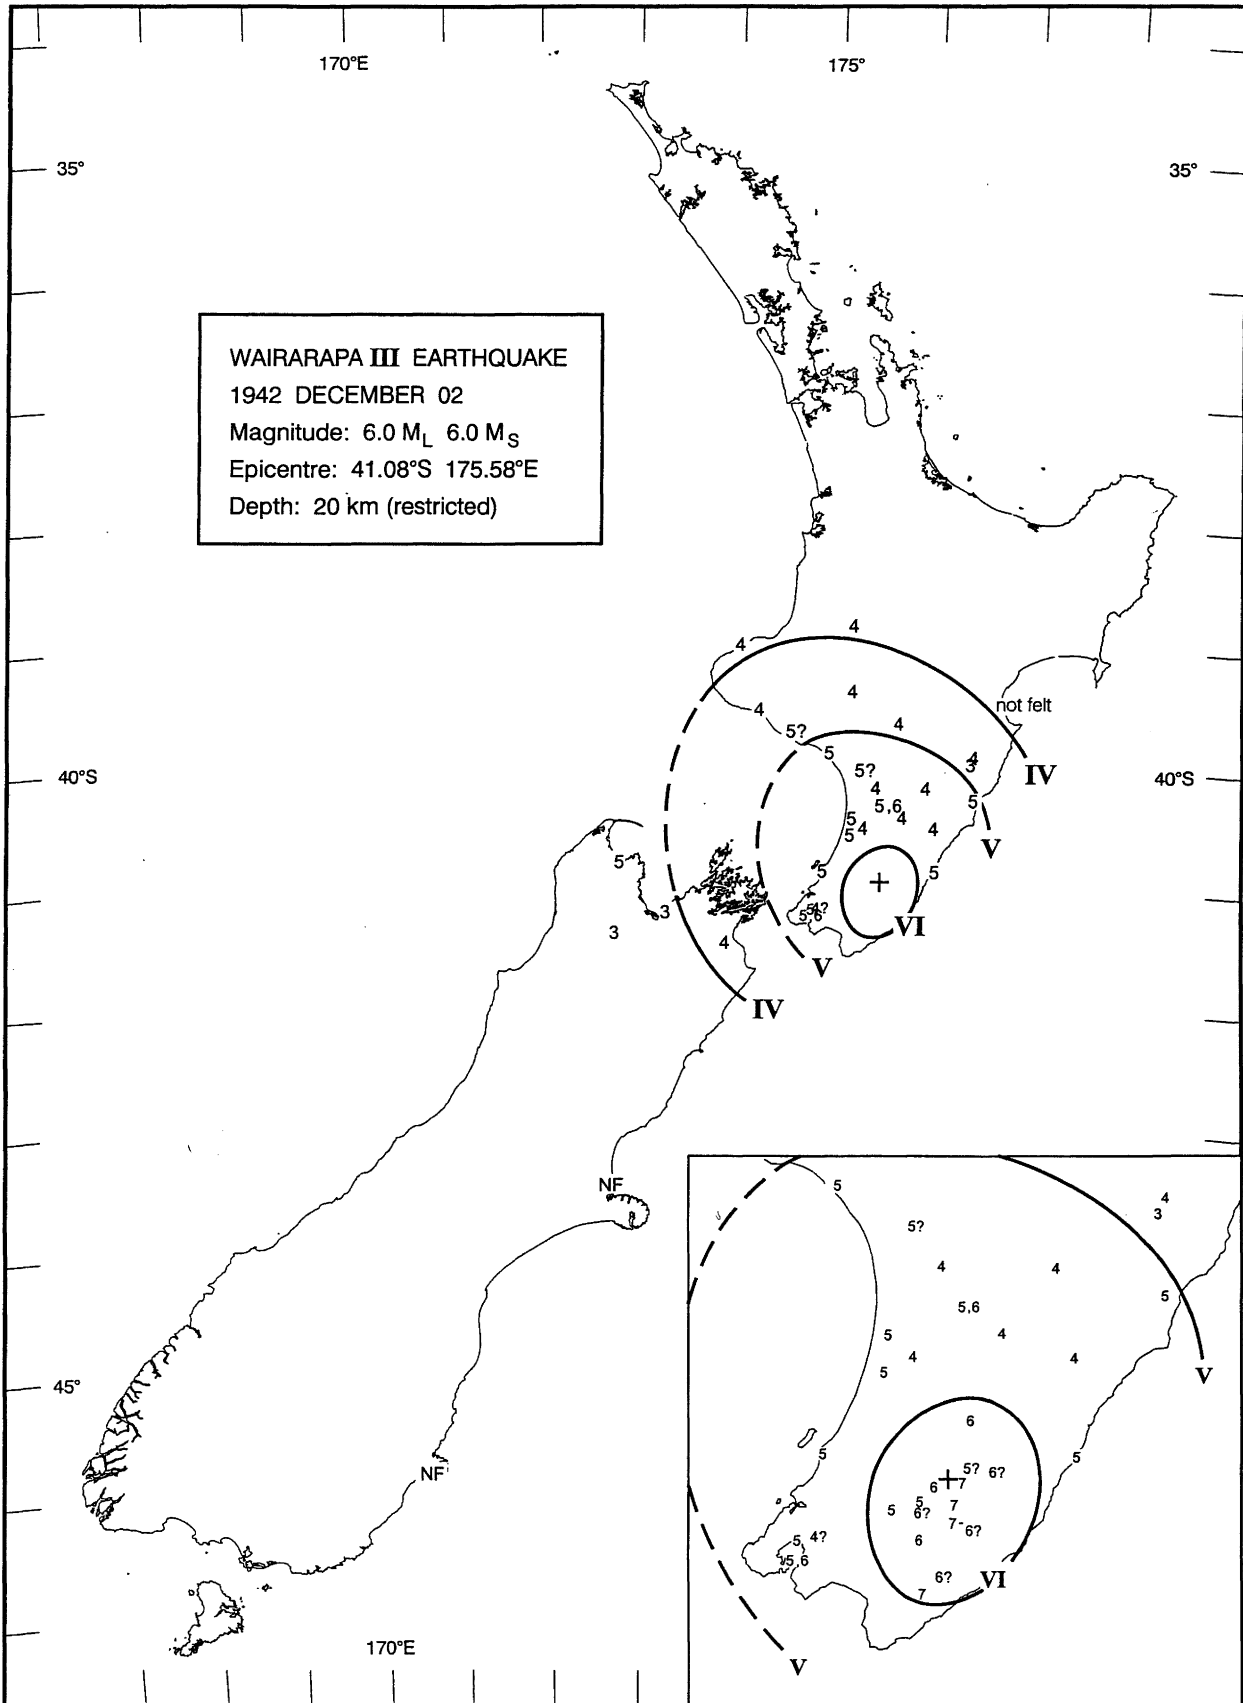
Figure 5: Iseismal map of the 1942 December 2 $M_{6.0}$ Wairarapa earthquake (Wairarapa III). Inset shows detail within the inner isoseismals. "+" denotes epicentre determined in this paper.

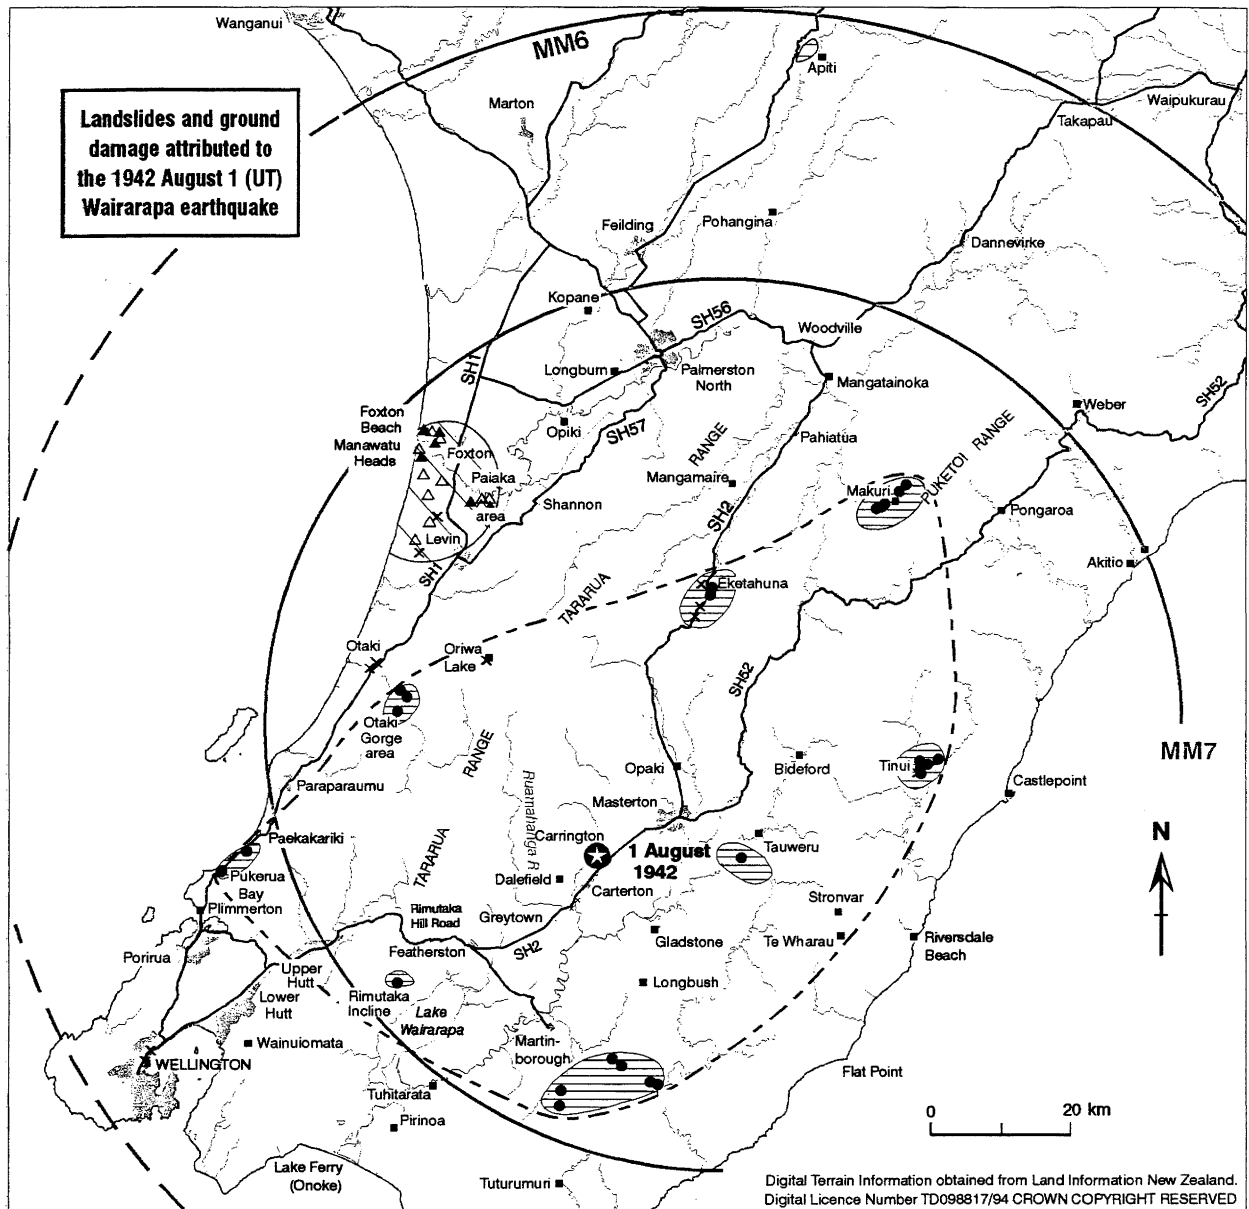
Landslides and ground damage attributed to the 1942 August 1 (UT) Wairarapa earthquake

There was only moderate landslide damage in the Wairarapa, and minor subsidence of bridge approaches. The most intensive damage occurred in the Martinborough area, with all roads to the coast again blocked by slips, cracks, and subsidence. Slips again blocked the Stronvar road southeast of Masterton. In the north, slips fell on to the road south of Eketahuna, where there was also road cracking and subsidence. Again, there were numerous slips in Makuri Gorge. A slip occurred on the Rimutaka Incline between Cross Creek and the summit, and small landslides were reported in the Otaki Gorge area. The Paekakariki Hill road was closed by a "big slip" while at Pukerua Bay there was a "slight fall of earth" near the railway line. On the railway line south of Plimmerton there was no further trouble from the June slip area at Goat Point. There was little landsliding in Wellington City with only minor, very small regolith slides and falling rocks reported in a few places.

Soil liquefaction effects were also evident during this earthquake, particularly in the far field. Significant localised liquefaction effects were again reported in the Foxton to Levin area (Figure 14). Sand fountaining occurred along the river front at Foxton Beach, and bridge approaches in the area subsided. In the swampy ground in the Horowhenua area, power poles were tilted over, probably by liquefaction-induced ground failure. On the Paiaka Road to the Manawatu River (west of Shannon) widespread "sand geysers" again occurred over about 5 acres (2 ha), with sand piled up 400-500 mm and spread out over 2-4 m from some vents. Similar effects also occurred in about the same location during the June earthquake, although possibly more widespread. The widespread liquefaction effects in the Foxton-Horowhenua area indicate local shaking bordering on MM8 in an otherwise MM7 area, emphasising the high susceptibility of ground in the area to soil liquefaction and hence, microzone effects.

Figure 14: Geographic distribution of landslides and ground damage attributed to the August 1 1942 Wairarapa earthquake. Isoseismal lines are from Figure 4.

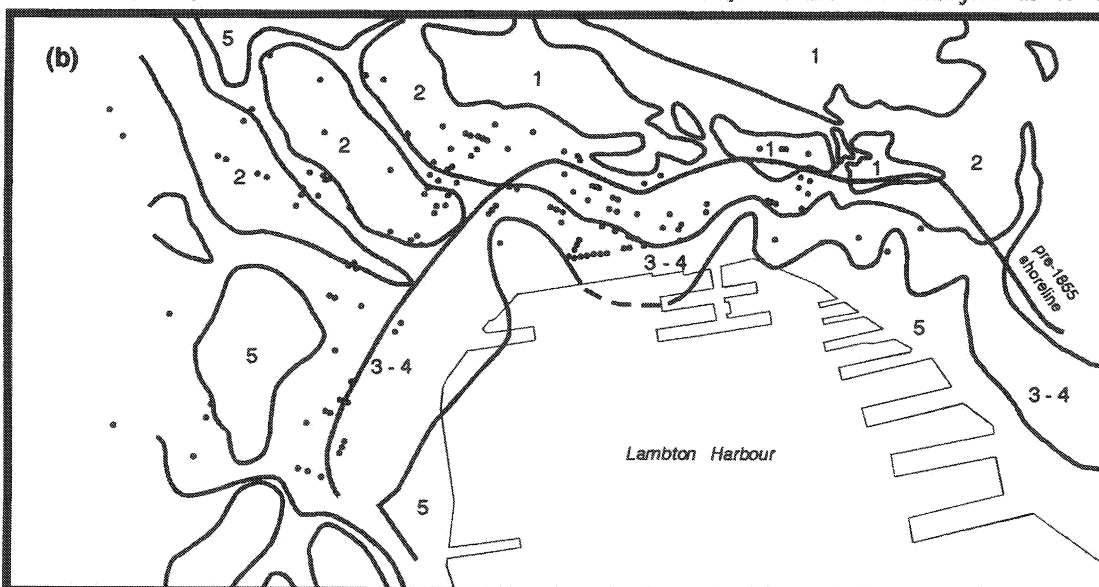
Figure 15 (b): Wellington ground shaking hazard map, based on strong motion, weak motion, and subsurface geology [57, 58]. Zone 1 (least shaking) corresponds to bedrock and Zone 5 (greatest shaking) corresponds to regions with greater than 10 m of soft sediment.

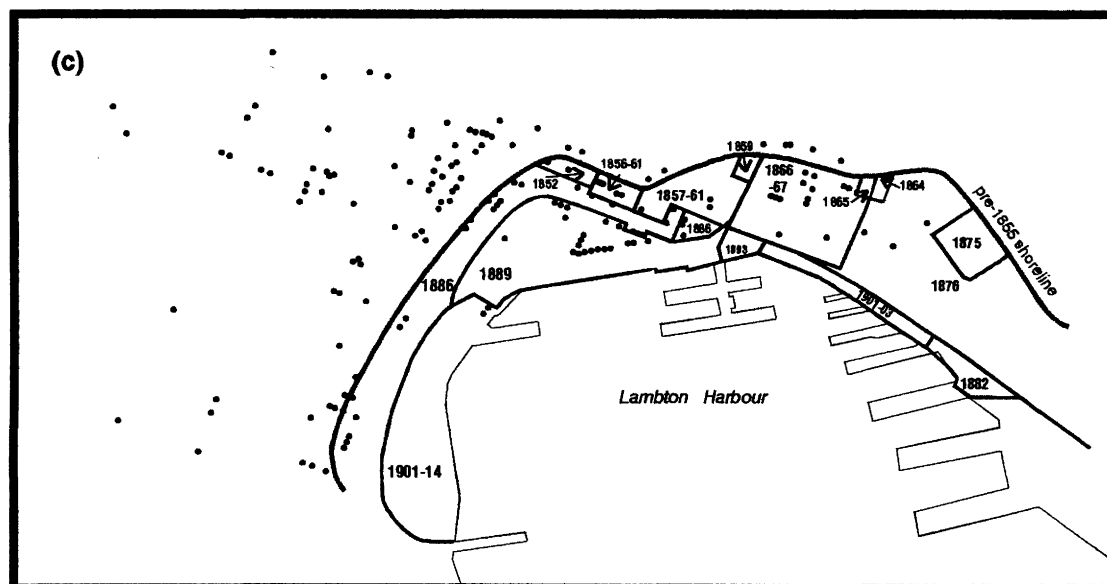
Figure 15 (c): Map of individual units of fill and dates of creation. Compiled using a 1936 Wellington Harbour Board map [59] and Baillie [60].
