# MARMARA SEA EARTHQUAKE RECONNAISSANCE REPORT

## Report of the NZSEE Reconnaissance Team on the 17 August 1999 Marmara Sea, Turkey Earthquake

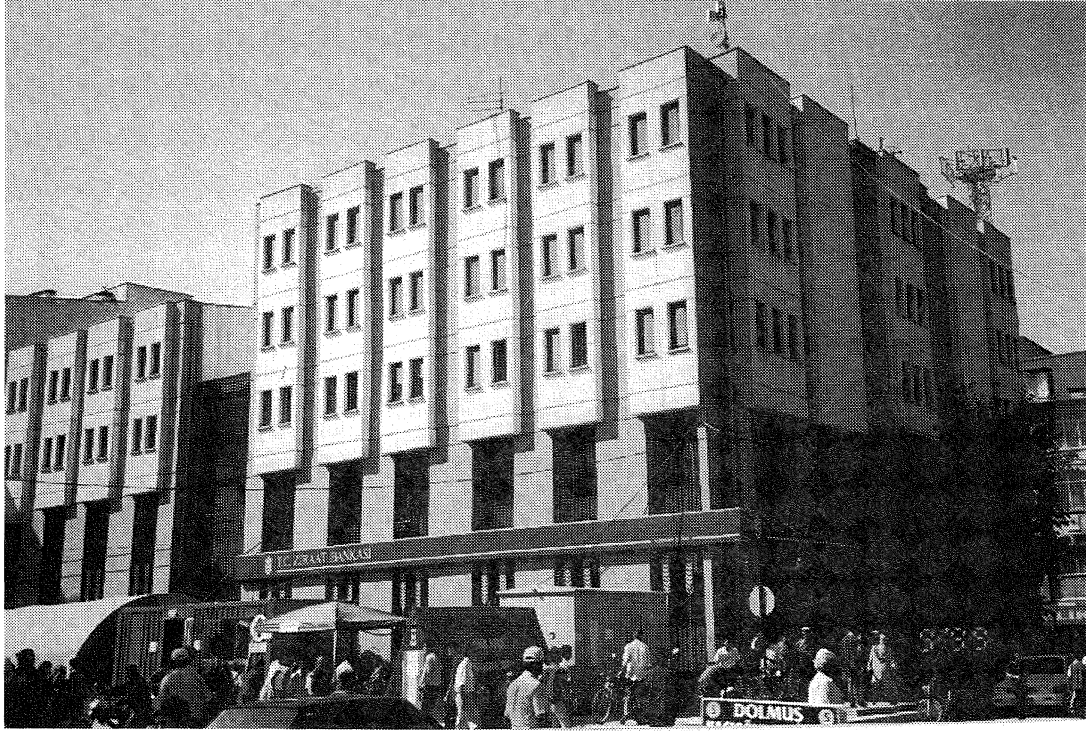
*Figure 24: T C Ziraat Bankasi Building, Adapazari.*

**T C Ziraat Bankasi Building, Adapazzari, Figure 24:** This building is located in the city centre of Adapazzari and had been constructed by a Japanese contractor. It was founded on driven steel piles with no evidence of settlement. The front half of the building is 6 storeys in height and the rear 5 storeys, with a single level basement. Framing to the building exterior, comprising reasonably substantial closely spaced columns coupled by deep beams, forms the major lateral stability system to the building. The building appeared to have minimal damage and was fully operational when inspected.

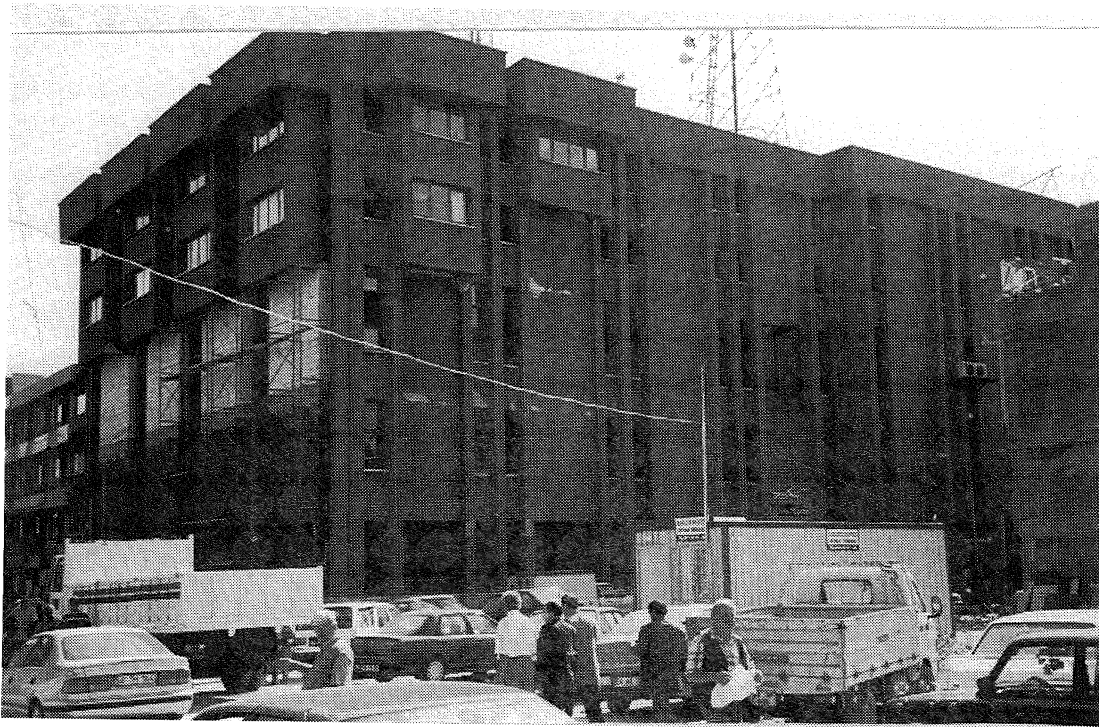
*Figure 25: Turk Telekom Building, Adapazari.*

**Turk Telekom Building, Adapazzari, Figure 25:** This 5 storey telecommunication building is located immediately adjacent the T C Ziraat Bankasi building in the city centre of Adapazzari. The structural system comprises internal core walls around the stair and lift shafts and peripheral framing of reasonably light proportions. Cracking occurred to the non-structural masonry infill panels to the building exterior typically at the interface between the upper courses of the panels and the floor structure over. Some areas of the 3rd level infill to the street facade had collapsed onto the footpath and street below and fallen switching cabinets had been visible in the interior of the building. These masonry infill panels were being reinstated at the time our inspection. Cracking had also occurred to internal masonry infill.

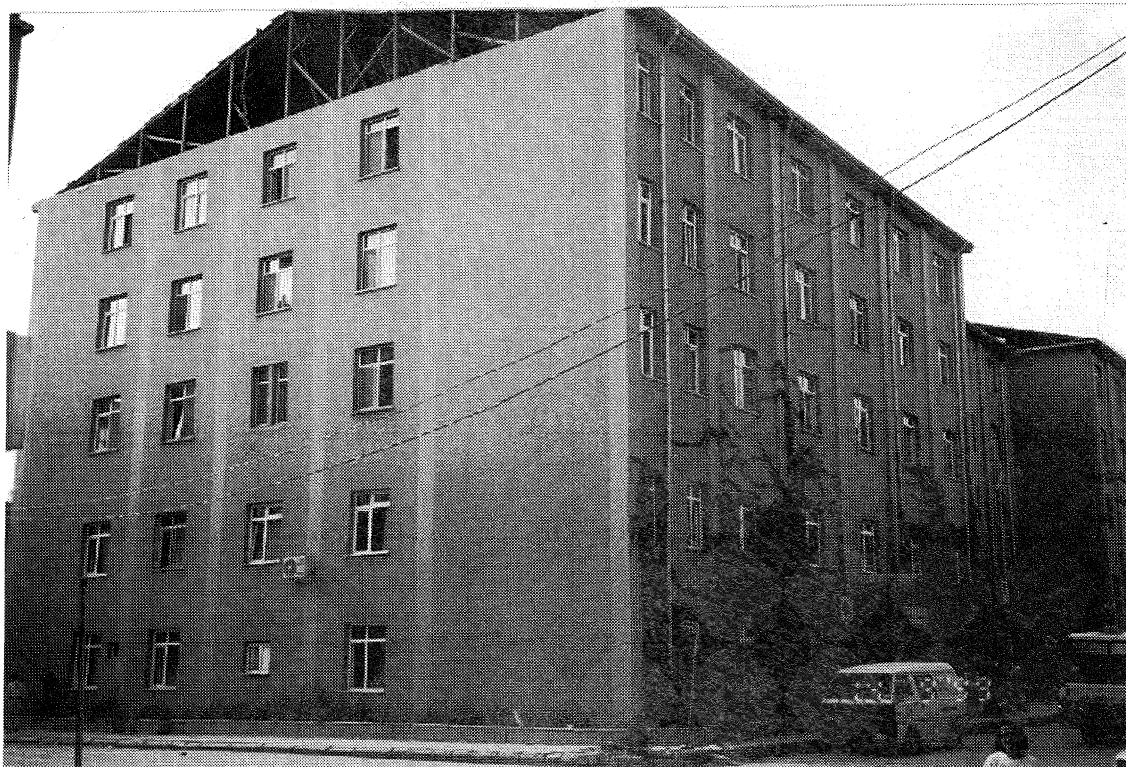
Figure 26: *Sakarya Birth and Childcare Home, Adapazzari.*

**Sakarya Birth and Childcare Home, Adapazzari, Figure 26:** This 5 storey, 160 bed maternity hospital facility comprised three separate buildings structurally separated from one another and was constructed in 1993. The buildings were reinforced concrete framed structures with non-structural masonry infill panels in the openings between. Whilst the structures had undergone very little structural damage, considerable cracking was evident in the masonry infill. The plaster finishes over the movement joints between each building had also cracked open, with gaps up to 20 mm evident.

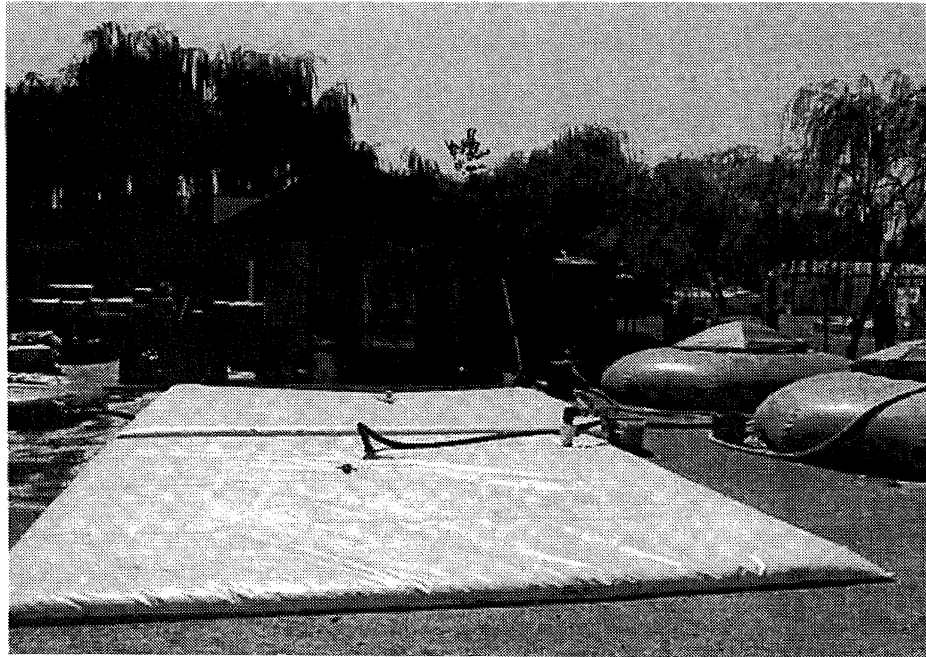
At tent camps and other strategic locations, temporary water supply was provided by 500 litre tanks and by 15,000 litre bladder, seen in Figure 34. With the Maltepe plant expected to be functional within days (approximately one month after the earthquake) there should be a stable water supply and the DART treatment units which have a much smaller capacity will be withdrawn. One remaining problem is the bulk water transportation from the filling station at the base of the treatment plant to the storage locations. Most of the trucks being used have come from Istanbul or Ankara and many were not purpose-built for the task. Some trucks had been sewer pump-out trucks and another, when the label on the tanker was translated, had been used for caustic soda. The trucks were returning to their home cities and the problem remained to co-ordinate a stable, reliable transportation network.

**Figure 34:** Water bladders, Canadian Disaster Assistance Response Team camp at Adapazzari.

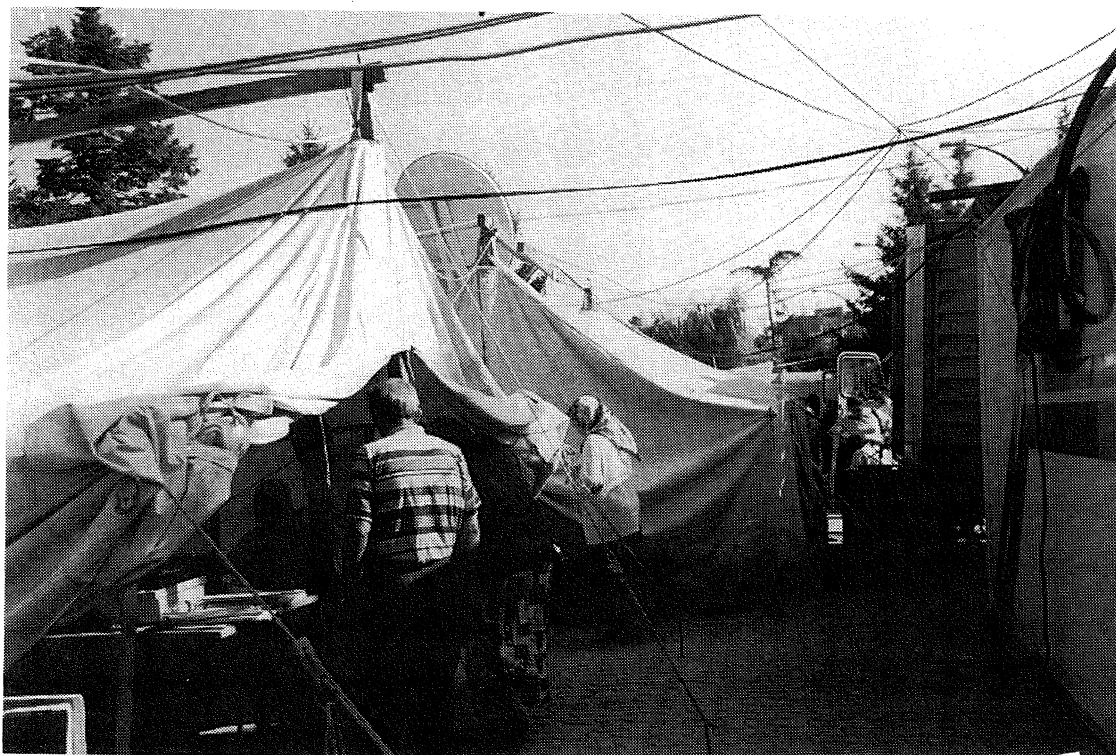
Our site inspection showed that the telephone exchange building at Adapazzari was damaged, but not as extensively as other buildings in the same area. This building was 5-storeys high with 2 antenna towers on top. Apparently the equipment inside was overturned during the earthquake. At the time of our visit, this building was not fully occupied but the equipment was apparently mostly put back in service. Turk Telekom had set up temporary offices on the boulevard nearby including a temporary satellite and exchange network, shown in Figure 38. They also provided 15 phone booths for local people to use.

Figure 38: Temporary Telecom office and satellite dish, Adapazzari.
