## DAMAGE AND INTENSITIES IN THE MAGNITUDE 7.8 1931 HAWKE'S BAY, NEW ZEALAND, EARTHQUAKE

David J. Dowrick<sup>1</sup>

This paper is the result of a study of the shallow  $M_W = 7.8$  Hawke's Bay earthquake which occurred in the North Island of New Zealand, 2 February 1931(UT), and which was the final spur to the production of the first earthquake loadings code in New Zealand issued in 1935. This earthquake was a direct hit on two provincial towns (Napier and Hastings) and was the most damaging in New Zealand's history, causing the most casualties, major fires, and much damage to the built and natural environments. It gives the first overall description of the damage (to the buildings and lifelines) in this major event in modern earthquake engineering terms, and presents the first intensity map for the event determined directly in the Modified Mercalli (MM) scale. The zone which experienced the highest intensity (MM10) was confined to a modest area of onshore land (about 300 km<sup>2</sup>) above the centre of the rupture surface.

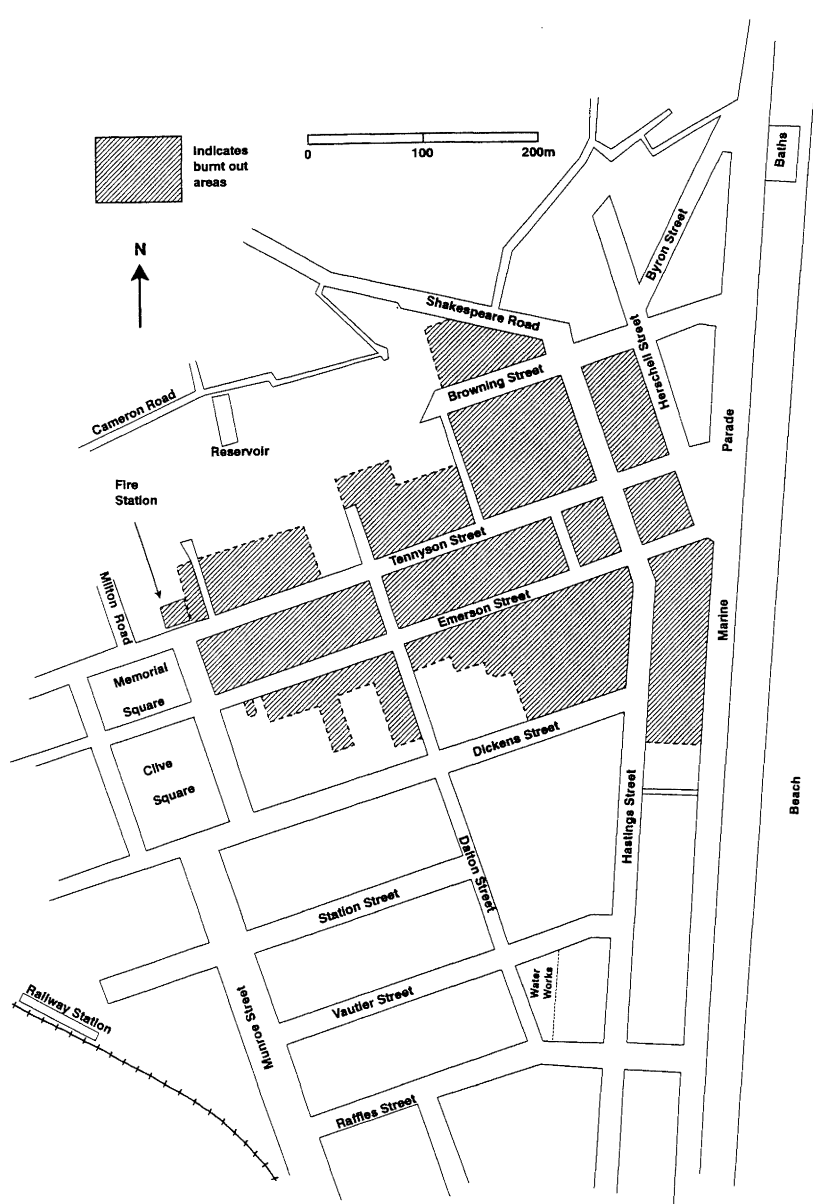
- Napier commercial: 86,000m<sup>2</sup> (eight complete town blocks, plus large parts of three others, Figure 12)
- Port Ahuriri: 21,000m<sup>2</sup> (one complete town block plus, about half of each of three others)

The boundaries of the above burnt out areas were determined by the present author, partly by a study of post-fire photographs, and also by comparison with contemporary maps from two sources [28,35] both of which were found to be not entirely accurate. Some buildings in the "burnt out" area were hardly damaged structurally from either shaking or fire, notably three substantial 3-storey reinforced concrete buildings, the "E&D" building [30], the new Post Office and Hannah's building, all of which were refurbished and reoccupied.

Figure 12: Map of the commercial centre of Napier showing the area gutted by the major earthquake-induced fire.
