EARTHQUAKE DESIGN AND PERFORMANCE OF STEEL STRUCTURES

H Krawinkler¹

This paper was presented as one of the keynote addresses at the Pacific Conference on Earthquake Engineering, PCEE 95, Melbourne, November 1995.

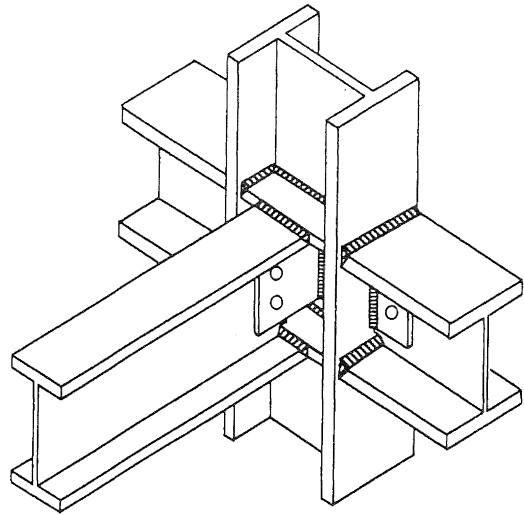
FIGURE 6. Three-way joint with welded connections

function is associated with a multitude of potential problems, particularly for the type of connection illustrated in Figure 6.
