# LESSONS FOR NEW ZEALAND LIFELINES ORGANISATIONS FROM THE 17 JANUARY 1995 GREAT HANSHIN EARTHQUAKE

This report outlines the observations and findings with regard to lifelines and other infrastructural items from each of the various New Zealand post-earthquake visits to Kobe subsequent to the NZNSEE reconnaissance team visit. The preliminary assessments on lifelines aspects made in the NZNSEE reconnaissance team report are developed further. Lessons and recommendations for New Zealand are presented.

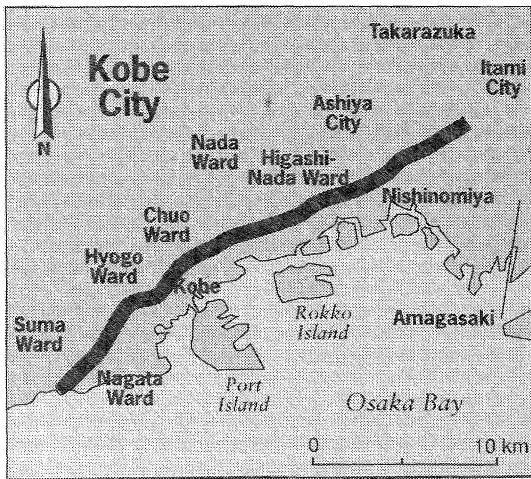
FIGURE 2.2 The approximate extent of MM9 and MM10 intensities [Alexander Howden Group Ltd, 1995]

The earthquake caused a narrow zone of intensive damage of 1.5 - 2 km width and length of nearly 30 km, parallel with the coast, as shown in Figure 2.2.

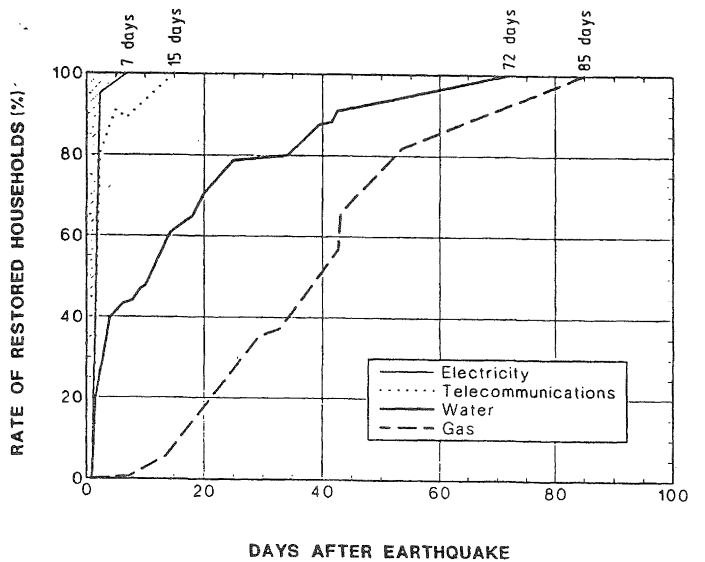
FIGURE 2.4 Restoration curves for lifelines after the Kobe earthquake [Takeda and Ueno, 1995]

The overall response of key utility services in terms of the rate of service restoration is summarised in Figure 2.4. The number of days taken to achieve 100% service restoration takes account of the number of destroyed buildings.

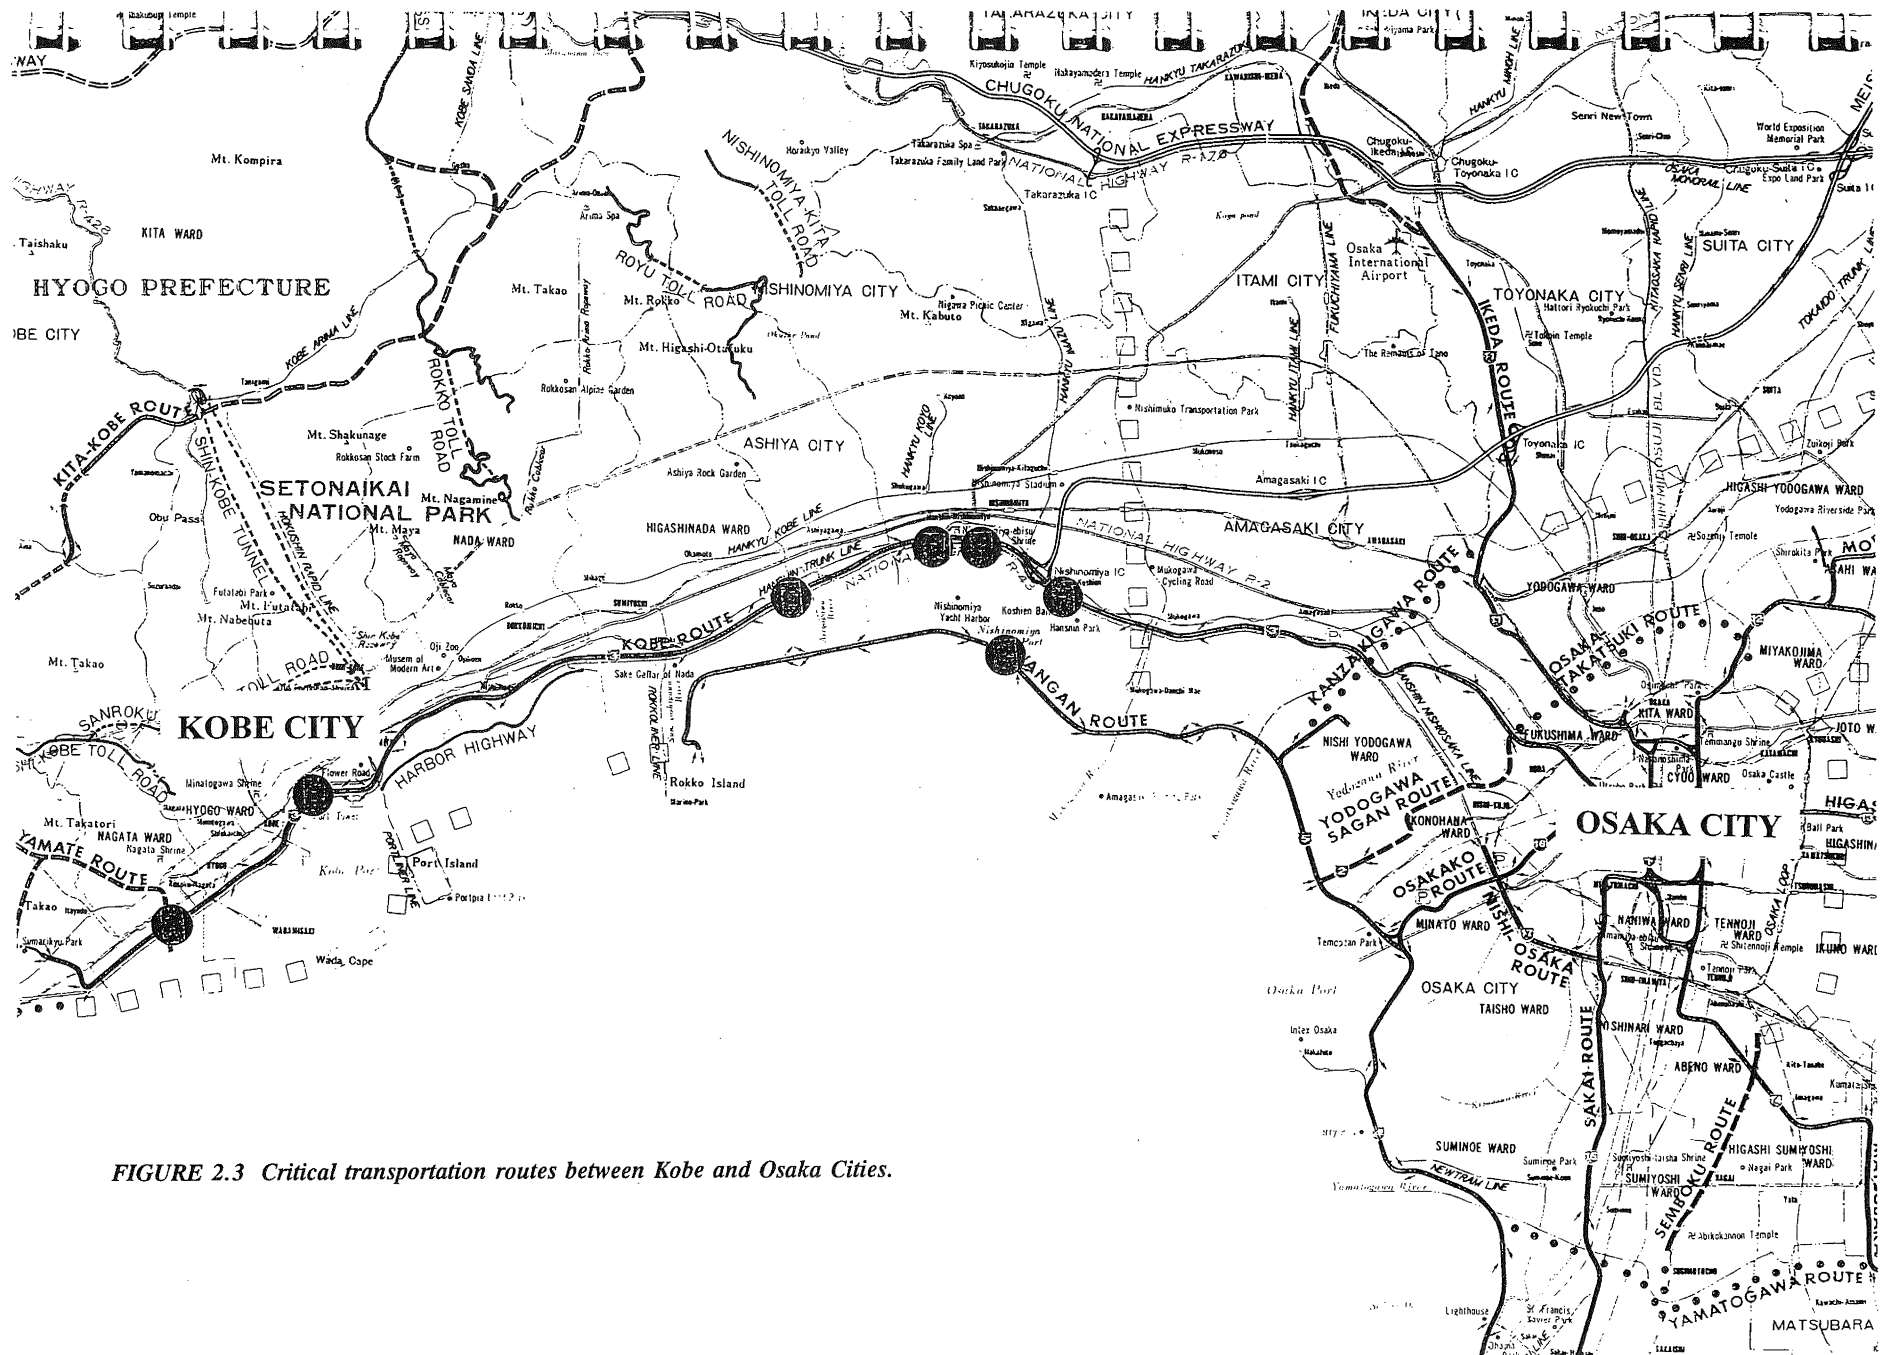
FIGURE 2.3 Critical transportation routes between Kobe and Osaka Cities.

The layout of Kobe and Osaka Cities is shown in Figure 2.3 with the critical east-west transportation corridor being readily apparent. The locations of critical expressway failures are indicated in this figure.

The loss of elevated sections of the Hanshin Expressways and the railway structures that were constructed prior to the early 1970's severely restricted transportation capability. The cost to repair the Hanshin Expressway and to upgrade to current earthquake standards is estimated at NZ\$7.6 billion.

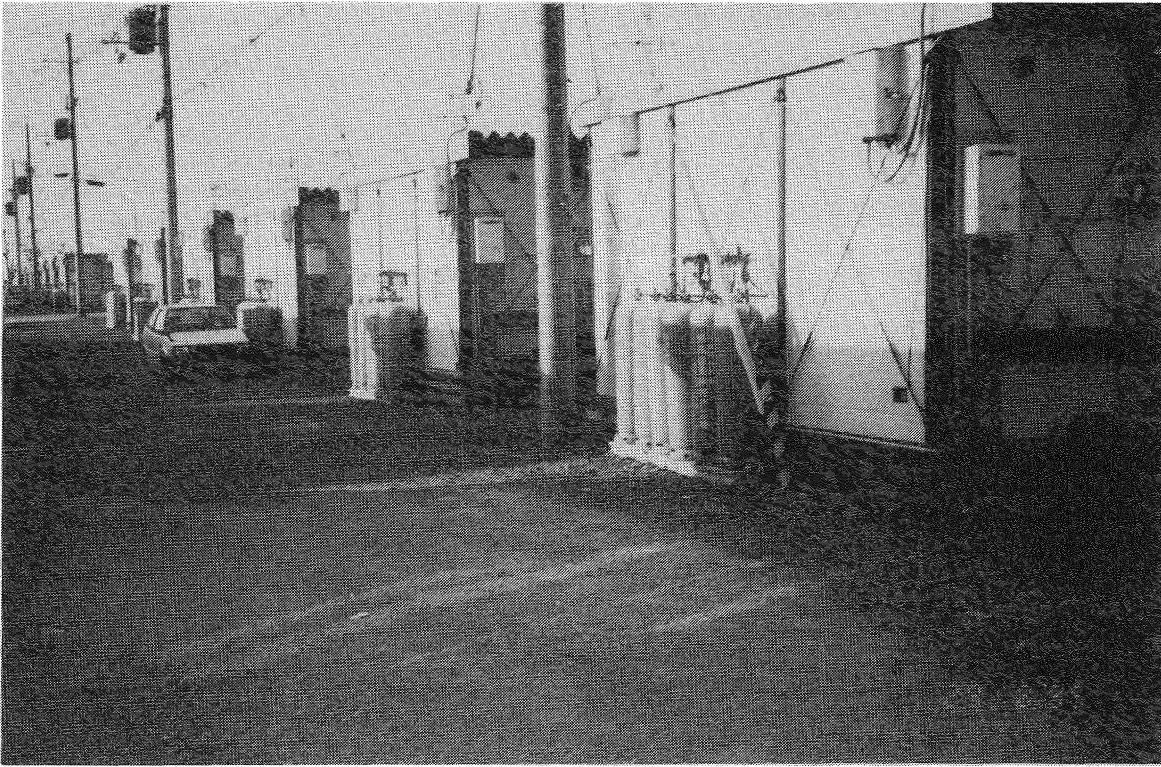
*FIGURE 12.1 Arrangement of Temporary Housing Units, Port Island*

A brief visit was made to two temporary housing camps on Port Island. One camp had 460 units, the other 800, each unit of approximate size 5.5m x 3.0m. They were of insulated panel construction, apparently of good standard, although it was not possible to view inside. Washing machines and air conditioning units were on the outside (refer Figures 12.1 and 12.2).
