DAMAGE AND INTENSITIES IN THE MAGNITUDE 7.8 1929 MURCHISON, NEW ZEALAND, EARTHQUAKE

David J. Dowrick¹

SUMMARY

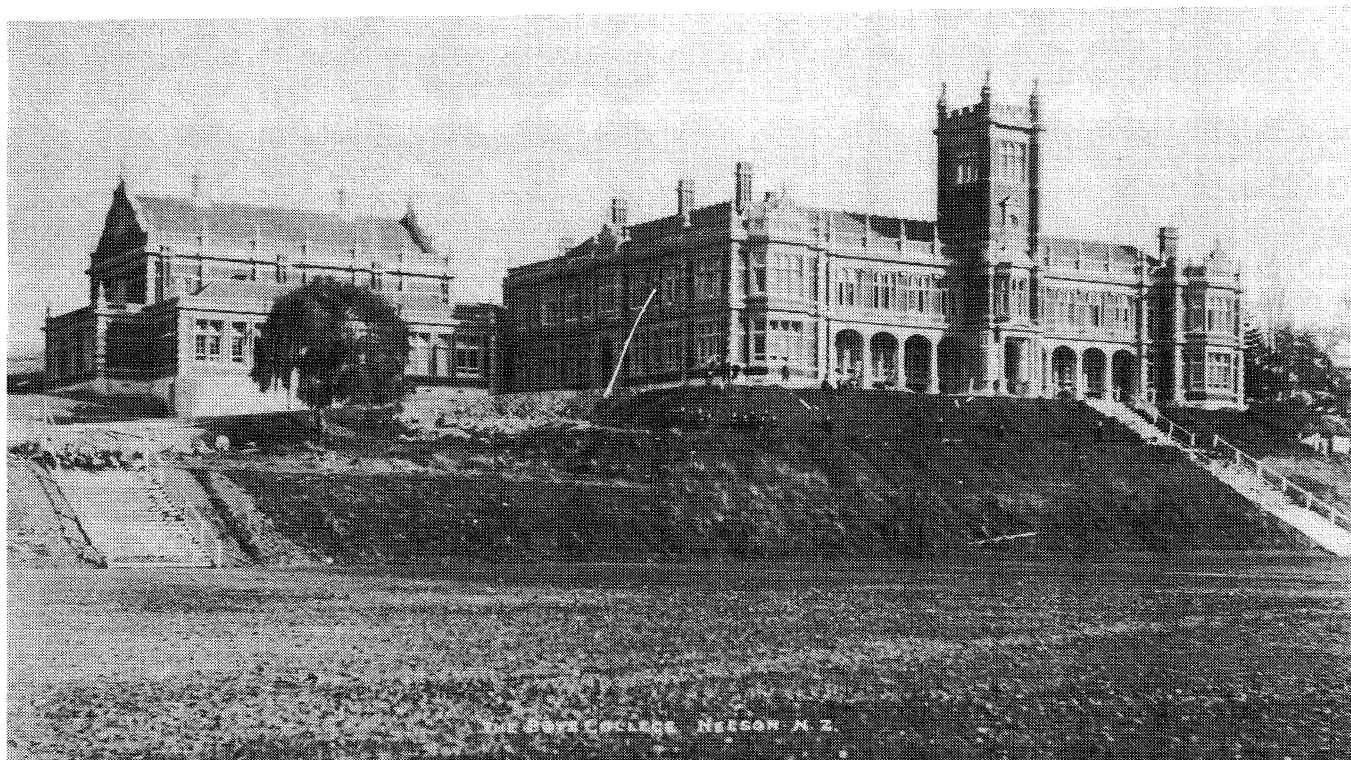
Two of these towers fell. At the Westport Post Office the complete tower fell, while at Nelson College Main Block the soft storey top portion of the tower fell (Figures 4 and 5). Also in all four cases the structure below the tower was damaged much more than it would have been if no tower had been present. This raises the question as to what masonry grade such buildings should be classified as, for intensity assignment purposes? These four buildings all conformed fully to the definition of Masonry C, i.e. Buildings Type II* (Appendix 2), as regards materials quality, workmanship and detailing. But the towers made them much more vulnerable to ground shaking than comparable buildings without substantial towers. The two buildings whose towers fell were the most seriously damaged buildings in their respective towns, despite being as well built as any of the other brick buildings. Thus for intensity assignment purposes, such buildings should be regarded effectively as Masonry D, i.e. Buildings Type I.

FIGURE 4 Nelson College Main Block before the earthquake. (Reproduced by courtesy of the Alexander Turnbull Library, Wellington, New Zealand).

FIGURE 5 Nelson College Main Block showing damage to tower and unbraced parapets. (Reproduced by courtesy of the Alexander Turnbull Library, Wellington, New Zealand).
