## THE 2016 MEINONG TAIWAN EARTHQUAKE: LEARNING FROM EARTHQUAKES REPORT

**Richard S. Henry<sup>1</sup>, Bo-Yao Lee<sup>2</sup>, David McGuigan<sup>3</sup>,  
John Finnegan<sup>4</sup> and Gordon Ashby<sup>5</sup>**

### ABSTRACT

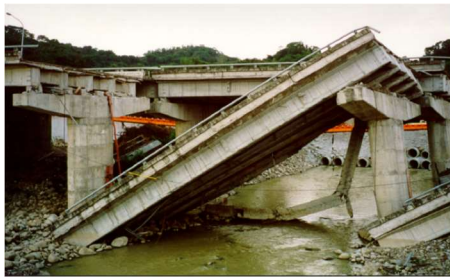
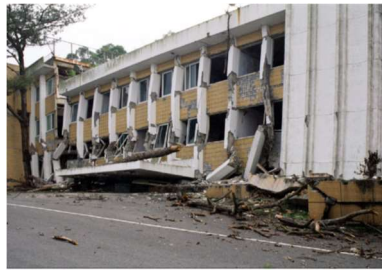
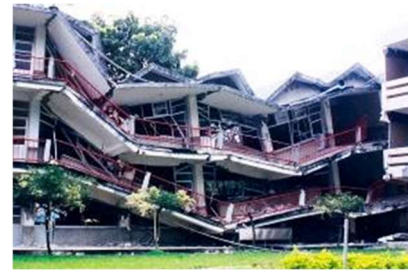
Figure 2: Damage during the 1999 Chi-Chi earthquake.

a) Bridge damage [7]

b) Building soft-storey collapse [8]

c) School building damage [9]

Chi-Chi and other earthquakes also highlighted a number of poor detailing practices in concrete structures, such as inadequate transverse reinforcement in columns, deficient lap splices, absence of beam-column joint reinforcement, 90-degree bends for anchorage or stirrups and ties [8]. Many of these deficiencies had been non-compliant with the concrete design standards for some time, but had continued to be adopted in practice. Despite the presence of these modern design standards, poor quality construction and the lack of adequate construction supervision by engineers were highlighted as key issues.

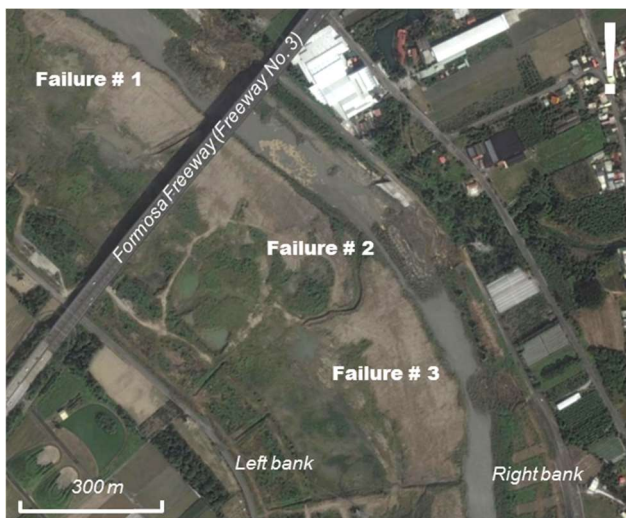
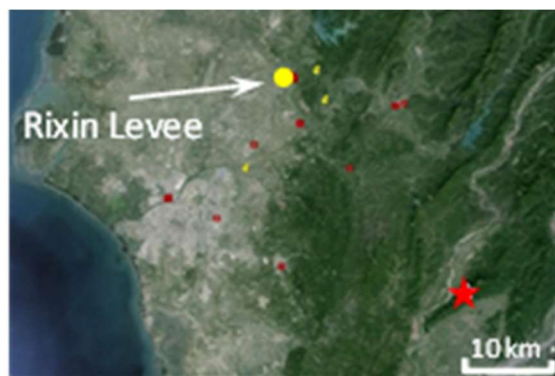
Figure 13: Tseng-Wen River levee failures.

a) Overall view (Source: Google Earth)

b) Location (red star indicates earthquake epicentre)

The slope instability of the Rixin Levee is considered to result from a particular saturated cohesionless fill layer at or below the base of the levee that liquefied during the earthquake, resulting in slope failure and lateral soil displacement (runout) of between approximately 30 m and 135 m. The fill is presumed to directly overlie a naturally occurring low permeability silty clay soil, which was identified in soil investigations associated with a pipeline bridge located approximately 500 m downstream from the adjacent Freeway bridge. Discussions with a local engineer indicated that there was most likely no subsurface investigation information associated with the levee (or its repair) away from any bridge structures. It is also understood that piles have been placed beneath the levee immediately adjacent to the upstream side of the right bridge abutment and opposite the factory structure visible in Figure 13. No instability was observed within this part of the levee. Some

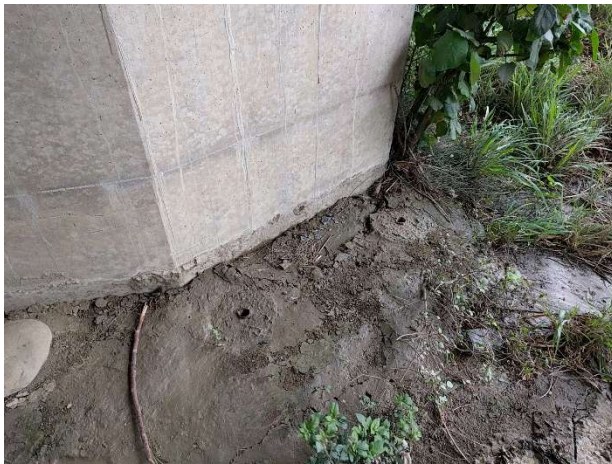
**Figure 14: Ground surface settlement and crack adjacent to Freeway bridge pier on the right abutment.**

ground surface settlement of the order of 100 mm and surface cracking was observed adjacent to the bridge pier on the right abutment of the Freeway bridge at an elevation coincident with the top of the river levee, as shown in Figure 14.

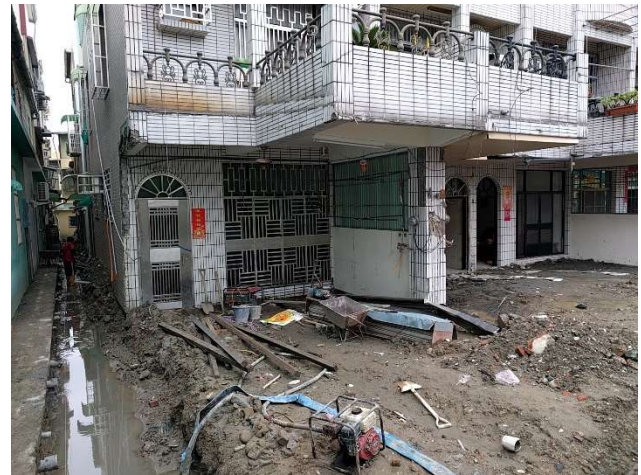
Figure 15: Liquefaction-related damage to residential building in the Xinshi District.

The photos within Figure 15 illustrate several points, including the relatively uniform settlement of the main residential building. In this case there is little tilting of the overall structure indicating that the foundation essentially punched into the underlying soil vertically. The settlement of the foundation ground beams, which are carrying the building loads, has resulted in the hogging of the ground floor slab. At the time of the NZSEE visit there was very little liquefaction ejecta evident

b) Site following demolition of damaged ancillary buildings

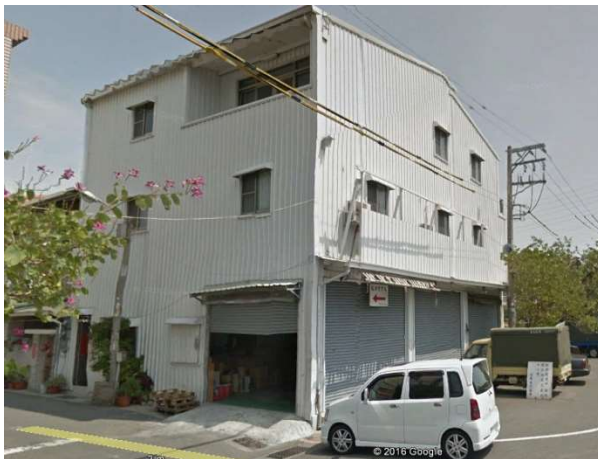
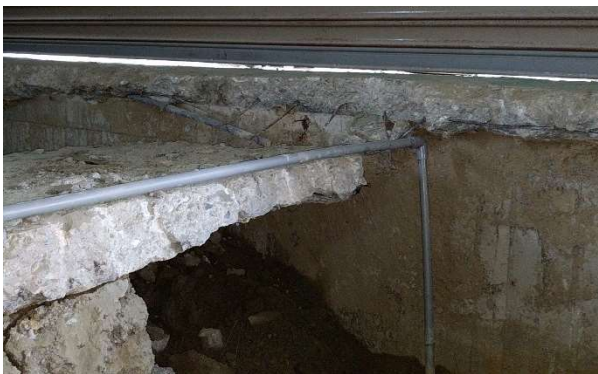
*Figure 18: Building undergoing foundation repair.*

*a) Overall building (Source: Google Earth)*

*b) Pipework for dewatering*

At the time of the NZSEE team visit a building in this area was undergoing repair involving jacking and re-levelling of the foundations. The photos in Figure 18 show the building and the nature of the foundation ground beams that had been exposed to enable positioning of the jacks. The perimeter foundation beams (Figure 18c) are approximately 0.8 m deep and 0.4 m wide. Dewatering was also carried out to facilitate the repairs and the plastic pipework is evident (Figure 18b). The unreinforced slab-on-grade floor is clearly shown along with nominal tie bars between the slab and the ground beams. At the time of the team visit the re-levelling had just been completed. Discussion with the owner indicated that the building had settled approximately 150 mm, although this was an estimate as no measurements were believed to have been taken of building settlement or tilt.

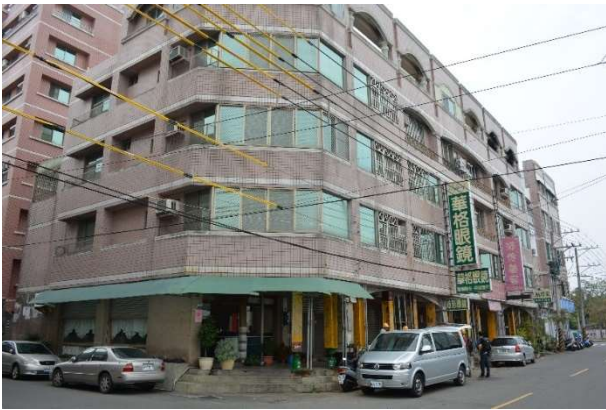
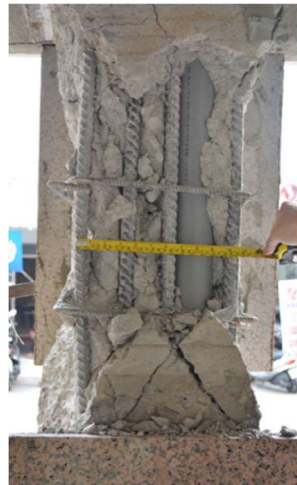
Figure 25: Poor column detailing.

configuration resulting in large demands on these columns, poor seismic detailing was observed in the columns, as shown in Figure 25. Identified detailing deficiencies included:

- Lap splices of all of the longitudinal reinforcement at the base of the column resulting in a weak section above (similar to short column effect).
- Widely spaced transverse reinforcement.
- 90-degree anchors in stirrups opened up at the corners.
- Fractured stirrups (possibly due to bending quenched and tempered steel).
- Large concrete cover depth (~100 mm).
- Electrical boxes embedded in the front of columns.
- Rainwater downpipes located within the column core.

a) Overall building

d) Downpipe, large cover, stirrup spacing

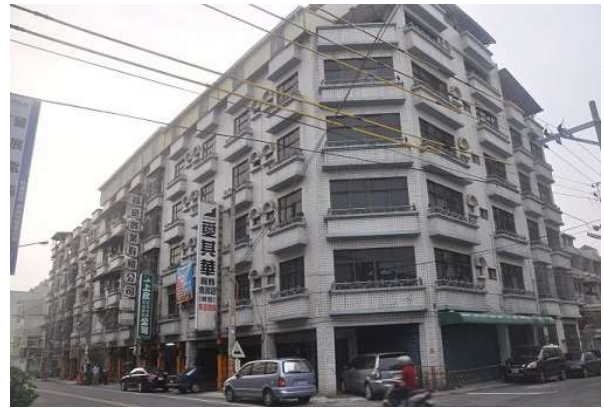
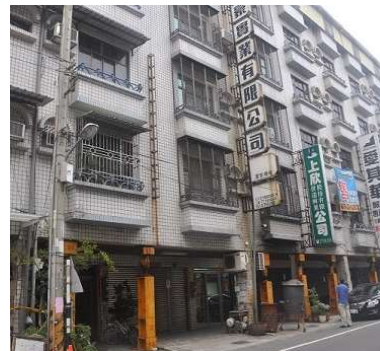
Another example of similar column damage was observed in the building shown in Figure 26. The building was built in 1989, originally a five and a half storey building, but over the years another storey had been added on top. As with the previous building, the columns on the street front of the building were all damaged with axial/shear type failures. The building had a red placard, but still had families living in the block. As shown in Figure 26c, a number of the deficiencies listed above were again identified and in this case the column appeared to be missing some of the stirrups. Additionally, the additional seismic mass of the added storey and the poor seismic resistance on the ground floor would have contributed to the observed column damage.

a) Overall building

b) Propped columns

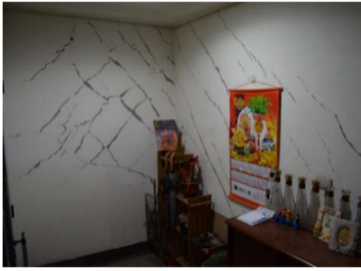
Some examples of observed infill panel damage are shown in Figure 27. Diagonal cracking of concrete infill panels is shown in Figure 27a and b, whereas Figure 27c and d show damage to columns and beams caused by the restraint provided by the infill panels. Damage to the primary structure from the infill systems is obviously much more of a concern and can require significant intervention to repair the damage. Column damage due to half height partition walls (short column effect) was also observed in many school buildings and district office buildings, as discussed in later sections.

a) Cracking in internal reinforced concrete infill wall

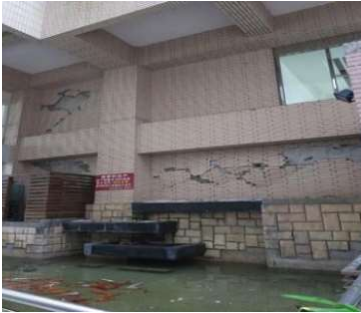
b) Infill wall damage (Source: Prof. Y-H Tu)

Figure 27: Infill wall damage.

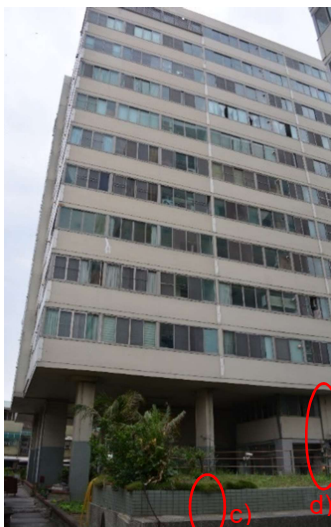
The core wall was relatively undamaged during the earthquake with only minor cracks observed. Minor diagonal cracking and cracking at the ends of the coupling beams was also observed up the height of the building, as shown in Figure 28e. However, the columns on the perimeter of the building did not perform well, and two columns were severely damaged, one in the basement (Figure 28c) and one at the ground floor (Figure 28d). In both cases the columns attracted high axial loads with large beam spans and had widely spaced transverse reinforcement at 400 mm spacing. Additionally, despite the drawings showing 135-degree hooks on all stirrups and ties, the damaged columns clearly showed that 90-degree hooks had been used during construction and these had opened up. Damage to the column in the basement was concentrated above a splice in the longitudinal reinforcement and the severe buckling of the reinforcement indicated that a significant tension demand must have been induced prior to the column failing in compression. The column at the ground floor indicates that no transverse reinforcement was placed in the beam-column joint region and that the longitudinal bars had buckled outwards as a result.

b) Rear view of damage tower

The building had been given a yellow placard and was in the process of being repaired when team members visited. The proposed repair consisted of installation of steel columns either side of the damaged column in the basement. The repair strategy had been proposed by an engineer and requires approval from the local district council.

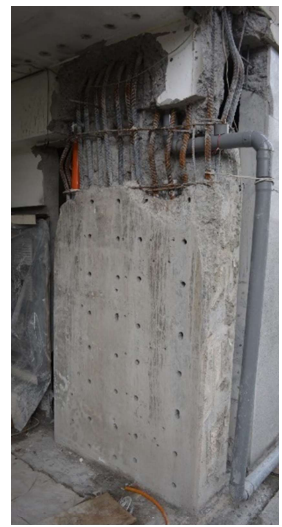
d) Ground level column

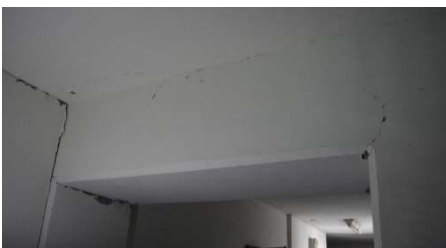
e) Coupling beams

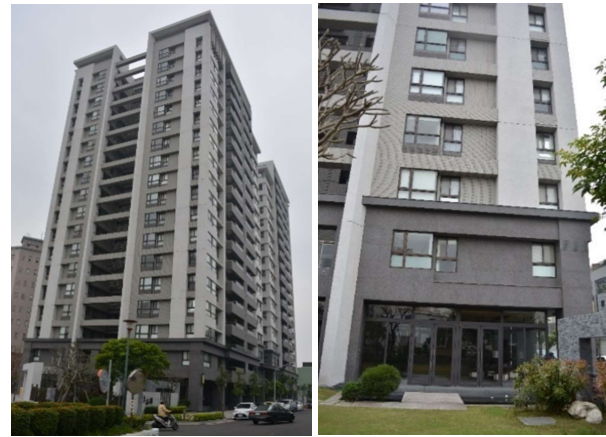
In recent years, an increasing number of taller apartment buildings have started to be constructed in Tainan, with large concentrations in the East District. Two such examples are shown in Figure 29, consisting of an 18 storey building constructed in 2012 and a block of 13 storey buildings of similar age. These buildings represent more modern building configurations with a greater awareness to potential soft-storeys effects. The buildings rely on a regular arrangement of reinforced concrete frames in combination with several reinforced concrete walls that extend up the full height of the building. Heavy infill partition walls and cladding elements are still used in the upper levels with an open plan foyer area on the ground floor. This configuration appears to have worked well with no visible damage to either of the buildings shown in Figure 29. High PGAs and damaged building were observed in the East District where these buildings were located, and so this provides some evidence that modern (post-Chi-Chi earthquake) building designs have improved.

*a) 18 storey building circa 2012*

**Figure 29: Undamaged modern apartment buildings.**

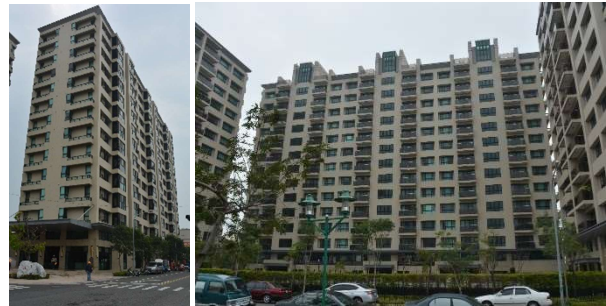
*b) 13 storey block*

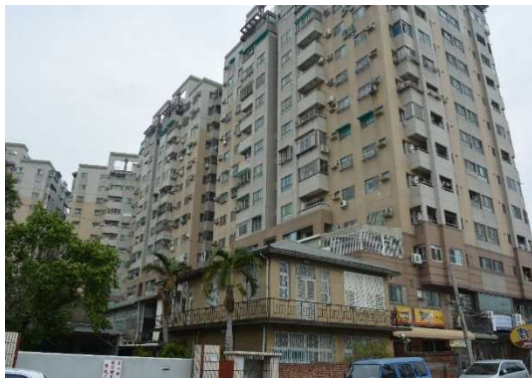
Nearby to the building described above was a block of 14 storey apartments built in 1998 and shown in Figure 30. The four towers were constructed above a single basement carpark with the weight of the upper storeys being transferred to columns with large spans up to 12 m. There was visible distress to the columns and infill walls at ground level, such as that shown at the corner column in Figure 30b. In the basement there was diagonal cracking in most of the reinforced concrete walls (Figure 30e), but most of the columns were not significantly damaged with the exception of one. The column under one of the corners of the building above was severely damaged with axial-shear failure along a 45-degree plane, as shown in Figure 30c. Despite closely spaced stirrups and ties (~120 mm centres), the 90-degree hooks in the stirrups and ties had opened up and a number of stirrups had fractured as well (Figure 30d).

*a) Block of four buildings*

**Figure 30: Severely damaged 14 storey apartment complex.**

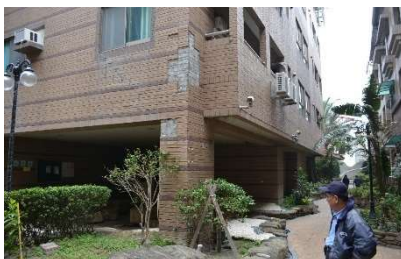
*b) Corner at corner of ground level*

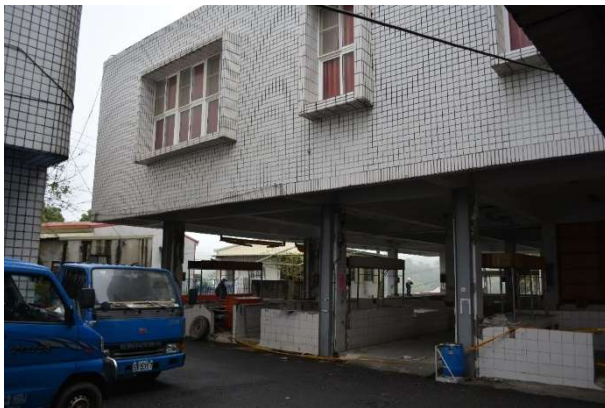
The old market in Nanhua (north of the epicentre) shown in Figure 31 is an example of a common local market with open plan ground floor with a heavy box like structure above. This market was damaged during the 2010 Kaohsiung Jiasian earthquake and subsequently strengthened with the installation of steel columns on either side of damage columns (Figure 31c). The market was subsequently closed in 2014. The ends of the columns sustained fresh damage during the Meinong earthquake, but the building did not collapse.

a) Overall building

Figure 31: Column damage at Nanhua old market

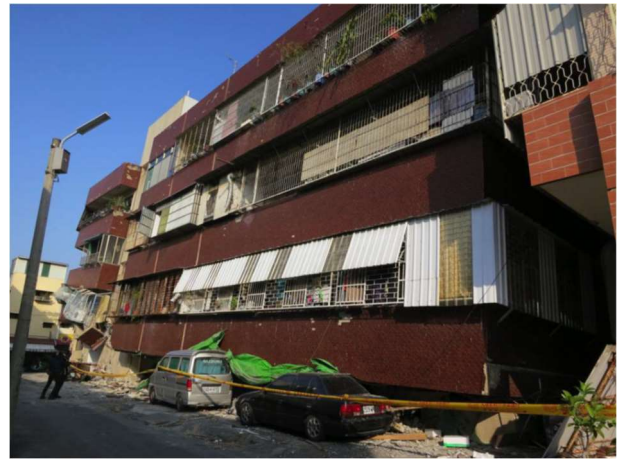
Two other markets in Tachi and Shanshang did collapse during the earthquakes and these are shown in Figure 32. Fortunately, the timing of the earthquake in the early hours of the morning meant that the market was empty and so no one was killed in these buildings. Residents in the upper stories that remained intact when the ground level collapsed were able to escape with minor injuries.

a) Tachi market

Figure 32: Collapsed markets (Source: Prof. Y-H Tu).

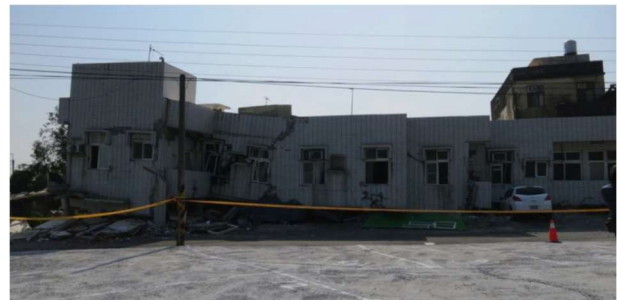
b) Shanshang market

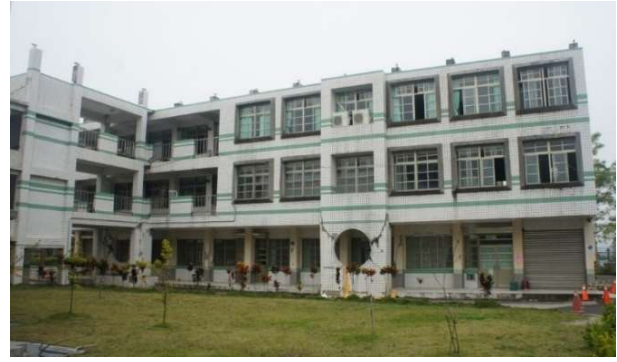
The Yujing Junior High School classroom block shown in Figure 34 is a three storey reinforced concrete building that was built in 1998 and had not been seismically retrofitted. The lateral load resistance in the long direction of the building is provided by reinforced concrete frames, but the impact of the reinforced concrete infill walls has not been fully considered. The front support columns are short columns, or “captive columns” as described in Taiwan. A downstand spandrel and an upstand concrete sill have restrained the column deformation resulting in a short column effect and shear failure, as shown in Figure 34b. The cantilevered front face of the building has also induced demands that damaged a feature wall with a circular hole. Non-structural damage consisted of a large area of ceiling tiles falling.

*a) Classroom block*

**Figure 34: Yujing Junior High Classroom (NCREE [21]).**

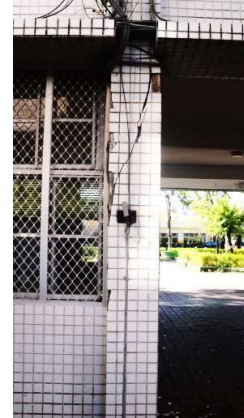
Guiren Junior High School presents an excellent case study on the impacts of the Meinong earthquake on a set of school buildings. The school has been part of the nationwide seismic retrofit programme and most of the retrofit work planned had been completed, but there were two buildings that had not been retrofitted at the time of the earthquake. As shown in Figure 37, these two existing buildings (of nine in total) suffered the typical damage seen in other buildings, including damage from short columns, pounding, and damage due to stiffness irregularity, particularly vertical stiffness issues.

*a) Damaged column*

**Figure 37: Guiren Junior High.**

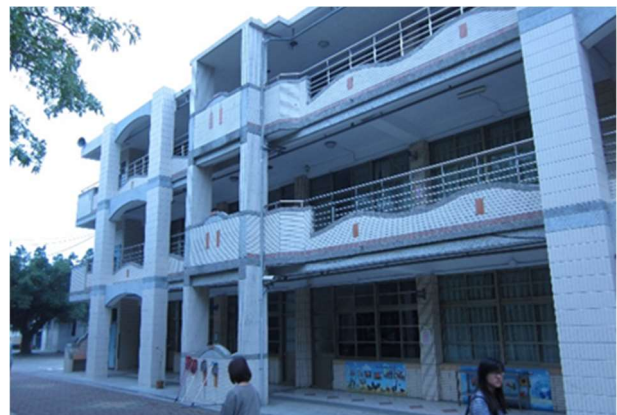
Figure 38 shows a photo of a school building that was strengthening prior to the Meinong earthquake. The strengthening work included the addition of a new moment frame adjacent to the original structure. This building did not suffer any visible earthquake damage.

**Figure 38: School building strengthened by the addition of a supplementary moment frame.**

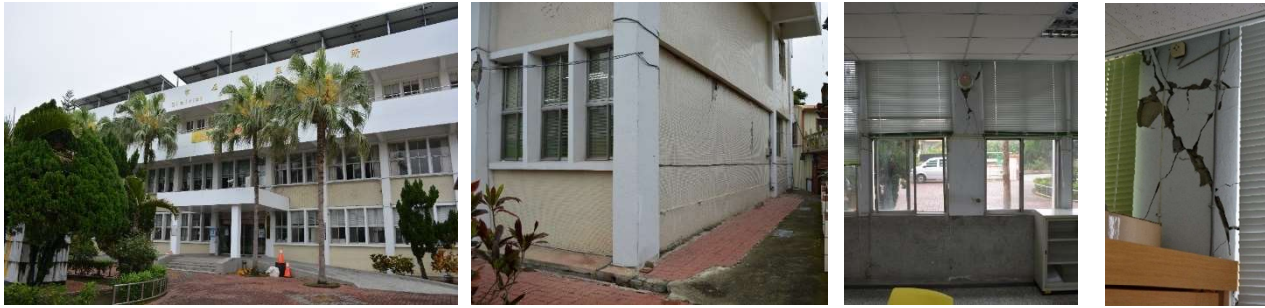
The observed damage to three district office buildings that had not been strengthened is shown in Figure 45. These offices were in Zuozen, Nanhua, and Shanshang districts, where significant PGAs were recorded. In all three of these buildings, damage occurred to the ground level columns at the front of the building with wide inclined cracks, spalling and crushing of concrete. The infill walls stiffen the frame at the back of the building, and

so the front frame is expected to experience larger deformations due to torsion. On top of this, the half-height infill below the window openings results in a short column effect (or captive column as referred to in Taiwan). The column restraint resulted in increased shear demands and with non-ductile detailing these columns were susceptible to shear failure. As with other buildings described earlier, the location of rainwater downpipes within the column core further reduced the capacity of the already slender columns. The columns in the Nanhua building were the most severely damaged, and did not appear to have much residual axial capacity, with the building appearing to be not far from collapse. Interestingly, the columns in the Nanhua building were smaller than the other buildings, being

360×500 mm compared to 400×600 mm. Damage to the infill walls in the Nanhua and Zuozhen buildings was relatively minor, with the building having sufficient lateral load resistance in the short direction. More significant infill wall damage was observed in the Shanshang building, with large diagonal cracking in the infill walls near the stairs, while the infill walls at the ends of the building performed adequately. The Shanshang and Nanhua offices were still in use one month after the earthquake and were in the process of being vacated. It is not known if these will be demolished or repaired. The Zuozhen office on the other hand had continued to be used since the earthquake.

a) Zuozhen district

Figure 45: Examples of original district office buildings.

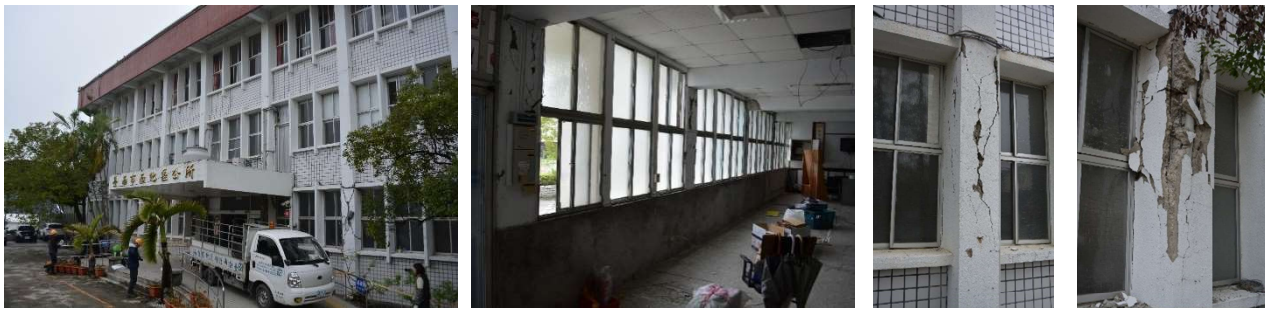
b) Nanhua district

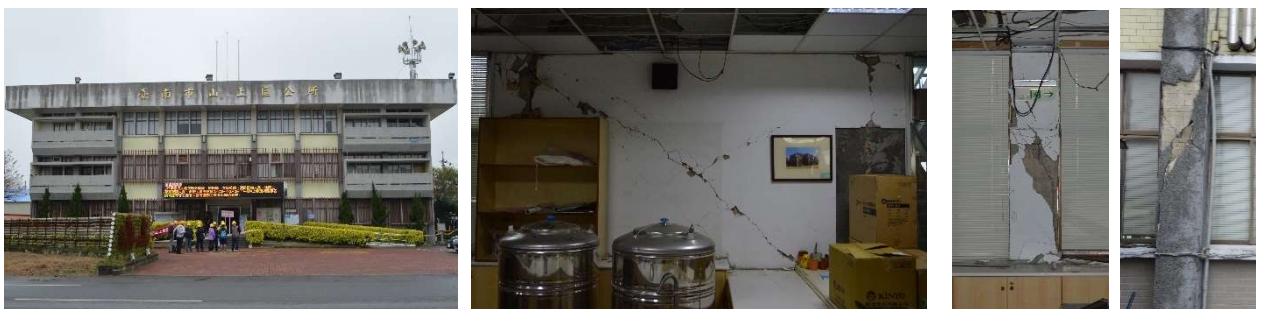
c) Shanshang district (Source: Purdue University)

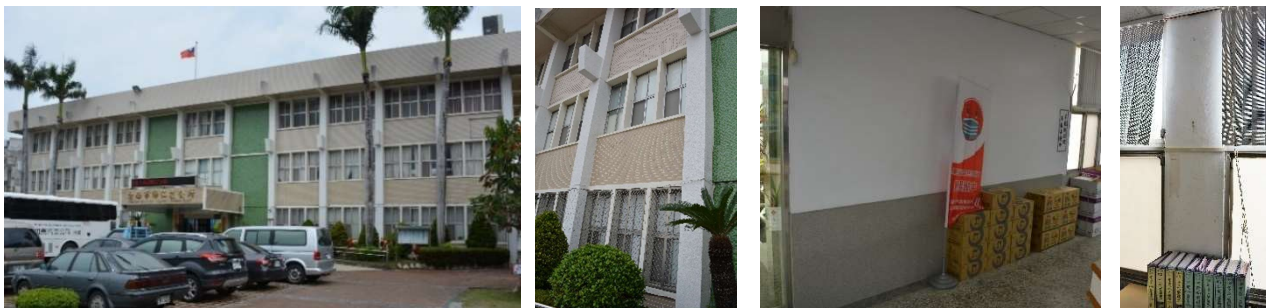
The Guiren district office (Figure 46a) was 3 storeys and of typical floor plan. The building was retrofitted in 2011 with the addition of 4 reinforced concrete walls. These walls were installed full height at the front and rear of the building to

un-strengthened district office buildings, and only minor cracking was observed at the interface between the retrofitted concrete walls and the adjoining columns.

a) Guiren district

Figure 46: Examples of retrofitted district office buildings.

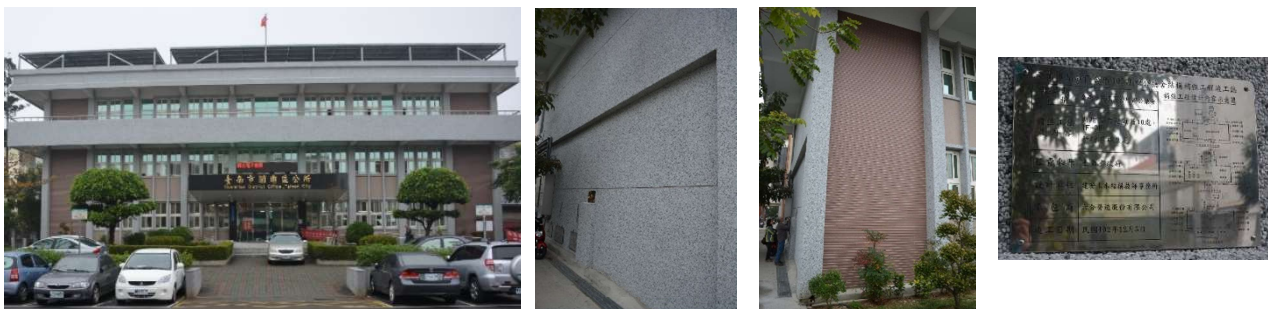
The 3-storey district office in Guanmiao (Figure 46b) was particularly grand looking with large wrap around balconies. The building had been retrofitted in 2013 with the installation of 10 reinforced concrete walls. The masonry infill in the walls at the ends of the building had been replaced with reinforced concrete walls in each of the 3 frame bays. In the long direction of the building, a total of 4 reinforced concrete walls were added, located in the last bay of the frames in the corners of the building. As with Guiren, the walls had been made an attractive feature of the building and a gold plaque on the side of the building clearly outlined the retrofit measured. Although only inspected from the outside, the Guanmiao building appeared almost undamaged, with the retrofitted reinforced concrete walls performing well. Guanmiao was close to the earthquake epicentre and experienced some of the largest intensity ground motions. The excellent performance of the building compared to the damage observed in un-strengthened district office buildings is a good example of successful seismic intervention.

b) Guanmiao district

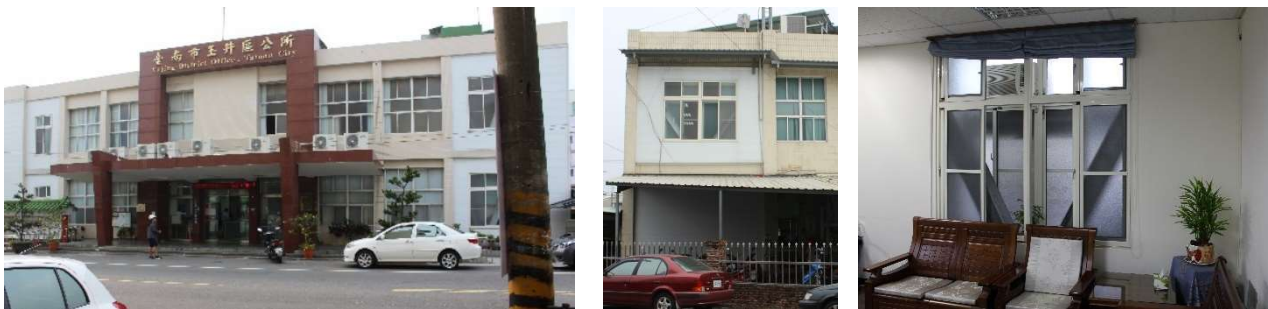
The Yujing district office (Figure 46c) was slightly unusual, with only two storeys and an unconventional floor plan. The building had been retrofitted with a combination of reinforced concrete walls and steel braces. The steel braces are visible in the end bays at the front of the building, and in the upper levels on the side and rear, with concrete walls below. Yujing is located between Shanshang, Zuozen, and Nanhua where the district offices were all severely damaged during the earthquake (Figure 45). The Yujing building suffered only minor damage during the earthquake, with cracking in the infill partition walls. However, the structural system performed well and as with the other retrofits damage to the non-ductile columns was prevented.

c) Yujing district (Source: Purdue University)

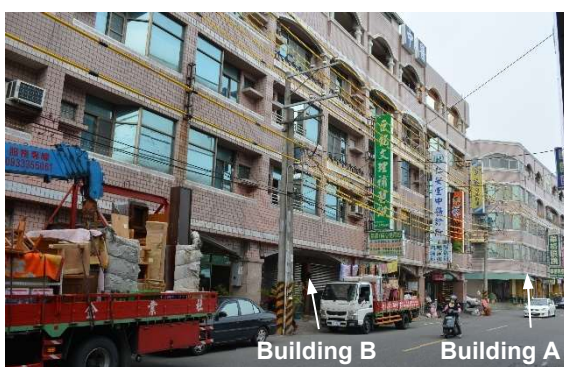
A number of buildings in Tainan had been damaged and repaired following previous earthquakes, particularly the 2010 Kaohsiung Jiasian earthquake. Pre-existing damage is obviously difficult to ascertain when conducting visual inspections, but anecdotal evidence provided some insights. One particular example was a group of apartment buildings in Guiren, where two of the buildings were a mirror image and positioned side-by-side. As shown in Figure 47, the two buildings are five storeys high and were constructed in 1992. The damage to Building A was described previously and shown in Figure 24 and Figure 25. The columns experienced severe axial-shear failures and were shown to have a number of poor detailing practices (Figure 47b). The columns in Building B were apparently damaged during the 2010 Kaohsiung Jiasian earthquake, with column damage similar to that observed for Building A during the Meinong earthquake. The columns in Building B were subsequently repaired and retrofitted using a concrete jacketing technique with additional reinforcement and concrete installed to encase the damaged columns. The retrofitted columns in Building B are shown in Figure 47b, and are noticeably larger than the respective Building A columns. The retrofit appeared to have worked, with minimal column damage observed following the Meinong earthquake. Instead the increased stiffness of the retrofitted column had shifted the earthquake deformations and damage into other parts of the building, notably the arched concrete beams that frame into the column. Interestingly the columns in Building A had not been damaged during the 2010 Kaohsiung Jiasian earthquake and so had not been strengthened at the time. This decision appeared to lack foresight, with the building not surprisingly following a similar fate during the latest earthquake.

a) Two identical buildings

Figure 47: Repaired and retrofitted building.

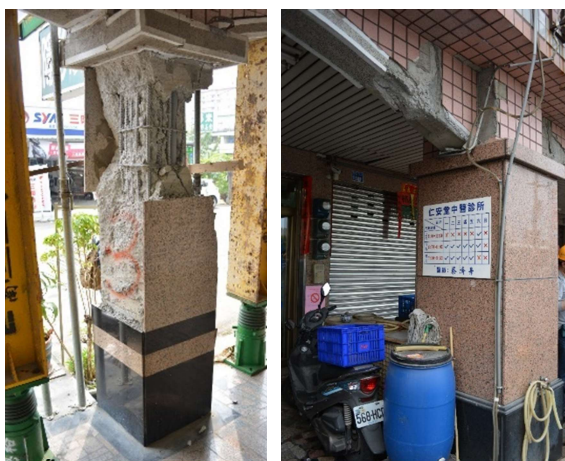
b) Original column (A)      c) Retrofitted column (B)
