## EARTHQUAKE OF 7 DECEMBER 1988, SPITAK, ARMENIA REPORT OF THE NZNSEE TEAM VISIT OF 1989

P.R. Wood<sup>1</sup>, J.B. Berrill<sup>2</sup>, N.R. Gillon<sup>3</sup>, P.J. North<sup>4</sup>

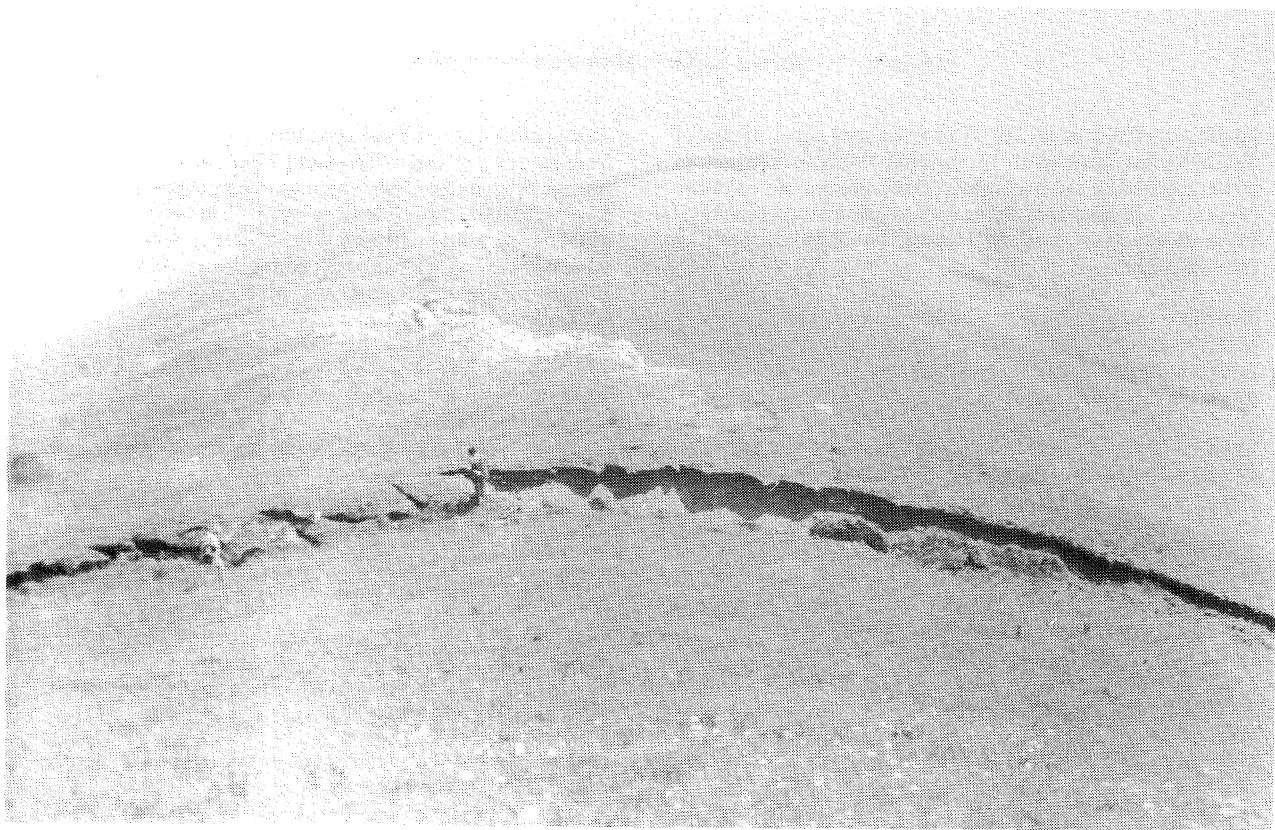
[1989] and Philip *et al.* [1992] to document some 40 km of discontinuous fault trace of variable width, comprised of three apparently separate parts which are nearly collinear (Figure 9). Photographs of the surface expression of the fault ruptures are presented in Figures 10-13 by courtesy of Dr A. Karakhanian.

The displacement slip vector observed at the ground surface reaches a maximum of 2 metres vertical with up to 1.8 metres right lateral slip recorded by Trifonov *et al.*, along with fault plane dips of 37-85°.

*Figure 11* Surface rupture. [A. Karakhanian]

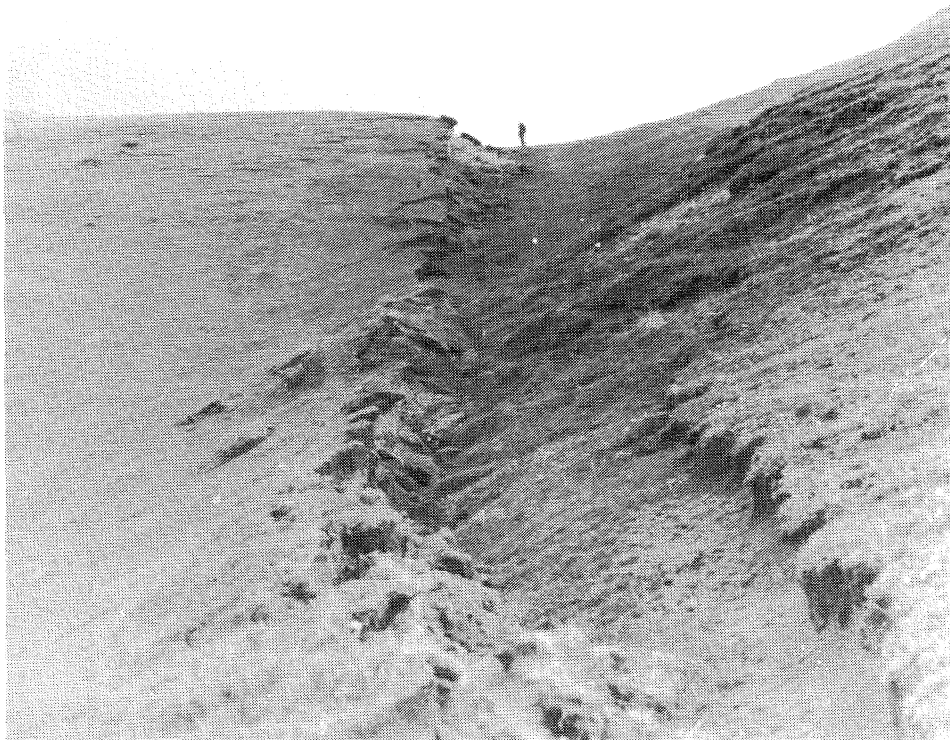
*Figure 12* Surface rupture. [A. Karakhanian]

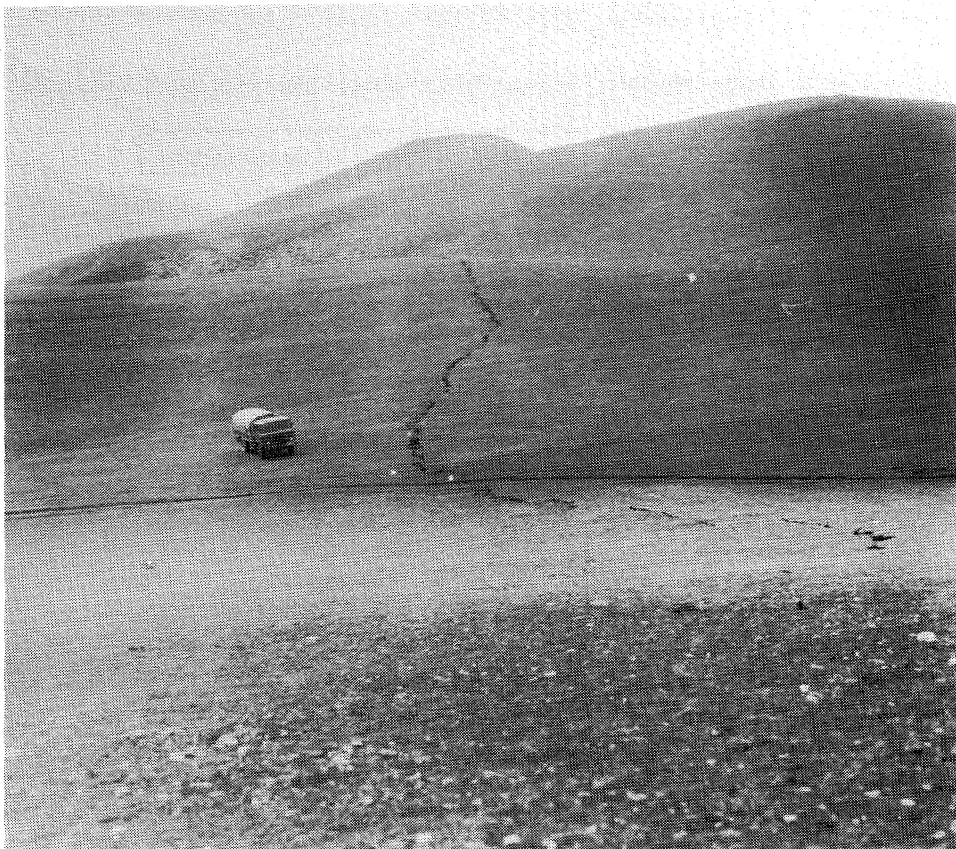
*Figure 13* Surface rupture, near its NW end. [A. Karakhanian]

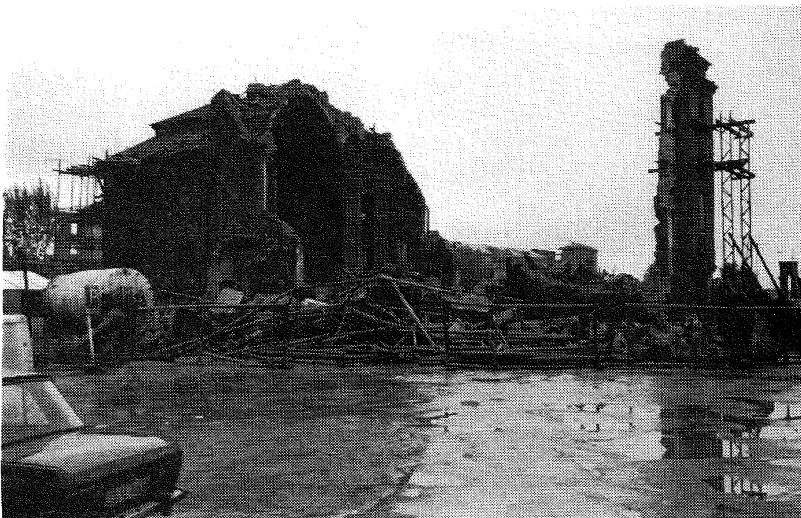
There were two high rise lift slab buildings in Leninakan and they both failed in the earthquake. One of 6 storeys stayed up but lost 30 cm in height because of crushing of the core at the first floor level. The second building, of 10 storeys collapsed completely. Many similar buildings could be seen under construction in Yerevan (Figure 38).

*Figure 38* Lift slab building under construction on the northern outskirts of Yesevan. Similar structures collapsed in Leninakan.

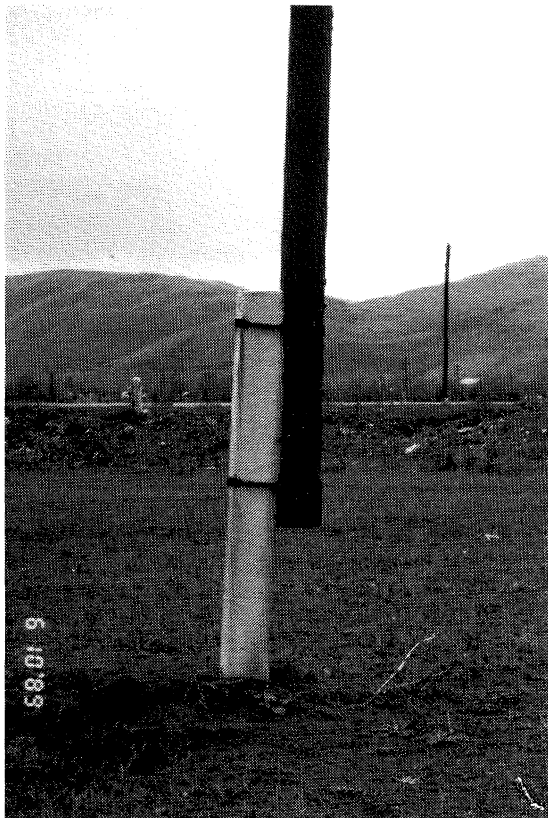
reinforced concrete, timber or rail iron ground posts (Figures 44, 45 and 46) and an A-frame pole with timber or reinforced concrete ground posts (Figure 47). Both types have wooden poles secured to the ground posts with wire ties. In Spitak a pole was observed to have failed, but it could not be identified as being a direct result of the earthquake shaking (Figures 48 and 49). High voltage transmission lines are supported on steel lattice type pylons anchored in concrete; these appear to have performed well. A number of power lines were supported on towers fixed to building roofs. Obviously these survived only when the building structures remained standing.

Figure 44 Power pole fixed to precast reinforced concrete ground post.

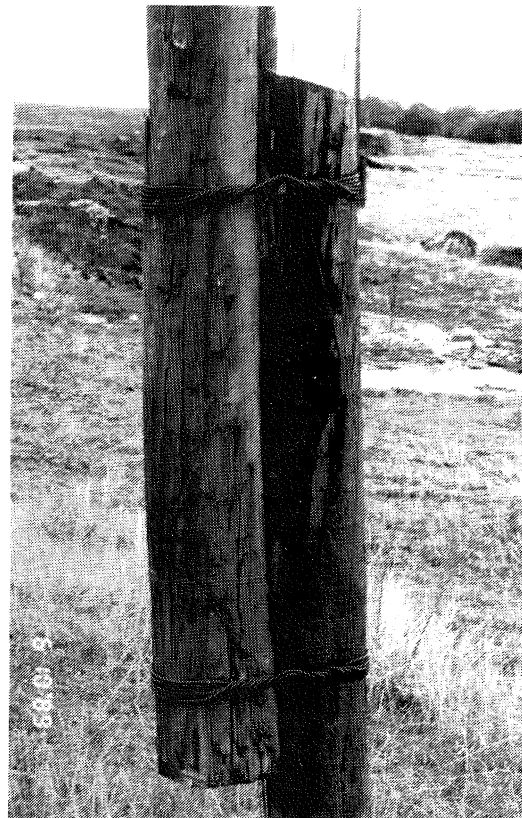
Figure 45 Power pole fixed to timber ground post.

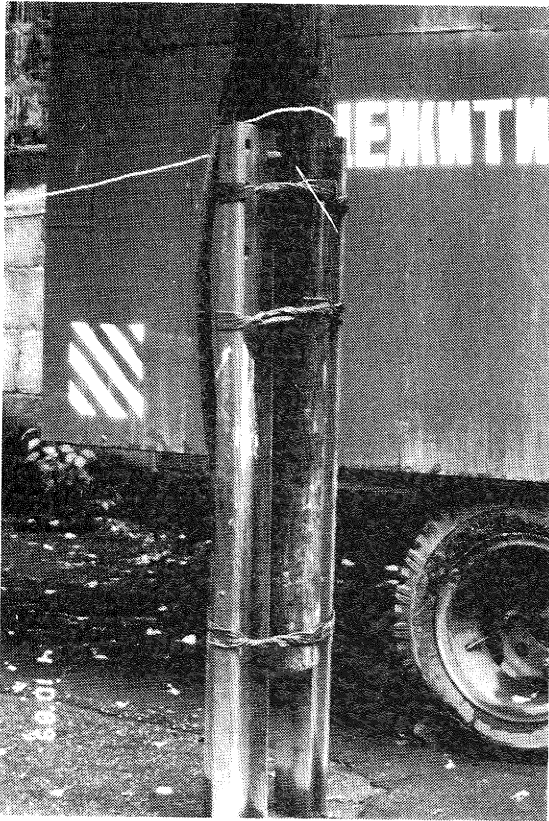
Figure 46 Power pole fixed to steel rail irons cast into pavement.

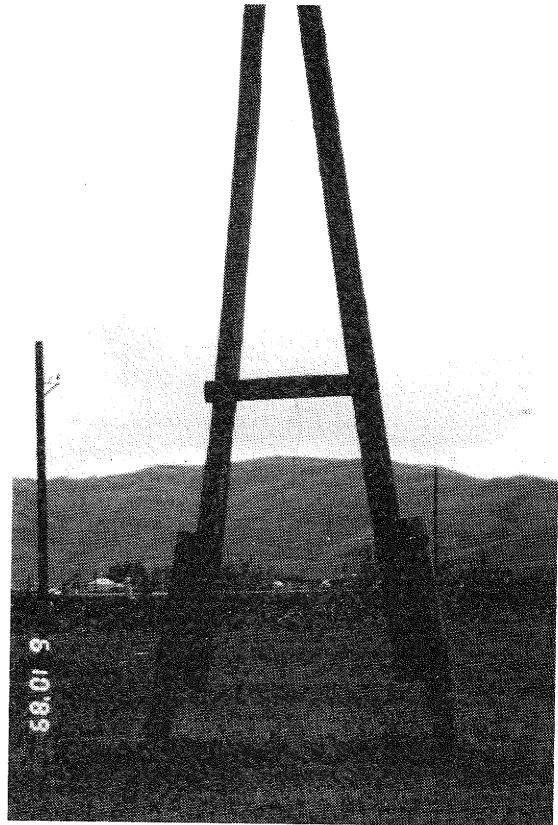
Figure 47 A-frame power pole (not used for local distribution).

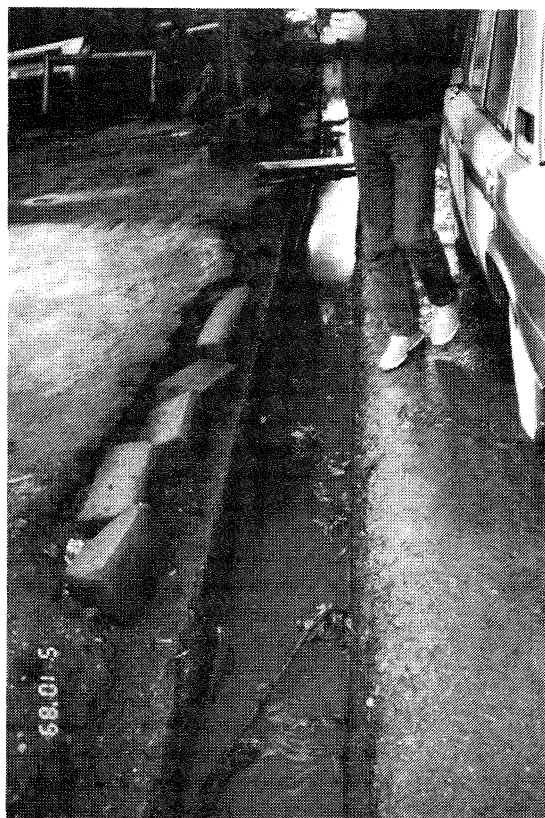
We were told that stormwater drains performed well. A feature of road drainage is that there is no roadside gutter. The road seal butts against the kerb blocks and large (approximately 600 mm square) stormwater grates are situated adjacent to the blocks. To assist in drainage of stormwater an open channel had been dug against the kerb blocks in at least one street of Spitak (Figure 50). Another feature of Soviet design is that building downpipes are generally not directly connected to the stormwater pipework. Large downpipes (100 mm diameter and greater) spill water onto the footpath adjacent to the building.

Figure 50 Stormwater channel dug up adjacent to curb blocks in Spitak.
