THE 1989 NEWCASTLE, AUSTRALIA, EARTHQUAKE: THE FACTS AND THE MISCONCEPTIONS

J.M.W. Rynn¹, E. Brennan², P.R. Hughes³, I.S. Pedersen⁴
and H.J. Stuart⁵

ABSTRACT

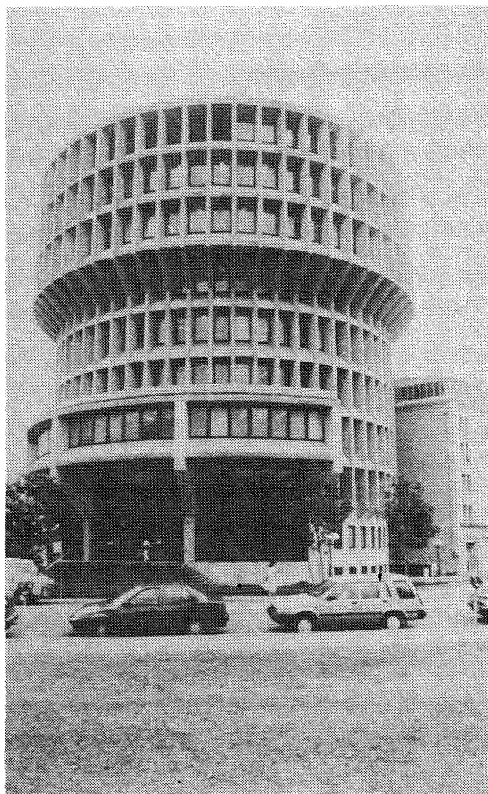
FIGURE 13 NEWCASTLE CITY COUNCIL ADMINISTRATION BUILDING AT CORNER OF KING AND BURWOOD STREETS, NEWCASTLE CBD WHICH DID NOT SUFFER ANY DAMAGE WHATSOEVER. (H.J. STUART)

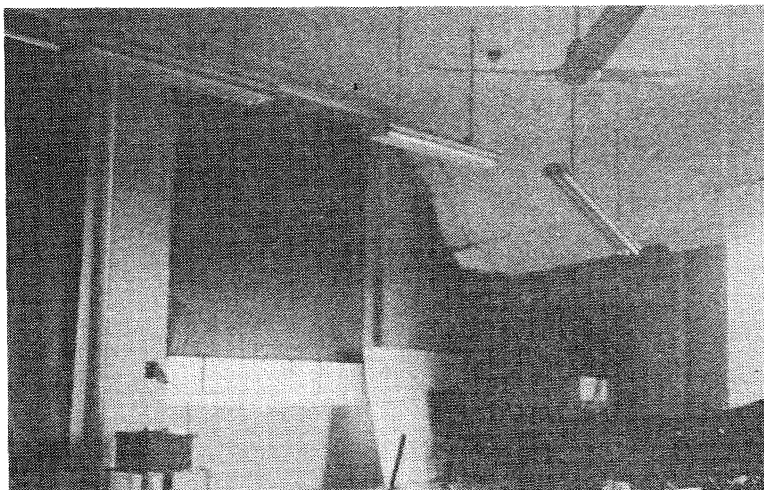
NEWCASTLE TAFE COLLEGE,
TIGHES HILL, SMALL BUSINESS
CENTRE: COLLAPSED SUSPENDED
CEILING AND DAMAGE TO
FURNITURE AND FITTINGS

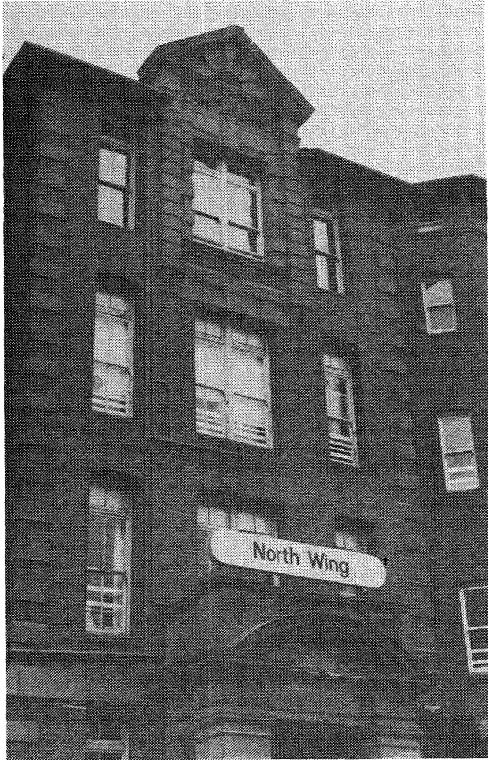
FIGURE 20

ROYAL NEWCASTLE HOSPITAL,
NORTH WING, NEWCASTLE EAST:
EXTENSIVE DAMAGE BOTH
EXTERNALLY AND INTERNALLY
TO MASONRY WALLS, CEILINGS,
PARAPETS AND ARCHITECTURAL
FEATURES (SIMILAR DAMAGE TO
ADJOINING YORK WING; BOTH
ORIGINAL WINGS OF HOSPITAL).
DAMAGE SEVERE ENOUGH TO
CONSIDER DEMOLITION OF BOTH
WINGS.
(4.1.90; J.M.FENWICK)

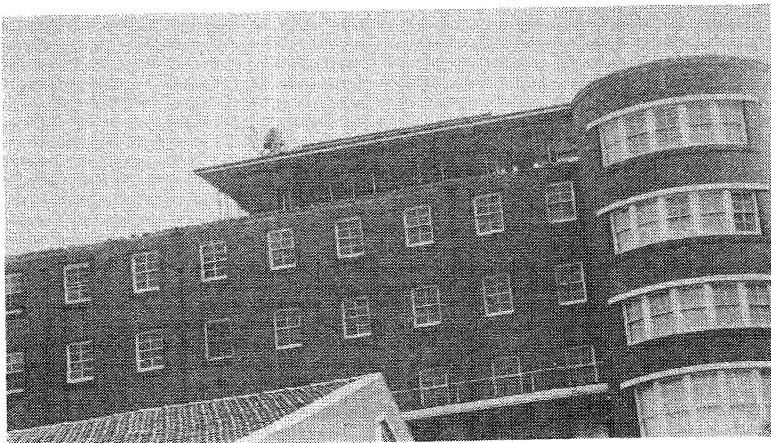
FIGURE 22

MATER MISERICORDIAE HOSPITAL,
EDITH STREET, WARATAH:
COLLAPSE OF UNREINFORCED
MASONRY PARAPET ENCLOSING
COVERED WALKWAY AT ROOF
LEVEL
(19.1.90; E. BRENNAN)

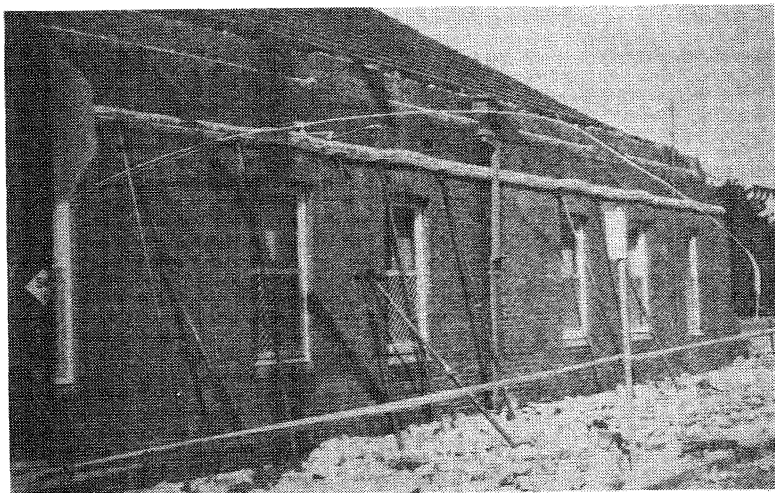
FIGURE 25

COOKS HILL FIRE STATION
(REGIONAL HEADQUARTERS), BULL
AND UNION STREETS, COOKS HILL:
SEVERE STRUCTURAL DAMAGE TO
THIS OLD BUILDING WITH
MASONRY PARAPET AND OUTSIDE
BRICK SKIN COLLAPSE AND
INTERNAL DAMAGE. NOTE
IMMEDIATE SAFETY PRECAUTIONS
WITH STEEL PROPS
(30.12.89; J.M.W. RYNN)

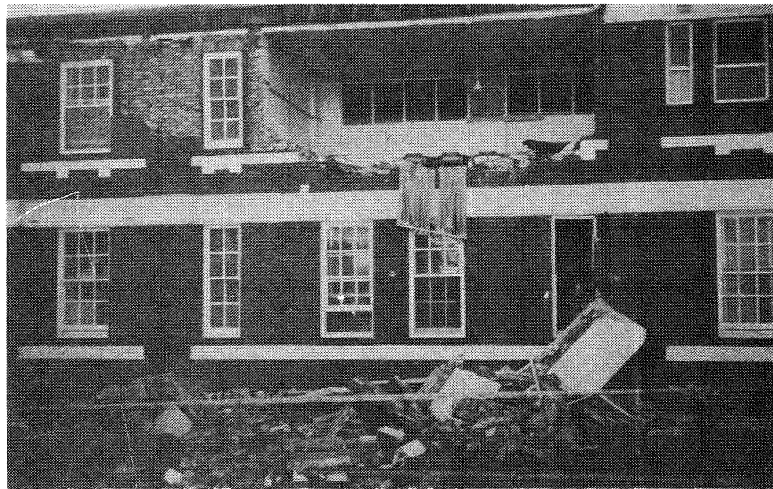
FIGURE 26
 HAMILTON AMBULANCE STATION
 (REGIONAL HEADQUARTERS),
 DENISON STREET AND PARKWAY
 AVENUE, HAMILTON: MASONRY
 FAILURE OF BOTH SKINS DUE TO
 LACK OF LATERAL SUPPORT
 WALLS. BUILDING ALSO
 SUFFERED OTHER SEVERE
 MASONRY DAMAGE
 (29.12.89; J.M.W. RYNN)

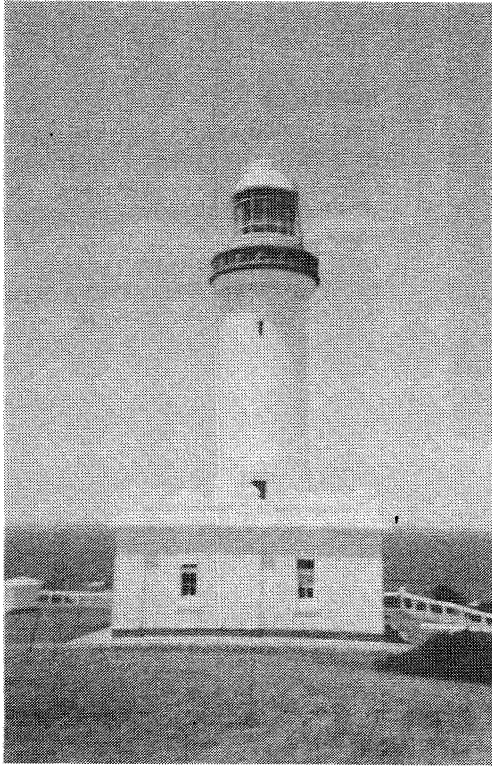
Norah Head Lighthouse - This lighthouse (Figure 31), situated 45 km SSW of Newcastle near Toukley, is a vital facility for shipping on the busy route between Sydney and Newcastle and the overseas shipping lanes along the east coast of Australia. It is founded on a solid sandstone coastal headland (Figure 6). Built in 1903 of precast concrete masonry blocks, the optical apparatus consists of a lens of 700 mm focal radius floating in a bath of mercury. This bath experienced a serious mercury spill (60 kg) because of the horizontal force applied, the liquid percolating down through the tower. The dangers created both to the lighthouse operation and to the staff could have serious consequences. Other damage recorded included a crack in the cast iron pedestal leg of the lens support, several cracks through mortar joints of the lighthouse building (Figure 32), and cracks in several of the station's outer buildings, most severely in the workshop (Lighthouse Keeper P. Bailey and Captain J. Nicholson, pers. comm., 1990, 1991).

FIGURE 31 NORAH HEAD LIGHTHOUSE, 45 km SSW OF
NEWCASTLE
(20.1.90; M.W. RYNN)

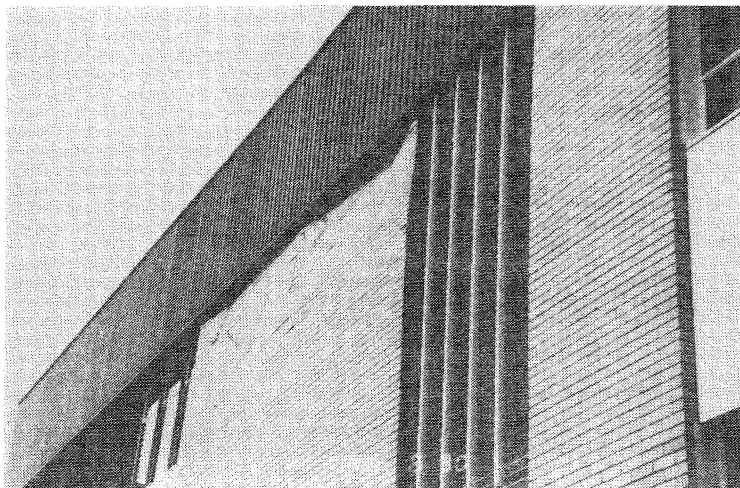
FIGURE 33

HAMILTON RSL CLUB, TUDOR AND CHAUCER STREETS, HAMILTON: SEVERE BUCKLING OF CHAUCER ST. (WESTERN) WALL - OUTSIDE BRICK SKIN FAILURE DUE TO LACK OF LATERAL SUPPORT. WALL STILL CONNECTED TO LOAD BEARING INSIDE SKIN BY BRICK TIES (5.1.90; C.R. FEATHERSTONE)

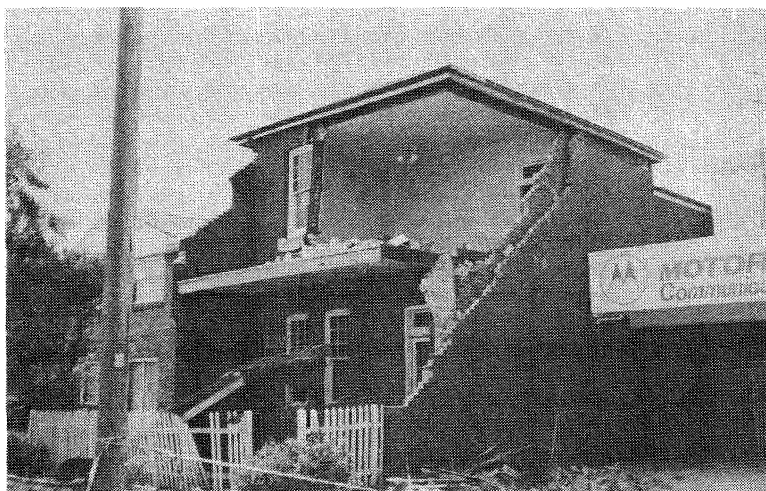
FIGURE 42 TERRACE HOUSE, LAMAN AND JOHN STREETS, COOKS HILL: FAILURE CRACKS ALONG LINES OF LEAST RESISTANCE. NOTE FAILURE ON PARAPET AND AROUND LINTEL. DAMAGE SO SEVERE THAT DWELLING WAS DEMOLISHED (5.1.90; C.R. FEATHERSTONE)

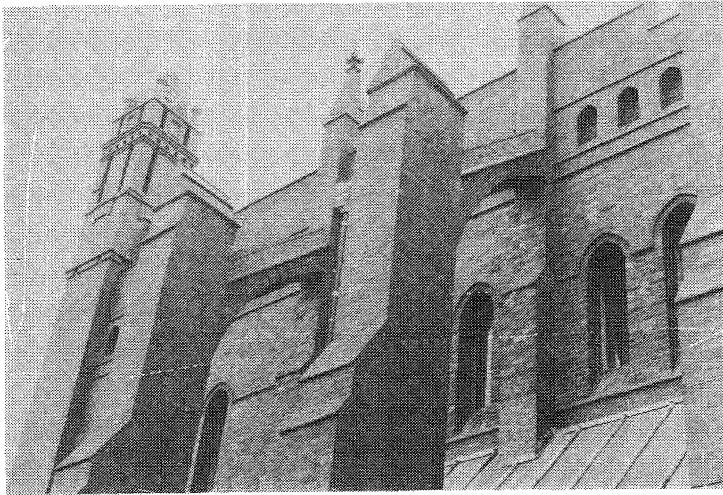
FIGURE 46

CHRIST CHURCH ANGLICAN CATHEDRAL, CHURCH STREET, NEWCASTLE: SEPARATION OF UNREINFORCED BRICKWORK IN FLYING BUTTRESSES WHICH WERE TIED TOGETHER WITH METAL STRAPPING AFTER THE EARTHQUAKE DAMAGE. SEVERE CRACKING IN BRICK SHELL-LIKE STRUCTURE OF CHURCH. MAJOR CRACKS WITH DISPLACEMENT IN BRICKS OF SPIRES. FINIALS ROTATED ON CENTRE SUPPORTS (4.1.90; J.M. FENWICK)

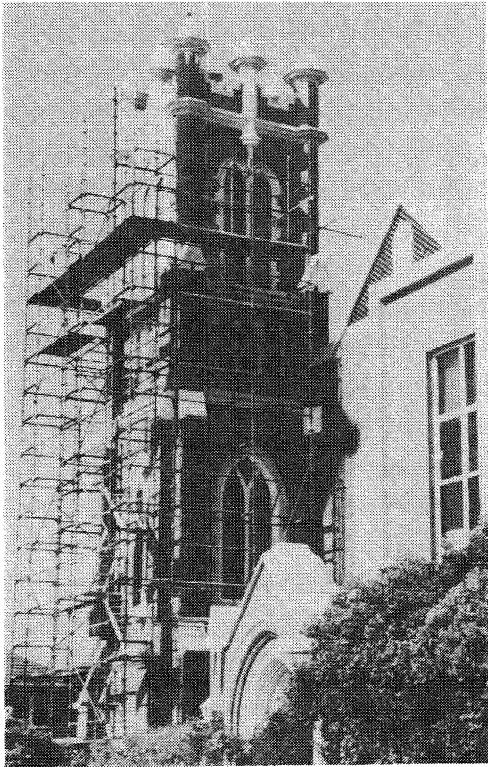
FIGURE 47 WESLEY CHURCH, BEAUMONT AND DENISON STREETS, HAMDILTON: LOAD BEARING MASONRY CHURCH TOWER - SEVERE DAMAGE TO TYPICAL MASONRY AND ARCHITECTURAL FEATURE, INCLUDING DAMAGE TO STAINED GLASS WINDOWS (4.1.90; C.R. FEATHERSTONE)

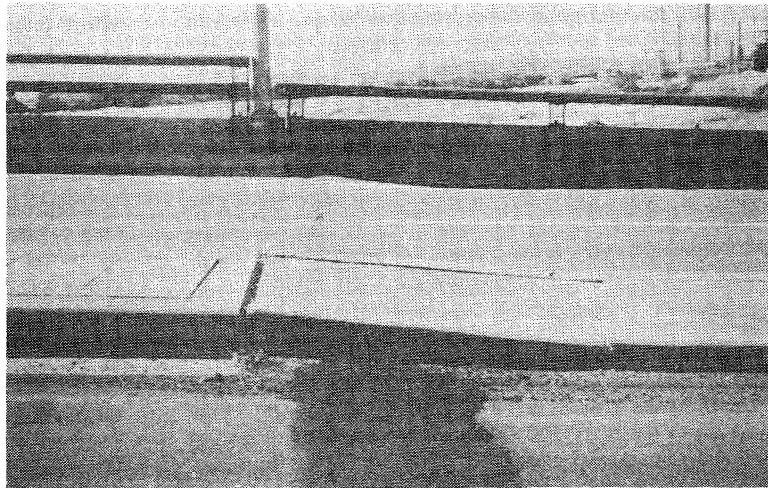
FIGURE 49

STOCKTON BRIDGE (HUNTER RIVER, NORTH CHANNEL): SETTLEMENT OF ABOUT 70 mm OF WESTERN APPROACH ABUTMENT EVIDENCED BY BITUMEN INFILL ON ROADWAY (PLACED SINCE EARTHQUAKE) AND CRACKED AND DISPLACED CONCRETE MEDIAN STRIP (29.12.89; J.M.W. RYNN)

Clear evidence of ground consolidation from ground shaking was shown in the western approach abutment of the Stockton Bridge (a long concrete arch structure over the north channel of the Hunter River) of about 70 mm (Figure 49). It would appear that settlement in the sands of the western bank of the Hunter River due to abutment loading had occurred. Some evidence of only slight movement (less than 50 mm) in the western abutment of the Cowper Street Bridge, an old wooden bridge across Throsby Creek at Carrington, was also observed (Figure 50).

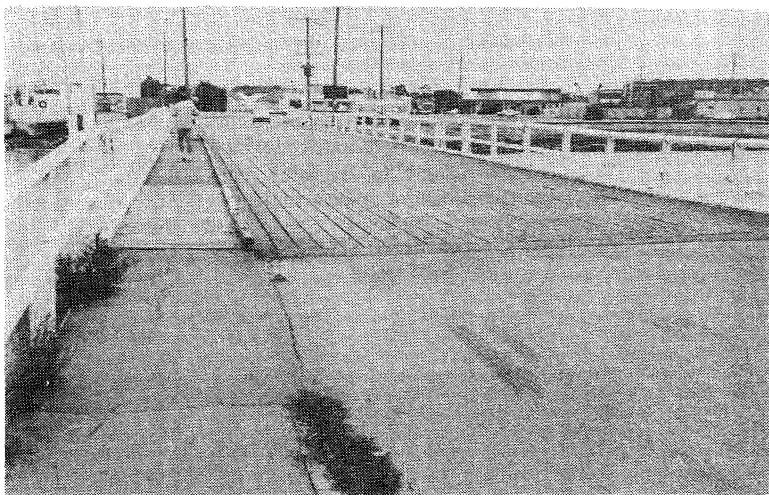
FIGURE 50

COWPER STREET BRIDGE, CARRINGTON, (ACROSS THROSBY CREEK): DROP OF LESS THAN 50 mm IN WESTERN ABUTMENT (INDICATED BY BITUMEN INFILL PLACED SINCE THE EARTHQUAKE) AND ABUTMENT SHOULDERS. EVIDENCE OF MANY FRESH CRACKS IN BITUMEN AND GRASS (LOWER LEFT QUADRANT) (5.1.90; C.R. FEATHERSTONE)

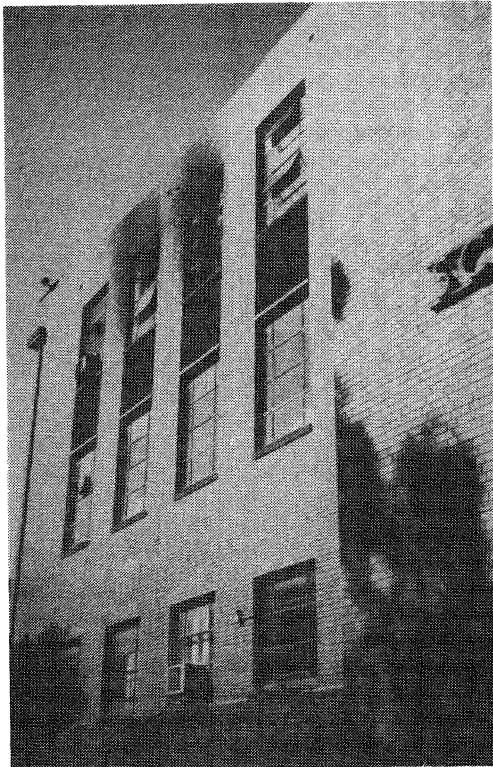
Only one fire was reported at the time of the earthquake. This occurred at the Newcastle TAFE College, Tighes Hill in the third (top) floor of the Science Block as a result of a chemical spill in a laboratory (Figure 51).

FIGURE 51 THE ONLY FIRE RESULTING FROM THE EARTHQUAKE WAS IN THE TOP FLOOR CHEMISTRY LABORATORY OF THE SCIENCE BLOCK, EDGEWORTH DAVID BUILDING, NEWCASTLE TAFE COLLEGE, TIGHES HILL, CAUSED BY A CHEMICAL SPILL
(29.12.89; J.M.W. RYNN)

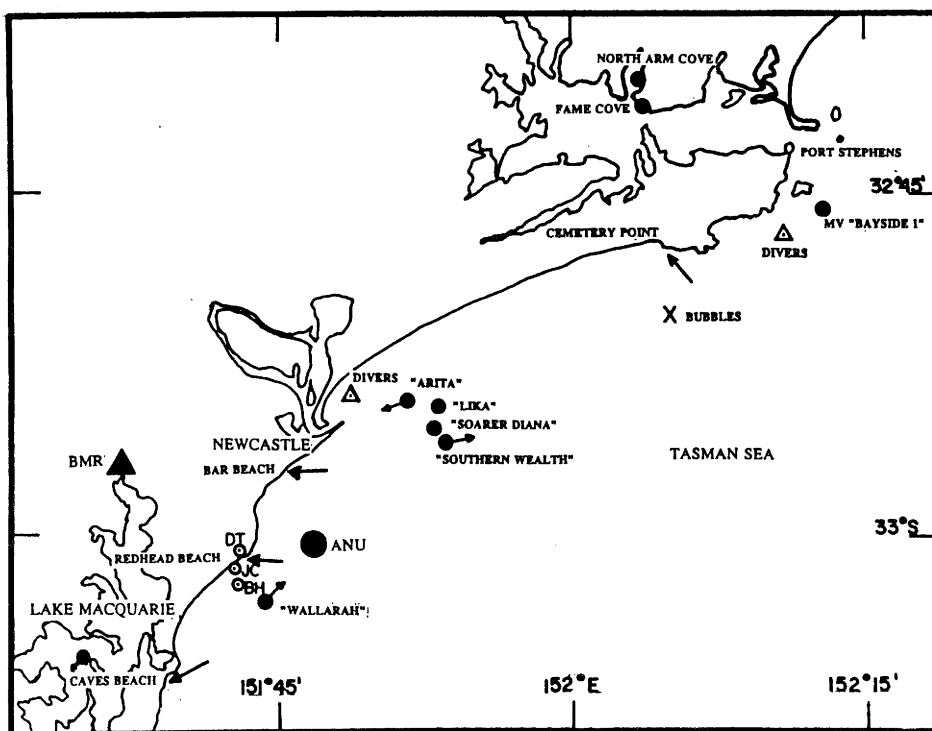
Of note was the major and very serious ingress of water at this mine, an increase of about 6 times that normally experienced prior to the earthquake. This high rate of inflow continued for several months. The water was fresh and did not represent a fracture to the sea.

FIGURE 54 EFFECTS AT SEA, ON THE COASTLINE AND IN UNDERGROUND COAL MINES IN THE EPICENTRAL REGION OF THE 1989 NEWCASTLE EARTHQUAKE

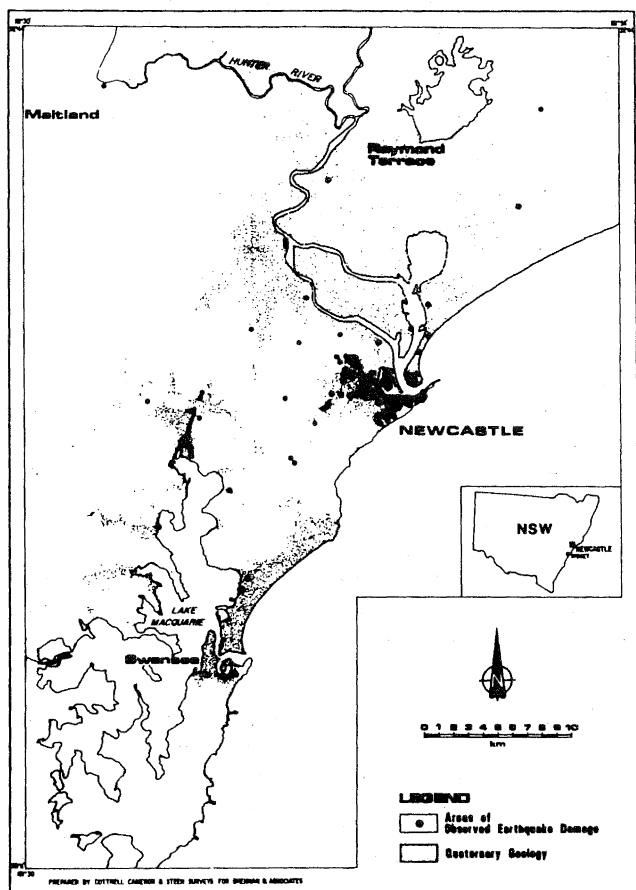
It was clearly evident in the early assessment of damage from the 1989 Newcastle earthquake that the total damage pattern was extremely dependent upon the geology of the area concerned [14]. Specifically, the zone of maximum damage coincides very closely to the areas of Holocene sediments (Figure 58).

FIGURE 58 MAJOR BUILDING DAMAGE REPORTED IN THE CITY OF NEWCASTLE AND SURROUNDING REGIONS IN RELATION TO HOLOCENE SEDIMENTARY AREAS (AFTER [14])

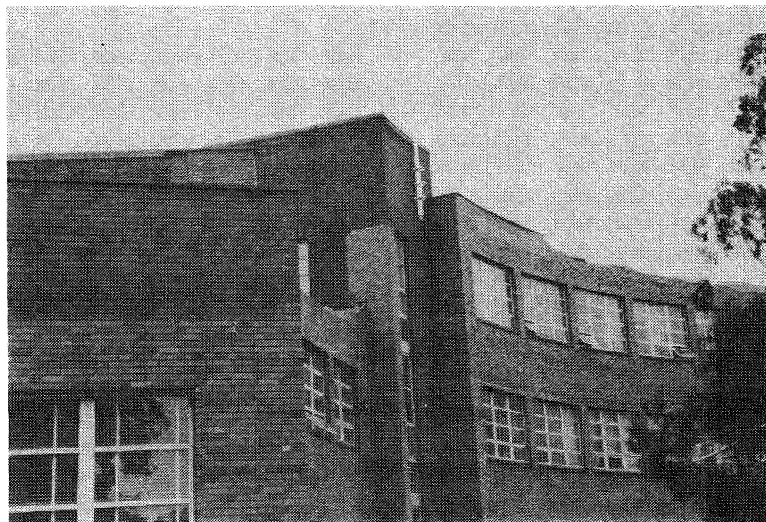
FIGURE 63

For the Newcastle earthquake, it is well documented that major and significant damage was suffered at the Newcastle TAFE College, Tighes Hill (Figure 63). Yet, only about 150 metres away, in the Tighes Hill shopping centre, the Varley Building (Figure 64) suffered no damage, except the dislodging of three small (approx 50 mm x 90 mm) tiles from the front exterior wall (Figure 65). The TAFE College is built on about 20 metres of creek fill alluvium flats underlain by the Newcastle Coal Measures, while the Varley Building is on Permian Tighes Hill Group sediments of Newcastle Coal Measures. There is

almost an infinite scale of damage between the two sites, both at virtually the same distance from the epicentre. It is also interesting to note that the Varley Building and the Darling Building at the TAFE (which sustained most severe damage) are of similar construction and age, both being built in the mid-1930's of largely unreinforced brick. This vast difference in damage must be caused by the effect of the local site geological conditions. Thus, amplification at the TAFE College on the recent alluvial cover, probably a factor of 6 or more, must have occurred.

NEWCASTLE TAFE COLLEGE, TIGHES HILL SHOWING SEVERE PARAPET DAMAGE TO THE CLEGG BUILDING

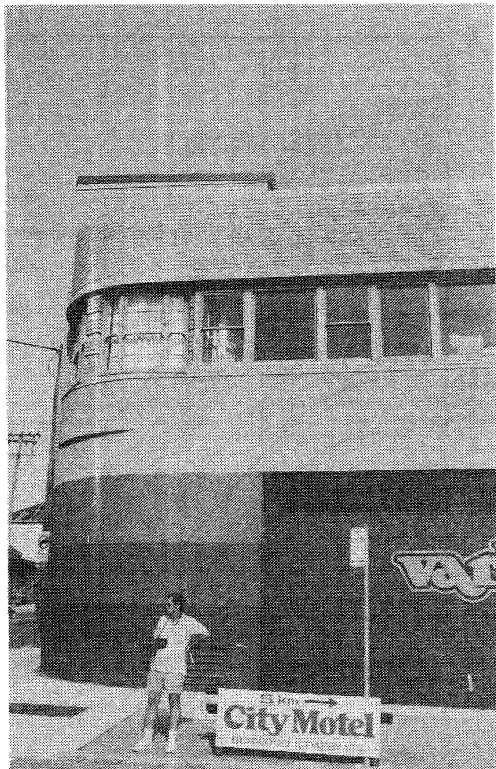
FIGURE 64

VARLEY BUILDING IN TIGHERS HILL SHOPPING CENTRE ABOUT 150 METRES FROM THE TAFE COLLEGE: ONLY DAMAGE WAS DISPLACEMENT OF THREE CERAMIC TILES ON FRONT WALL (LOWER RIGHT HAND CORNER; DETAILED IN FIGURE 65)
(19.1.90; E.BRENNAN)

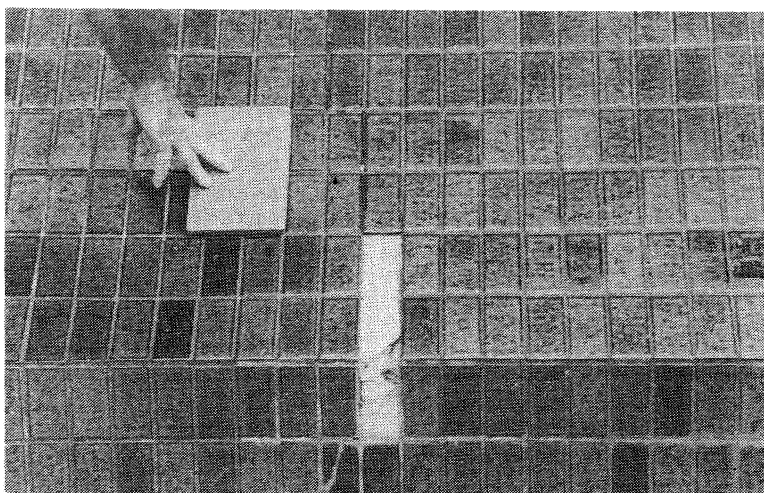
FIGURE 65

CLOSE-UP OF THE THREE CERAMIC TILES DISLODGED FROM THE VARLEY BUILDING (FIGURE 64)

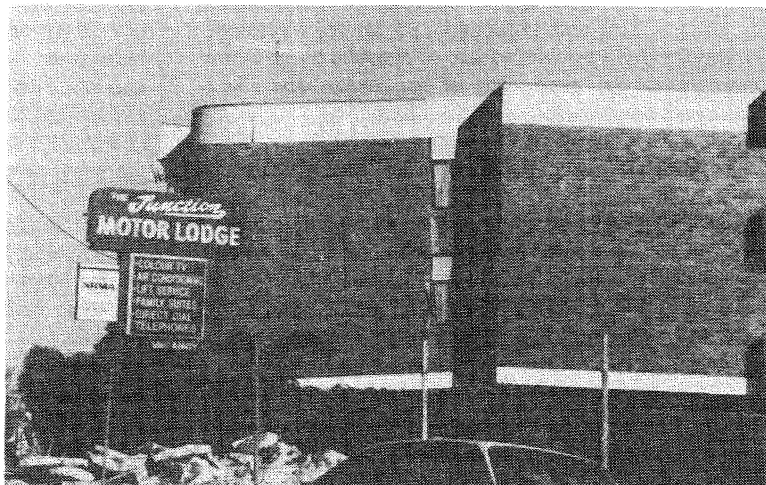
FIGURE 67

With the exception of the Newcastle Workers Club (Figure 7) and The Junction Motor Lodge (Figure 67), the majority of structural failure and damage has occurred in what can be termed "old structures". There has been little evidence of overall building collapse. In general, it has been elements within the building that has caused excessive damage to the building structure itself and to the public. The building stock in Newcastle is generally old (i.e. pre-1950's), with few major developments having taken place in the past 20-30 years. The main area for major commercial development has been Hunter Street. Of the buildings constructed to date, approximately 20 are greater than 6 storeys in height whilst approximately 40% of the buildings are over 2 storeys in height. The remainder are single and two storeys which make up approximately 50-60% of the building stock in the CBD of Newcastle [65]. The extent of damage can be divided into two classifications, pre-1950 (older building) and post-1950 (newer) construction.

THE JUNCTION MOTOR LODGE, CORLETTE AND KENRICK STREETS, THE JUNCTION: MAJOR STRUCTURAL DAMAGE NECESSITATING DEMOLITION, THE RESULT OF SOFT STOREY FAILURE WITH ASYMMETRICAL DESIGN LAYOUT (28.12.89; I.S. PEDERSEN)

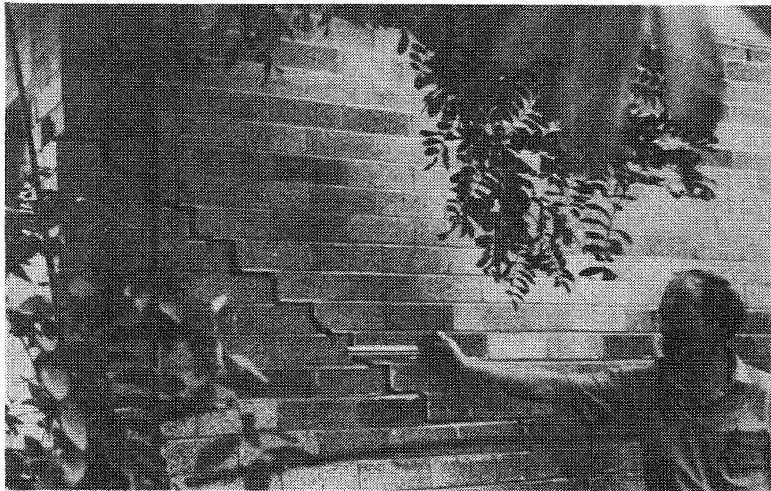
FIGURE 73 CORRODED BRICK TIES FOUND IN OLDER BUILDING, NEWCASTLE (27.11.90; I.S.PEDERSEN)

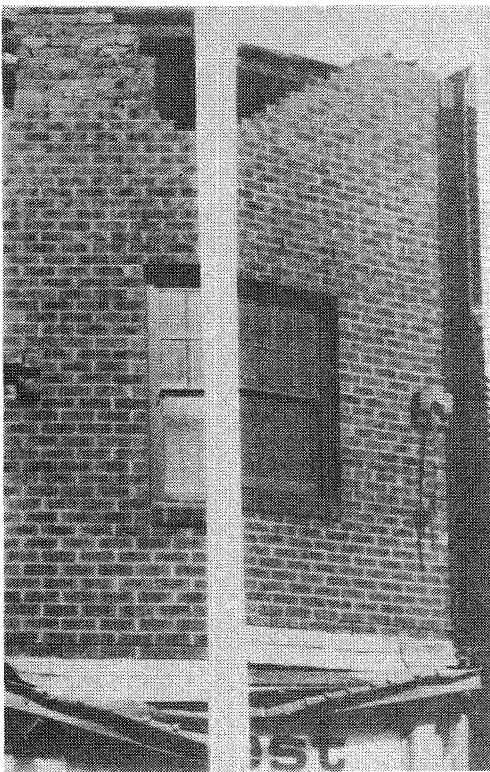
FIGURE 74
TYPICAL DAMAGE TO BRICK WALL
IN BRICK VENEER PRIVATE
RESIDENCE
(FEBRUARY 1990; I.S.PEDERSEN)

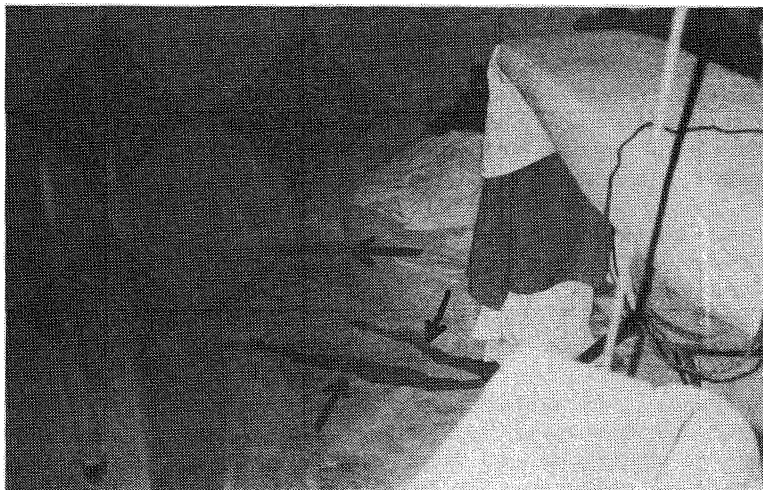
FIGURE 79

INGRESS OF WATER INTO SUBTERRANEAN BASEMENT OF CONSTRUCTION (CONCRETE SLAB) TATTERSALL'S CLUB, WATT STREET, NEWCASTLE CBD, MORE THAN ONE YEAR AFTER THE EARTHQUAKE DUE TO OPENING OF EXISTING CONSTRUCTION JOINTS AND CRACKS (ARROWS) (23.3.91; J.M.W. RYNN)

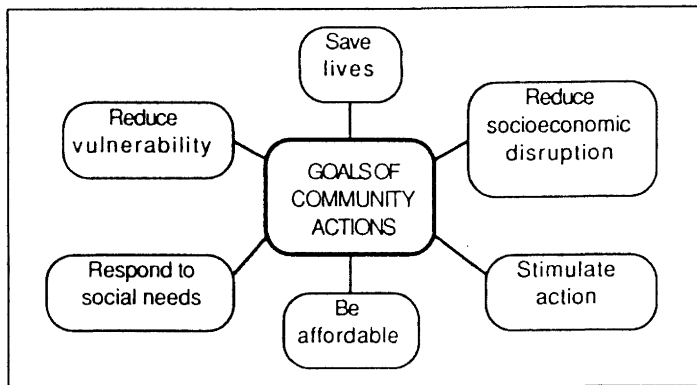
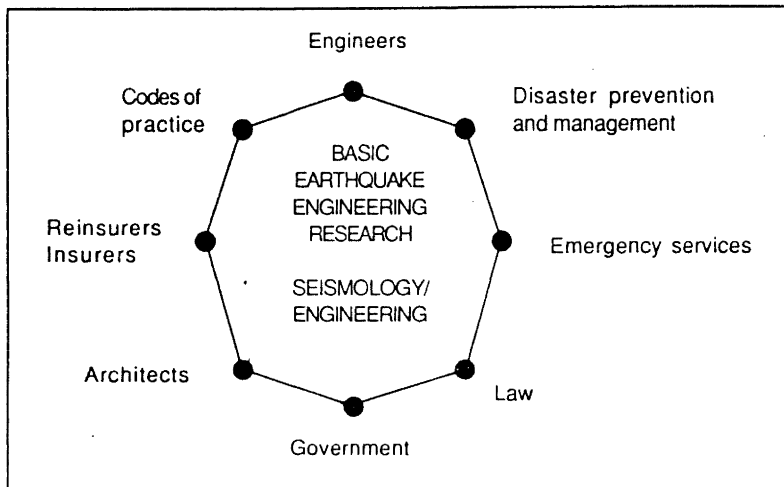
FIGURE 80 THE DUAL APPROACH FOR THE REDUCTION OF LOSSES FROM EARTHQUAKES (FROM [7])

(a) Goals of community actions in implementing loss reduction measures (per W.W. Hays USGS, from [6]).

(b) The multidisciplinary approach to earthquake research in the mitigation programme

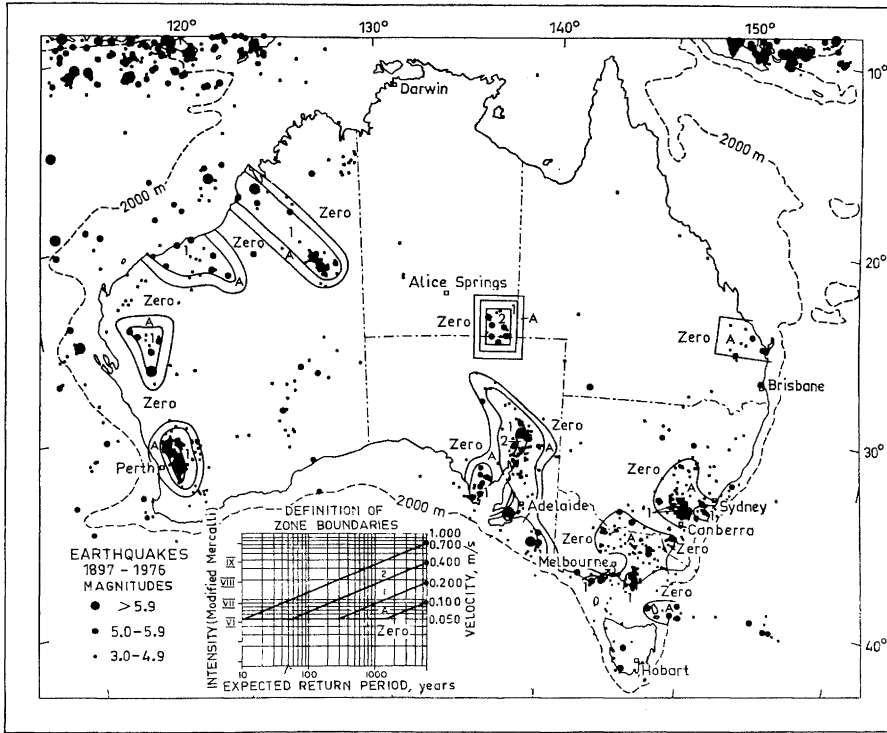
FIGURE 81 STANDARDS ASSOCIATION OF AUSTRALIA EARTHQUAKE CODE AS2121-1979: SEISMIC ZONE MAP OF AUSTRALIA (AFTER [22])

The current Australian Earthquake Code AS2121-1979 [22] was based solely on the earthquake data available through 1976. It is well accepted that, based on the information available today there are many inadequacies and discrepancies. For the situation at Newcastle, the AS2121-1979 classification (Figure 81) is Zone Zero which is defined as "includes all areas not otherwise zoned; although significant shaking may arise in any part of this zone at some time in the future." The relevant zoning criteria states that "No shaking below (in terms of ground motion velocity) 0.050 m/s (MM VI) is expected to cause structural damage to normal buildings and so velocities below this figure

can be ignored." It should be noted that the constraints used in the definition of zone boundaries in AS2121-1979 were based on the latest information available from California in 1976 for "average" site conditions.

Unfortunately, the Draft Code as it presently exists [28] fails to take adequate account of all the factors necessary. This translates into practical terms whereby not only the earthquake data (probability estimates of the hazard in terms of contour maps as in Figure 81) but also the geological conditions (both structure/tectonics and surface sediments) and engineering information must be essential input to any revised code. The 1989 Newcastle earthquake has clearly provided the latter two inputs through the building damage observed in terms of both design and the geological controls of the alluvial deposits in the region. The question of building foundations, in terms of amplification and liquefaction and thus the alluvial - structure interaction, must be addressed. It is thus mandatory that the seismologists hazard maps of [23] be suitably modified by the geological and engineering conditions particularly in relation to urban regions.

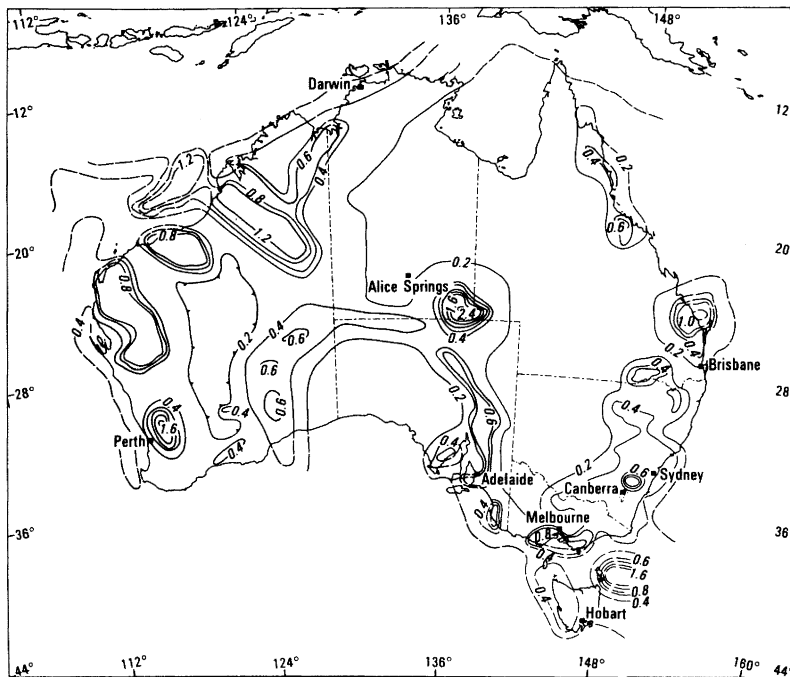
FIGURE 82 PROBABILISTIC EARTHQUAKE RISK MAP OF AUSTRALIA IN TERMS OF PEAK GROUND ACCELERATION (MSEC^{-2}) WITH A 10% PROBABILITY OF BEING EXCEEDED IN A 50 YEAR PERIOD (AFTER [23])

In 1989, just prior to the Newcastle earthquake, the decision was made to revise AS2121-1979 in terms of limit state format using the currently available, and obviously more extensive, earthquake data for Australia. This was to be based on the most recent probabilistic earthquake risk maps, (completed in 1986-1987 using the Australian Earthquake Data File through 1985 analysed in terms of the Cornell-McGuire method [23]) which gave estimates of peak ground motion acceleration, velocity and intensity with a 10% chance of being exceeded in a 50 year period (that is, a 1 in 500 year return period), (Figure 82).
