# EARTHQUAKE RECONNAISSANCE REPORT

## Damage to the Power Generation and Transmission Facilities in the Loma Prieta Earthquake of 17 October 1989

Tan Pham<sup>1</sup>

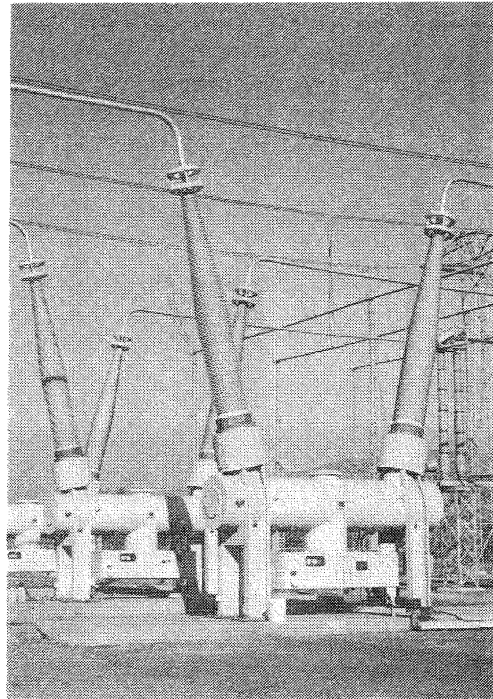
It should be noted that the Hitachi 500 kV dead tank breaker (Fig.13), which was tested to 0.5g ground acceleration using the sinewave method, was undamaged.

Figure 13 - MITSUBISHI 500 kV DEAD-TANK CIRCUIT BREAKER INSTALLED AFTER THE EARTHQUAKE - METCALF.

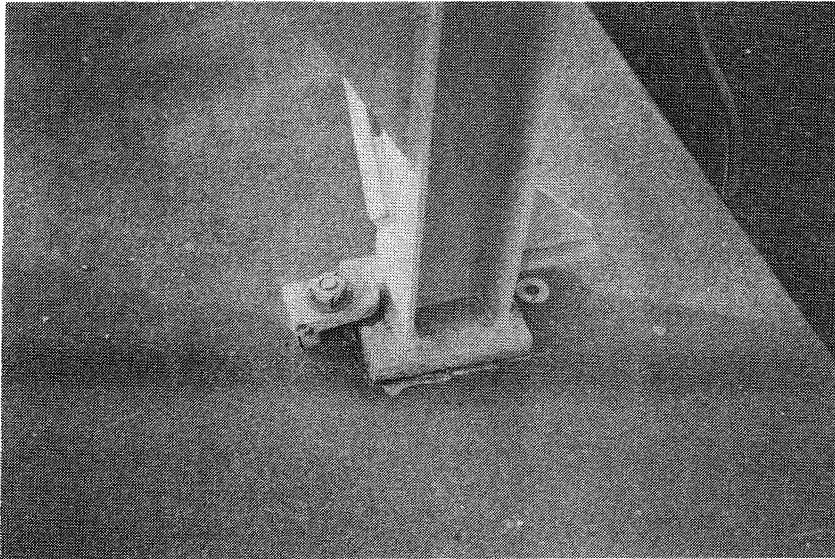
Figure 16 -

UNDAMAGED HOLDING DOWN BOLT FOR  
500 kV CIRCUIT BREAKER SUPPORT  
STAND - METCALF.
