## VULNERABILITY AND SEISMIC RISK ASSESSMENT OF BUILDINGS FOLLOWING THE 1989 NEWCASTLE, AUSTRALIA EARTHQUAKE

A.M. Chandler<sup>1</sup>, J.W. Pappin<sup>2</sup>, and A.W. Coburn<sup>3</sup>

### ABSTRACT

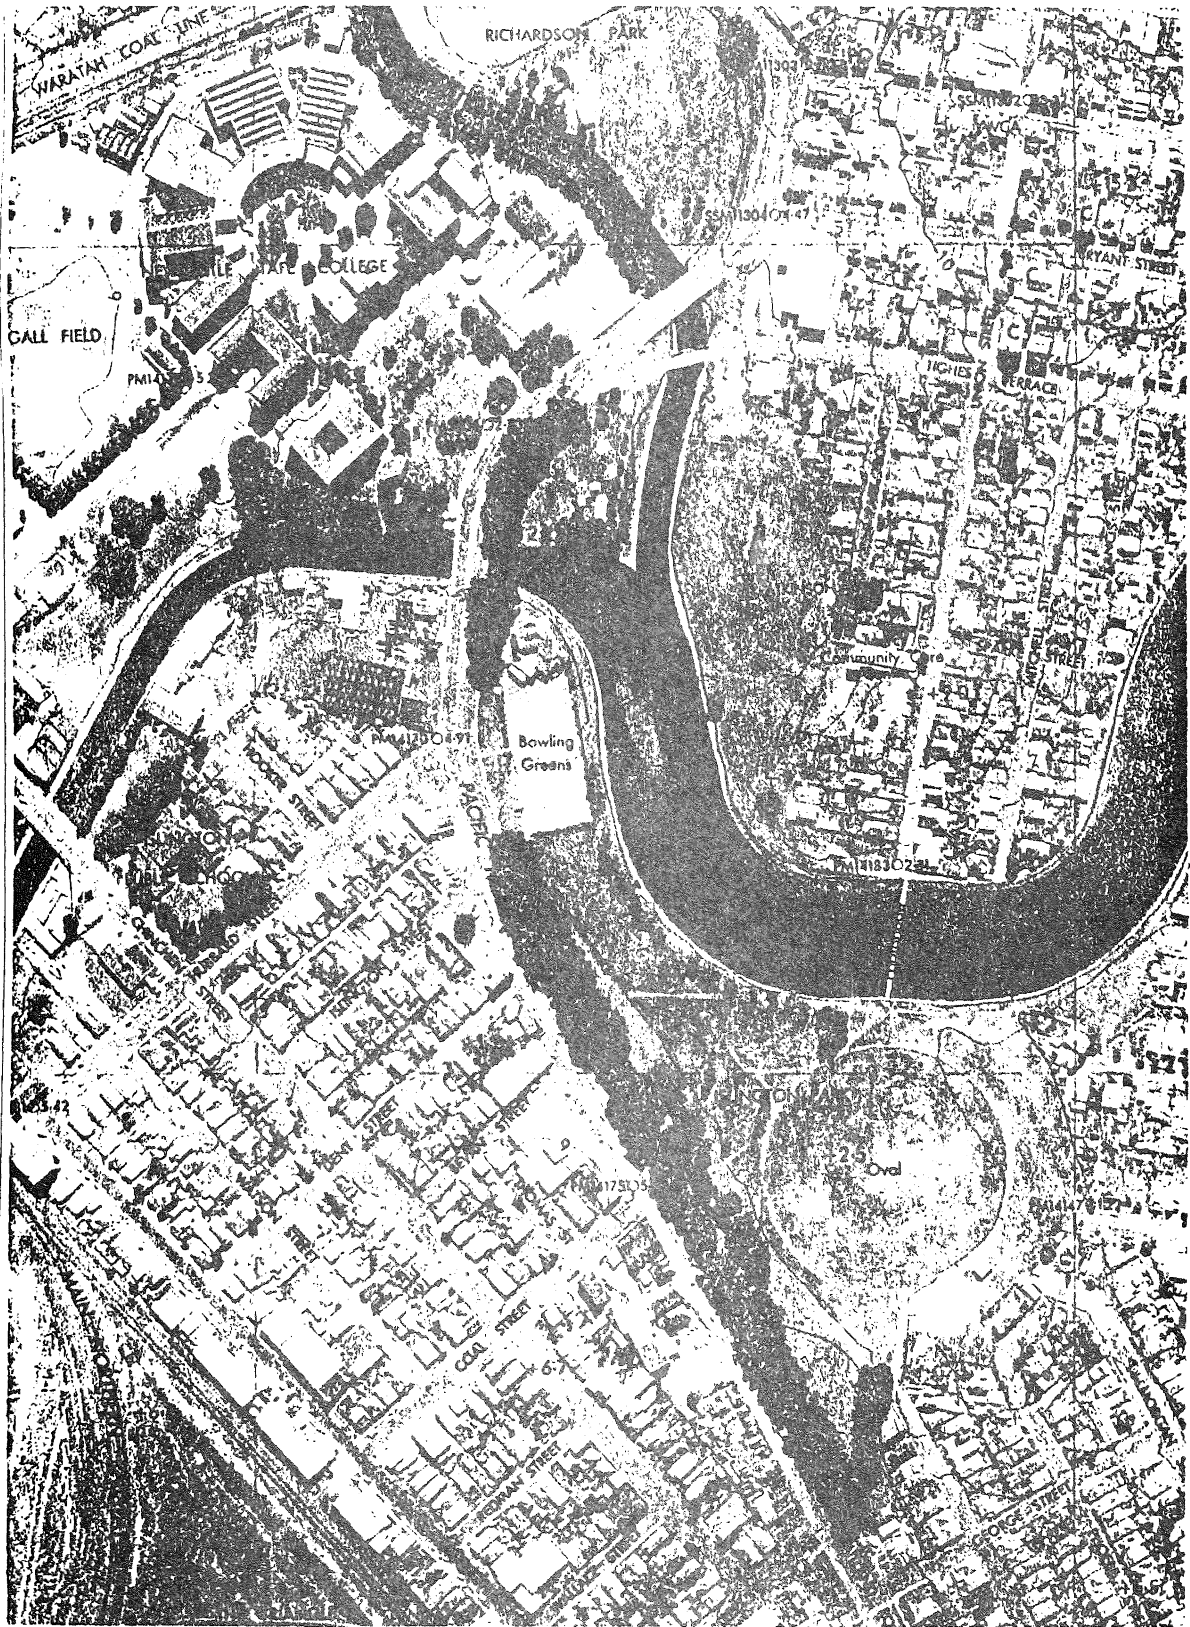
FIGURE 1 PART OF AERIAL PHOTOGRAPHIC MONTAGE OF NEWCASTLE, NSW (SCALE 1:4000)  
 (Source: Central Mapping Authority of N.S.W. "Orthophotomap" Sheet "Adamstown U6350-3", 1988)

As described earlier, a general survey was carried out with buildings having visible damage being marked onto the 1:4000 scale aerial photographic montage (Figure 1). In the Hamilton area and central business district all streets were surveyed. In the adjacent areas generally alternate streets were surveyed due to time limitations. Two levels of damage were recorded as follows:-

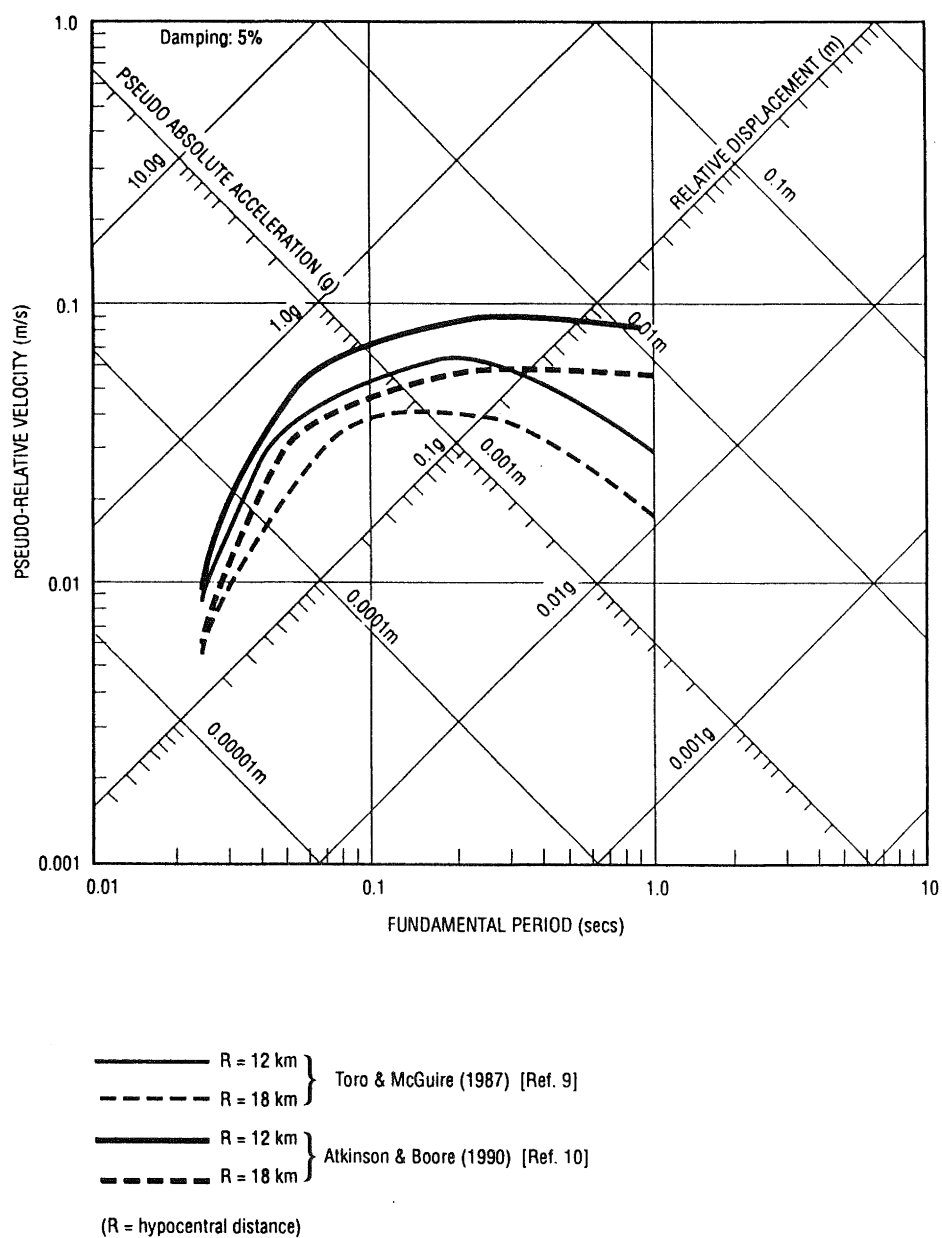
Predictions of ground motion parameters have also been carried out using the attenuation laws derived by Toro and McGuire [9] and Atkinson and Boore [10] for the Eastern United States. The response spectra appropriate to a rock outcrop calculated using their relationships are shown in Figure 2. The peak acceleration values, represented by the spectral values at a structural period of 0.025 seconds, are seen to agree well with those calculated using Gaull et al. [3] listed in Table 1. The peak velocity values from the Gaull relationship are however about three times higher than those indicated by the response spectra in Figure 2.

FIGURE 2 RESPONSE SPECTRA FOR ROCK SURFACE MOTION DERIVED FROM REFS. [9] AND [10]

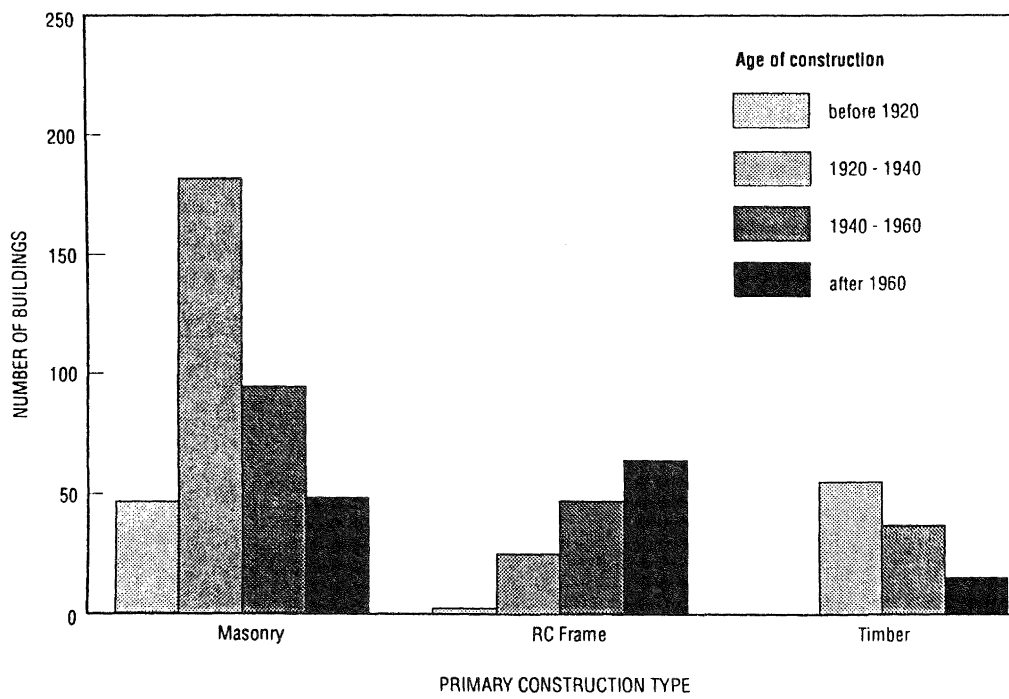
Further classification of the surveyed buildings was carried out by age of construction and by height in number of storeys. Classification by age is shown in Figure 5. A total of 48 buildings were dated pre-1920 (8%), mostly of brick masonry construction. The greatest proportion of buildings (260 or 42%) were built between 1920-1940, whilst 176 buildings (28%) were from the period 1940-1960. Recently constructed buildings (post-1960) numbered 126 (20%). Of the remaining 15 buildings (2%), 12 were of non-classified construction

FIGURE 5 NUMBER OF BUILDINGS BY AGE OF CONSTRUCTION

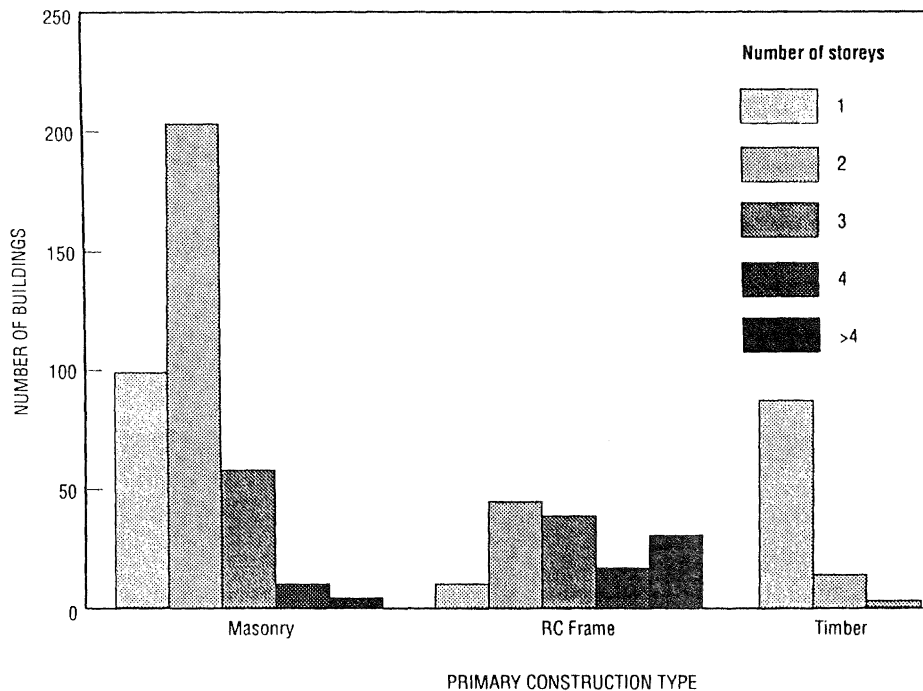
Classification by height in number of storeys is shown in Figure 6. The majority of the buildings surveyed were low-rise with less than 5 storeys, with only 34 buildings (6%) being in the mid-height range, namely 5-10 storeys (classified in Figure 6 as greater than 4 storeys). No buildings of more than 10 storeys were surveyed. These figures are representative of the City as a whole, where low-rise construction dominates. The proportion of buildings with 1, 2, 3 and 4 storeys in the survey was 31%, 44%, 15% and 4%, respectively. A high percentage of the brick masonry buildings (55%) were of 2 storeys height, with only 19% being 3 storeys or higher. The reinforced concrete frame buildings were almost entirely multi-storey (93%), as expected, with 30 buildings (22%) being over 4 storeys in height. In contrast, 85% of the timber framed buildings were single storey.

**FIGURE 6 NUMBER OF BUILDINGS BY HEIGHT IN STOREYS**

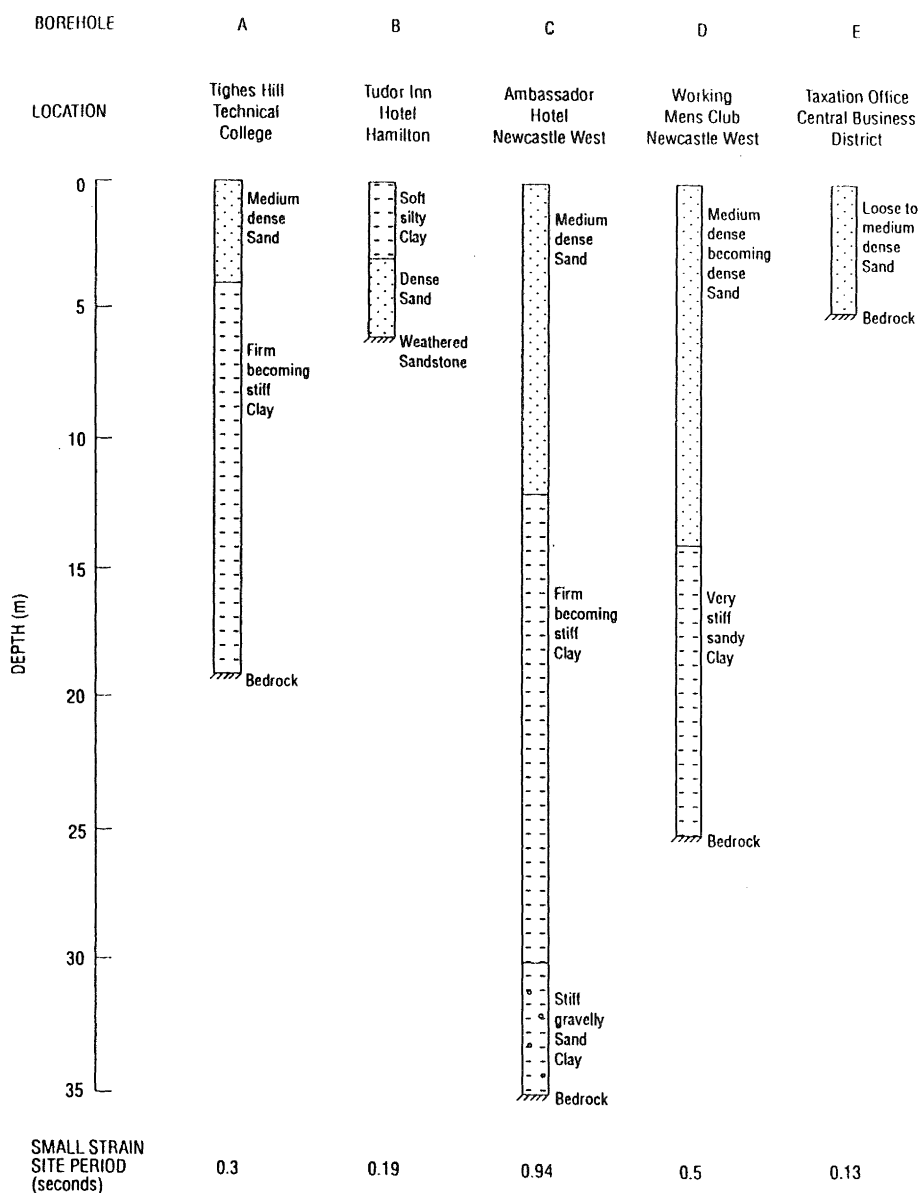
See Figure 14 for borehole locations

**FIGURE 16 BOREHOLE DATA FOR STUDY OF SITE SOIL RESPONSE EFFECTS  
(COURTESY OF COFFEY AND PARTNERS INTERNATIONAL PTY LTD)**

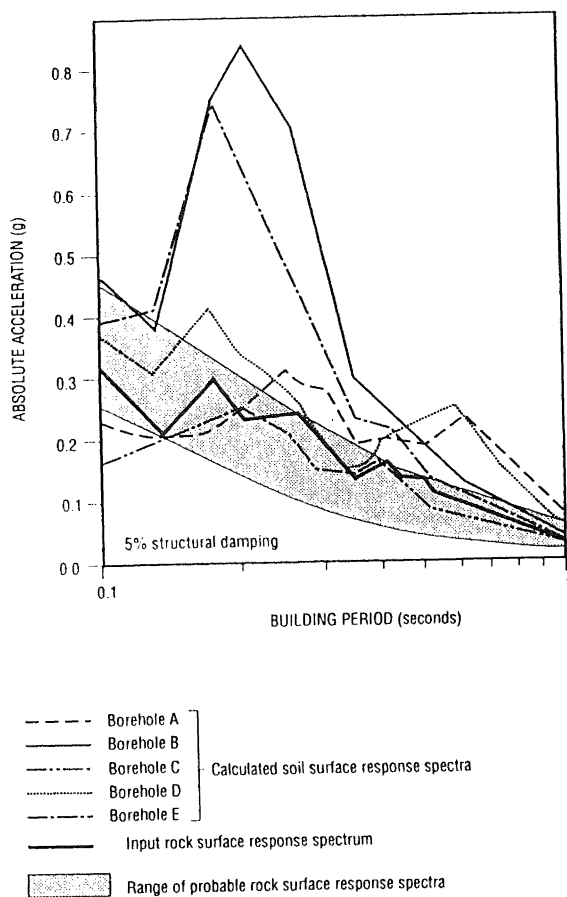
The resulting calculated ground surface acceleration response spectra for 5% structural damping are shown in Figure 17 over the range of fundamental building period (0.1-1.0 seconds) relevant to buildings in Newcastle.

damage in the areas underlain by these soils. As the soil thickness increases (Boreholes A and D) the amplification is seen to reduce in magnitude but extend over a wider period range. For the deepest deposit (Borehole C) a slight attenuation compared with bedrock motion is indicated. These results agree reasonably well with the trends observed in Figures 14 and 15, but there is too large a variability in the data to draw any firm conclusions.

FIGURE 17 RESPONSE SPECTRA OBTAINED FROM STUDY OF SITE RESPONSE EFFECTS
