Report on Field Visit

On July 16 1990, an earthquake of magnitude 7.8 caused widespread damage, disruption and loss of life in Central Luzon, north of Manila.

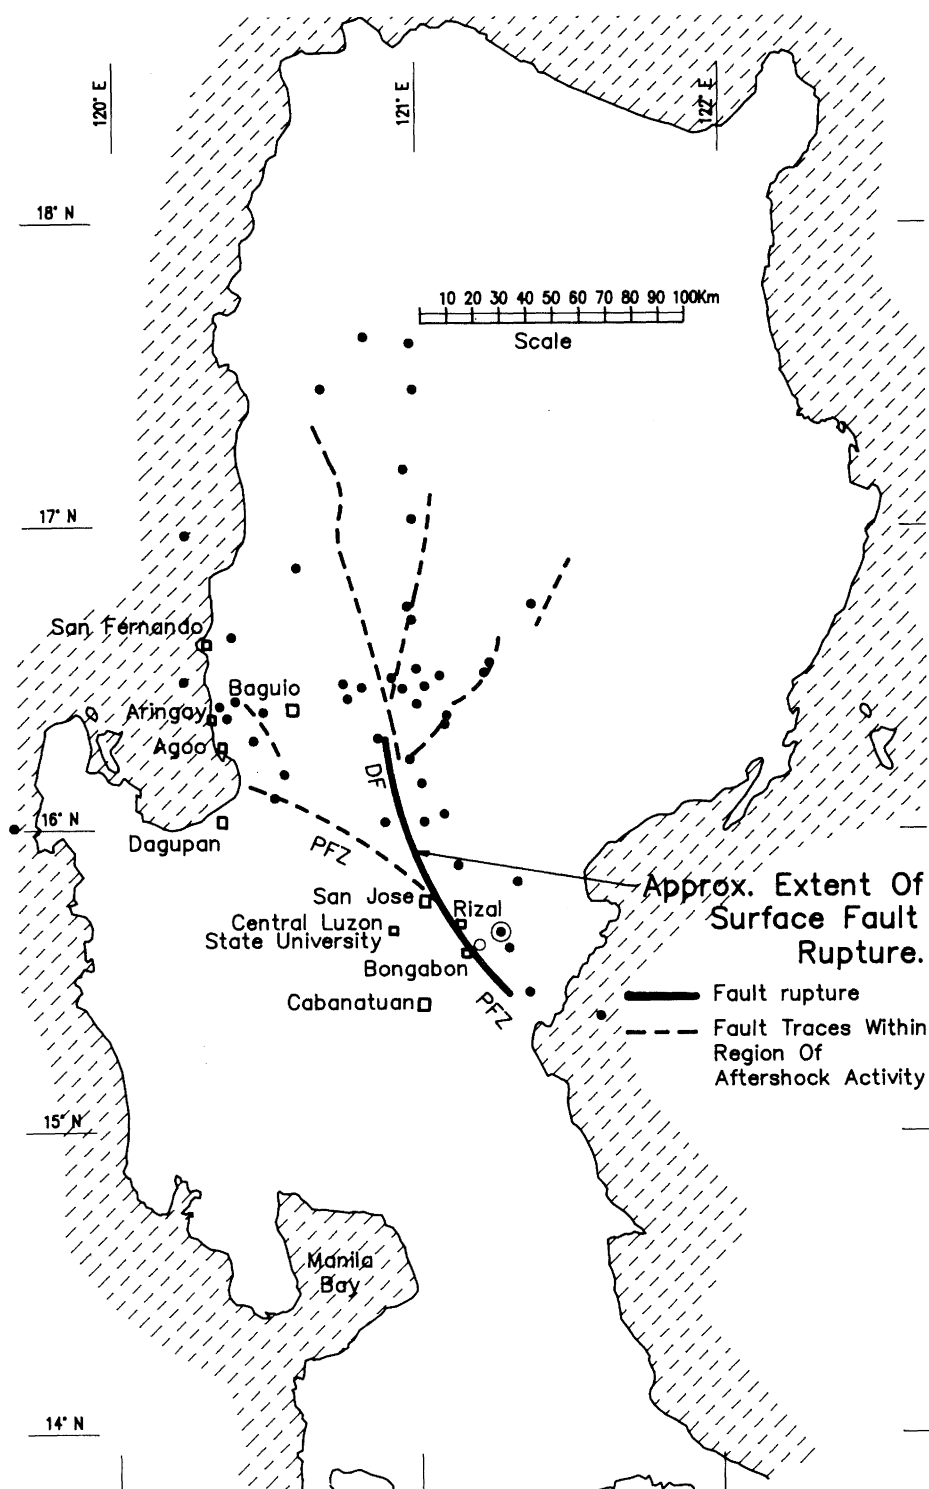
Figure 4.1: Map of surface faulting and aftershocks associated with the July 16 1990 earthquake.

Heavy lines indicate left-lateral fault ruptures that were observed and measured on the ground. Dotted lines represent other fault traces within the region of aftershock activity; surface displacement on these is either absent or unknown (locations from Geologic Map of the Philippines, Bureau of Mines, 1963). Heavy dots are NEIC-located epicentres of aftershocks ($4.44 \leq M \leq 6.5$) within 27 days of the mainshock (circled dot). Open circle near Bongabon shows approximate epicentre of aftershock associated with small creep displacement observed at Rizal. All epicentral locations are approximate. Labels PFZ and DF indicate Philippine fault zone and Digdig fault, respectively (after Newhall et al., 1990)

Preliminary plots of aftershocks indicate most occurring to the north of the epicentre, towards Baguio, and over a relatively large area as shown on Figure 4.1. The large scatter may be due to errors associated with preliminary determinations. It also suggests that movement may have occurred on faults other than those observed to rupture.

Extensive fault rupture accompanied the earthquake and the extent of this is shown on Figure 4.1. It extends north-west from Gabaldon to San Jose along the Philippine Fault and then along the Digdig Fault from near San Jose northward to a point 6km south of Kayapa. The total distance of surface fault rupture was close to 110km. The rupture also probably extended an additional 50km to 100km north, based on the extent of aftershocks.

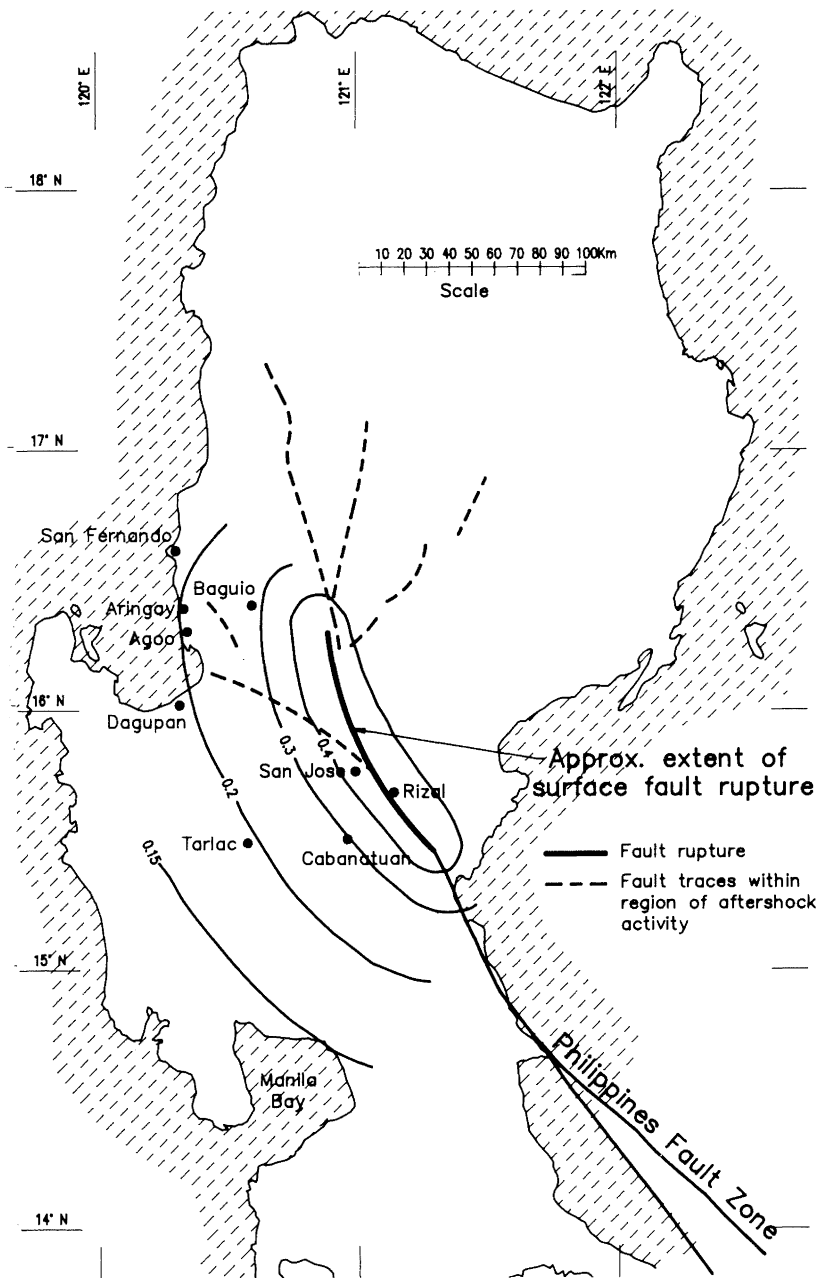
Figure 4.5: Estimates of Peak Ground Acceleration (g)
(Fault locations after Newhall et al., 1990)

Estimates of ground motion in terms of peak ground acceleration are shown on Figure 4.5. These are based on the attenuation model by Idriss [5] for rock sites but modified for alluvial sites, such as found within the Luzon Central Plain and along the coastline. The modifications for alluvial ground were based on correlations between peak ground acceleration on rock and other ground conditions proposed by Seed et al [6], but also taking into account the results from the 1989 Loma Prieta earthquake. Contours of peak ground acceleration shown on Figure 4.5 correspond to those which would be expected on the actual typical ground conditions. Values less than about 0.3g are for alluvium sites which occupy extensive areas to the west of the fault rupture in the Central Luzon and coastal areas.

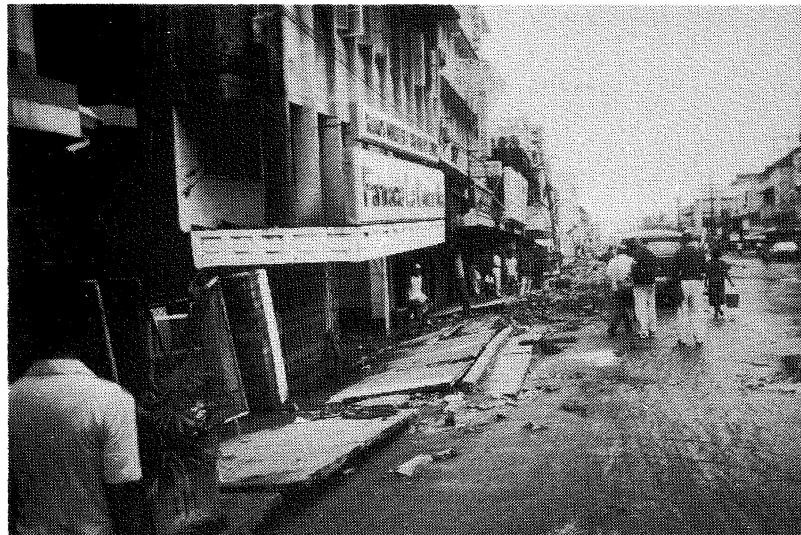
Figure 5.1.5: Dagupan City, Perez Blvd, building settlement relative to road

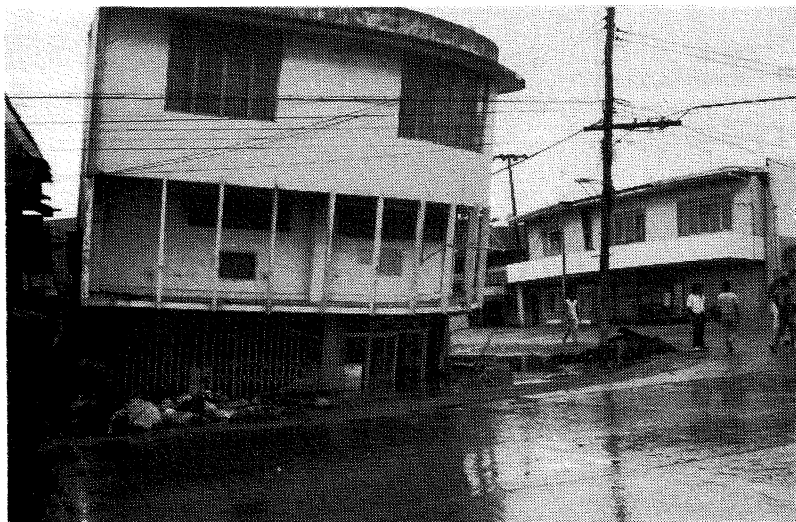
Figure 5.1.6: Dagupan City, Perez Blvd, building settlement and tilting

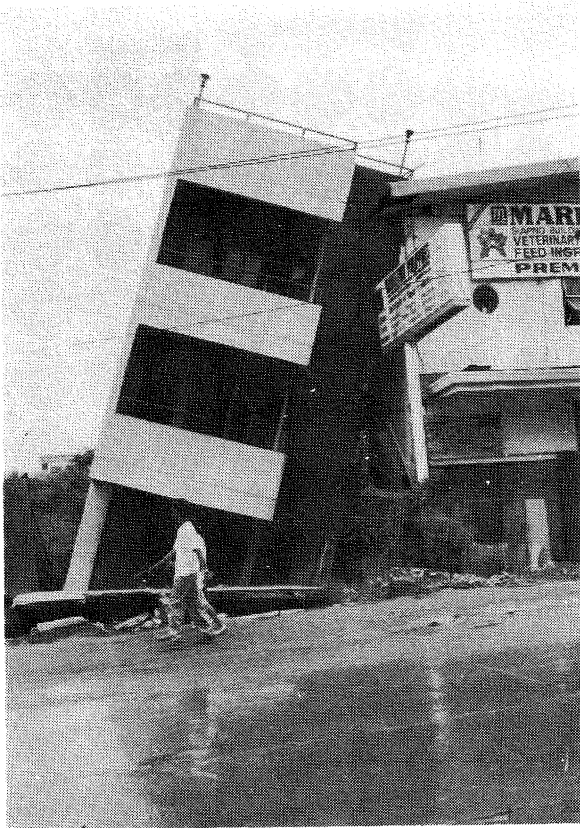
Figure 5.1.7: Dagupan City, Perez Blvd, 3 storey building tilted and impacted on adjacent building

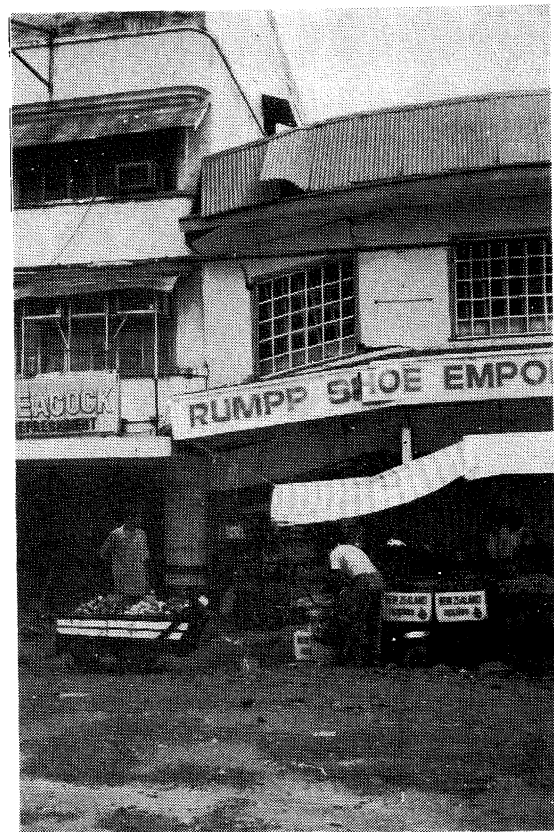
Figure 5.1.8: Dagupan City, A.B. Fernandez Ave, relative settlement of building with different bearing stress

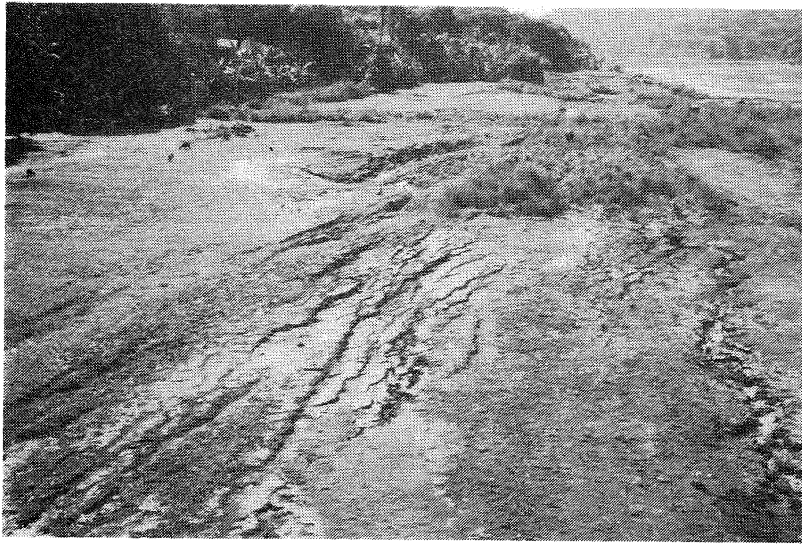
Figure 5.1.13: Lateral spreading of river bank showing ejected sand

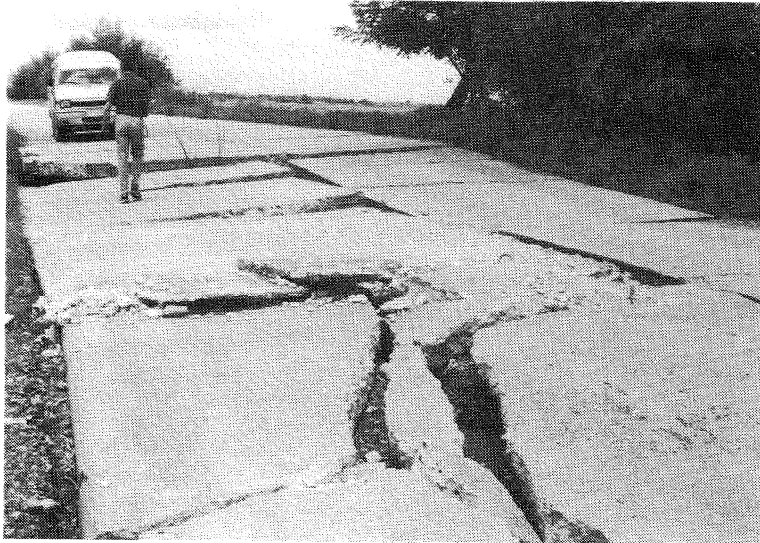
Figure 5.1.14: Liquefaction in low lying alluvial areas distorting road fills and pavement surface

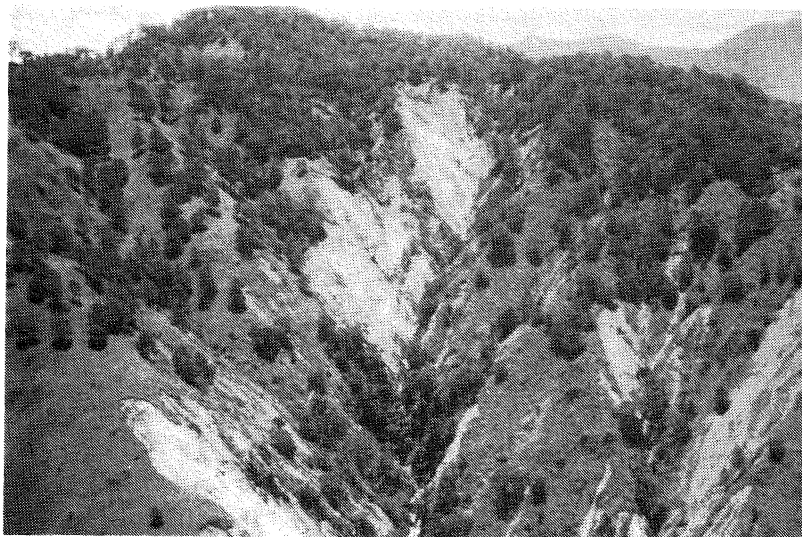
Figure 5.1.15: Landslides in mountainous area north of Baguio; many originated at crests of steep slopes and ridges

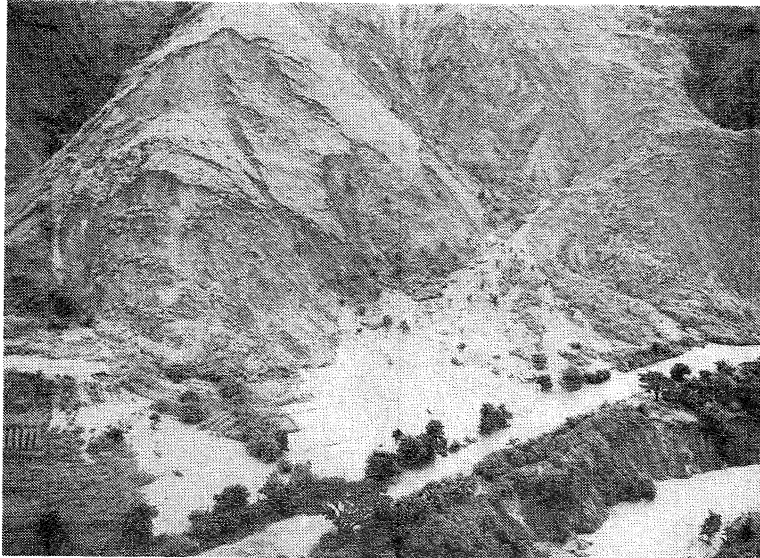
Figure 5.1.16: Dalton Pass road; landslides and mud flows obliterating houses, rice fields and roadway (Photo: Dodong Teves, PNOC)

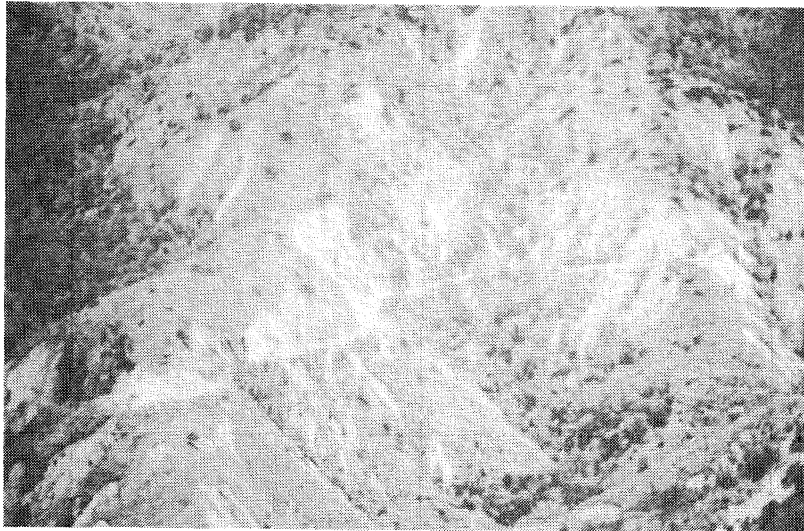
Figure 5.1.17: Landslides in mountains north of Baguio blocking road to Ambuklao hydroelectric plant and villages

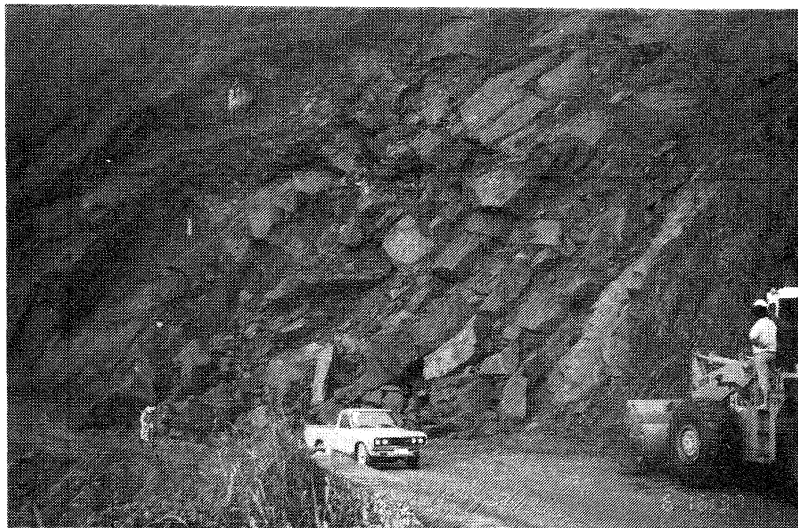
Figure 5.1.18: Naguilian Highway; rock slide due to aftershock, 3 weeks after main event

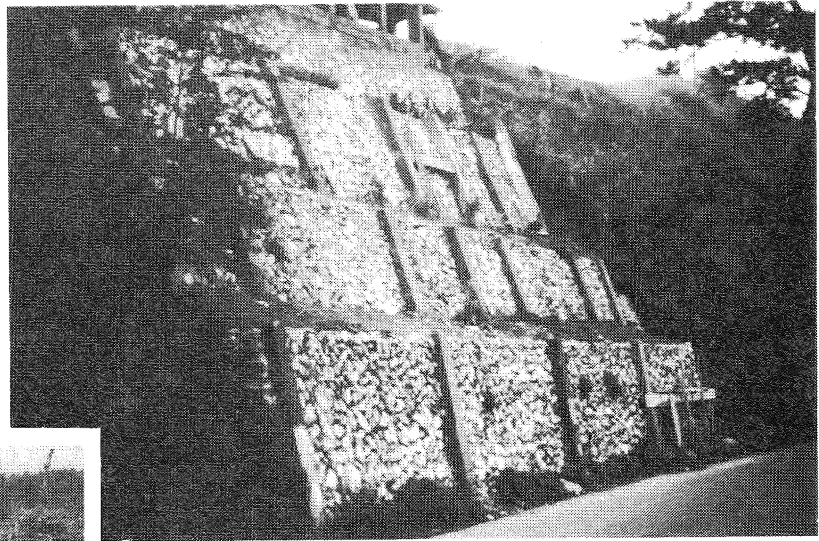
Figure 5.1.20: Rock-faced cut along Naguilian Highway near Baguio

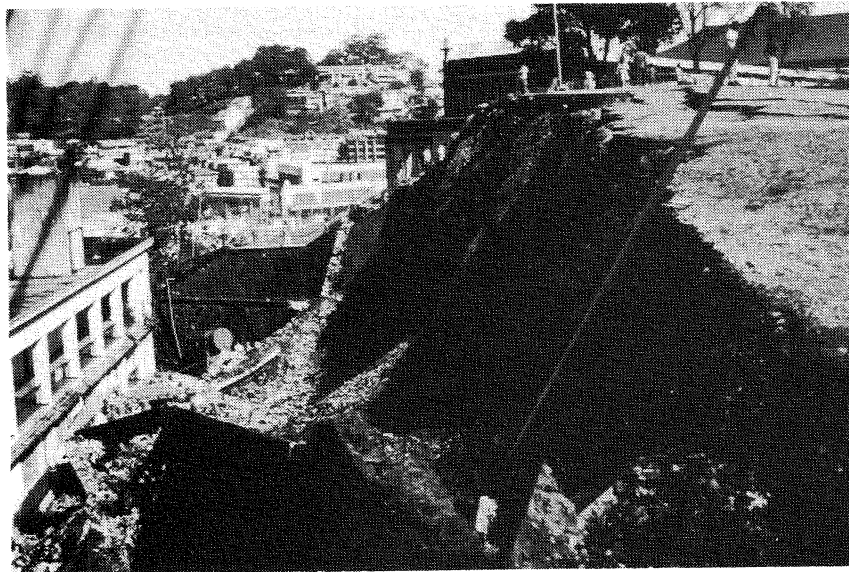
Figure 5.1.22: St Mary's Cathedral, Baguio; approximately 18 m high bank of volcanic pyroclastic material faced with cemented rock and concrete panels

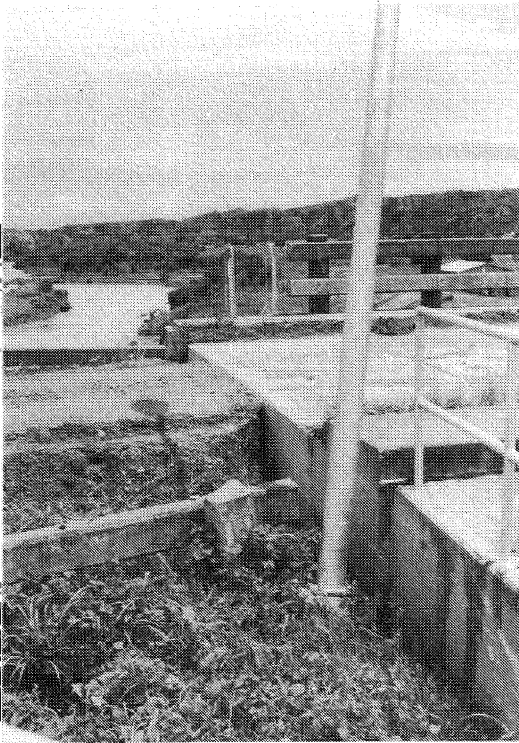
Figure 5.1.24: Masiway Dam; settlement of rockfill dam at spillway interface. Note temporary approach fill

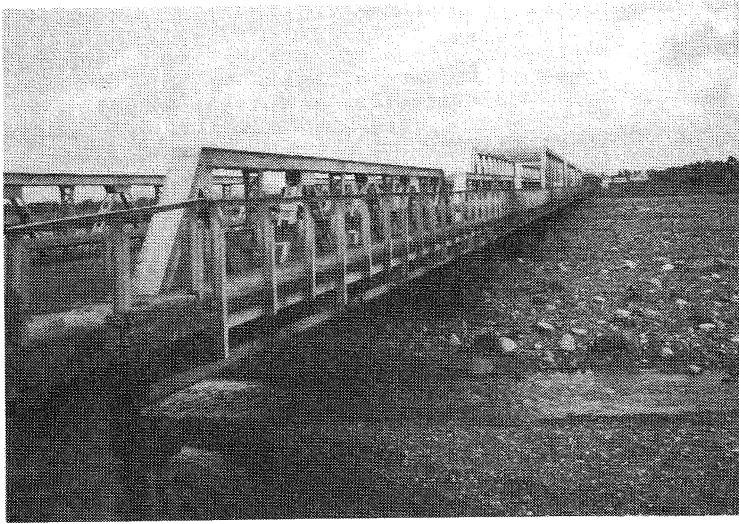
Figure 5.2.3: Rivetted steel Warren truss bridge with concrete deck

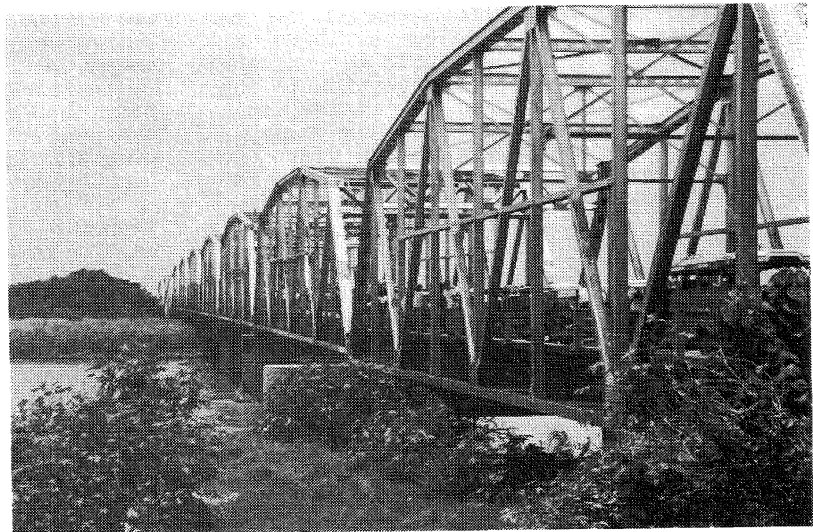
Figure 5.2.4: A standard 50 m span rivetted steel truss bridge with concrete deck - Carmen Bridge

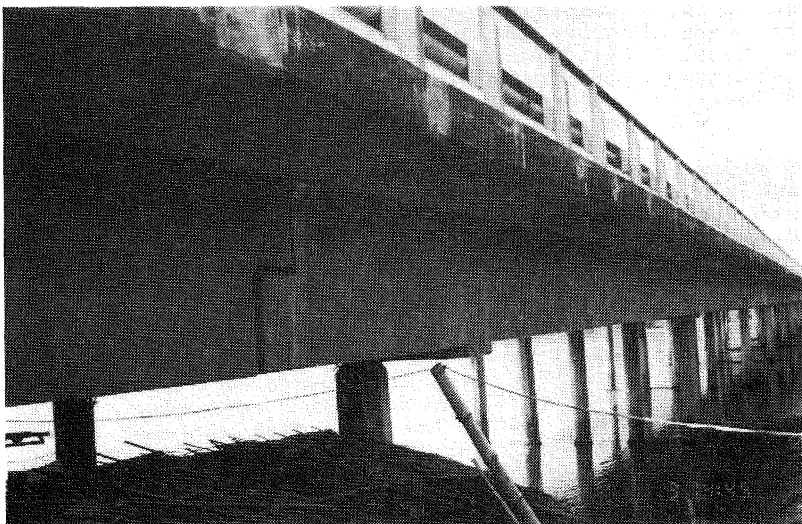
Figure 5.2.5: Reinforced concrete bridge supported on concrete piers and transverse diaphragms

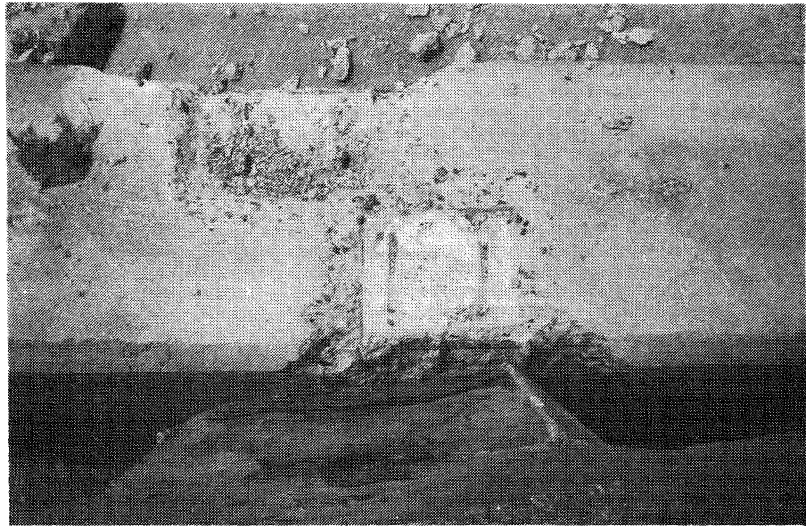
Figure 5.2.6: Rizal Canal Bridge; cast-in steel bearing plate to support reinforced concrete bridge beams, view down onto pier cap. The bearing plate has two longitudinal ribs, 25mm high, formed on the lower and upper surfaces to provide a key into the pier and beam to resist transverse loading

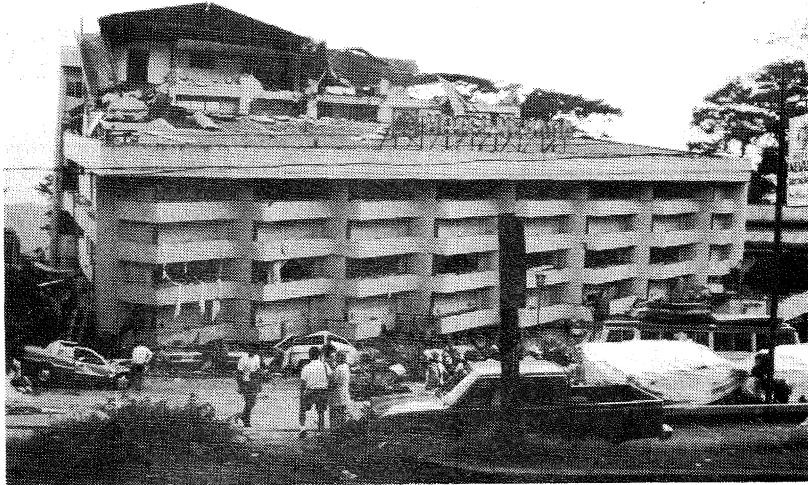
The Nevada Hotel (Figure 5.3.1) collapsed spectacularly, pitching forward into the entrance roadway. It appears that the demand for open space at entry level created a soft storey and a particular lack of stiffness at the front. Detailing of reinforced columns and walls was incapable of sustaining imposed displacements and brittle failure of the front walls/columns occurred. A further possible contribution to this collapse was failure of the retained ground on one side. The six metre high retaining wall formed the foundation for the hotel side wall. Sideways movement of this would have added to the lateral displacements on the first floor columns.

Figure 5.3.1: Effects of soft storey at Hotel Nevada, Baguio

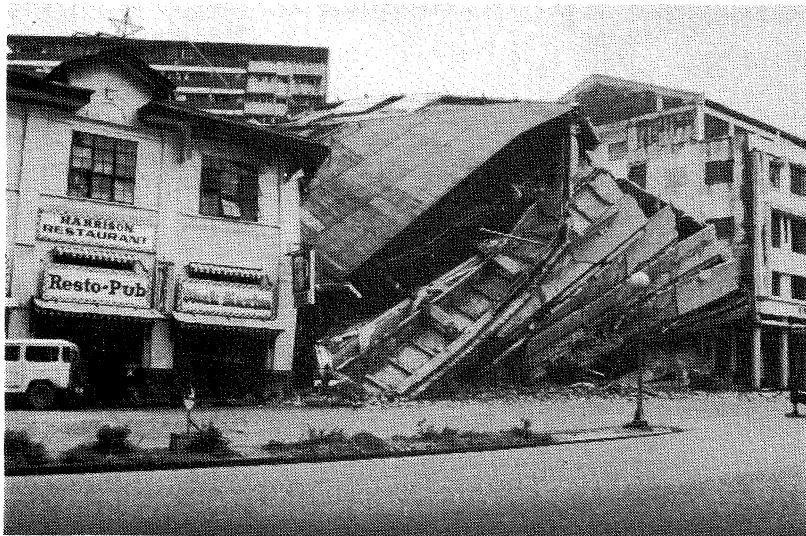
The Baguio Park Hotel (Figure 5.3.4), a modern reinforced concrete structure of nine storeys, faced on to Burnham Park, the central feature of Baguio City which includes a large boating lake. The ground floor entry and rooms facing the park were made as open as possible and this, coupled with inadequate reinforcing details appears to have contributed to its total collapse.

Figure 5.3.4: Demise of the Baguio Park Hotel, damaging its neighbour

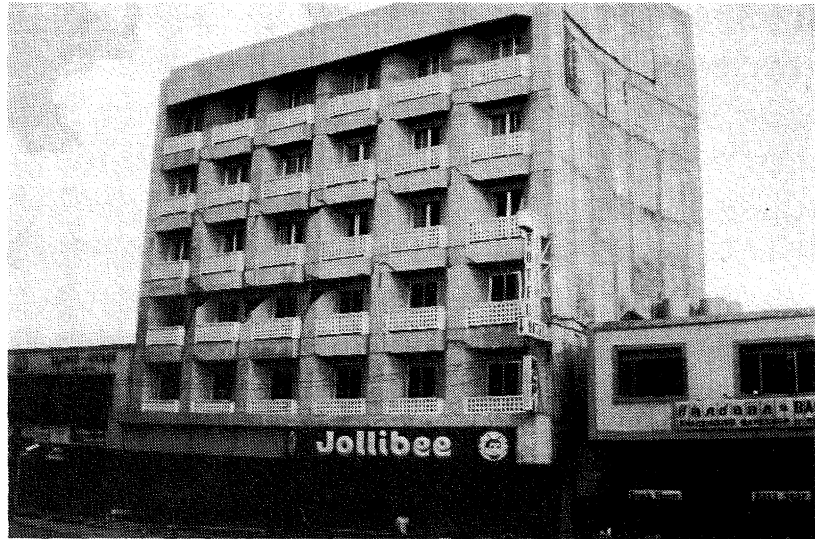
Figure 5.3.5: Apparent survivor - Prime Hotel, Baguio

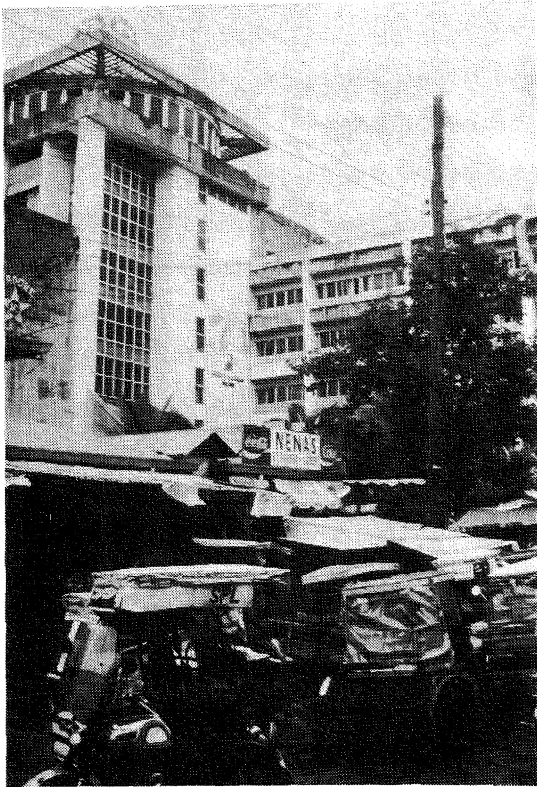
Figure 5.3.6: Deprived of sewer and water, the International Palace Hotel, Dagupan, could not operate. It was understood the building is supported on deep piles

Another hotel, the International Palace (Figure 5.3.6), the largest in Dagupan, was out of service due to lack of water and power, but was undamaged, indicating that ground shaking in Dagupan was not extreme.

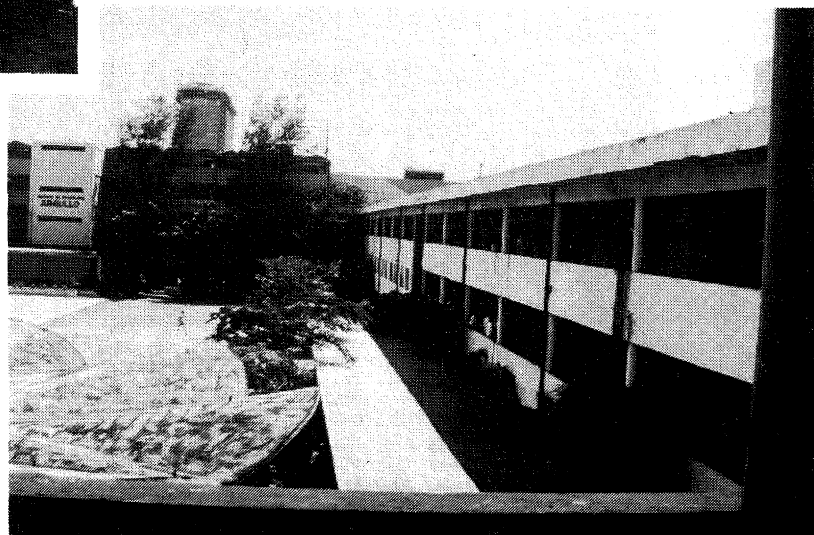
Figure 5.3.7: Damage to 117 schools in Manila caused widespread concern about their safety for continued occupation; most suffered minor damage only. The Araullo High School was partly closed off due to damage to block shear walls

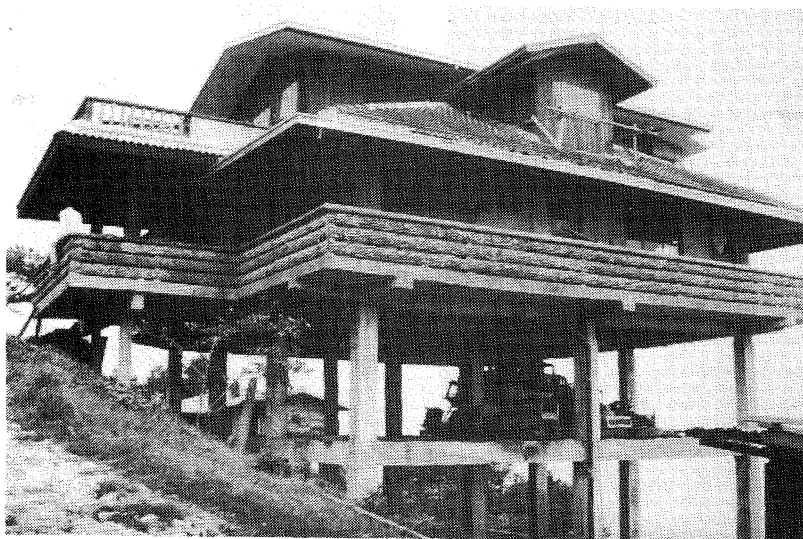
Two surviving houses in Baguio were notable for the height and eccentricity of their foundations. Three levels of reinforced concrete framing supported one side while the other was at ground level (Figure 5.3.11). In Agoo an owner was strengthening the lower storey of his house, while across the road a new house was being constructed with plywood walls, a wise alternative to block infill.

Figure 5.3.11: Notable survivor; a reinforced concrete house in Baguio. Even the balustrade is concrete, not timber

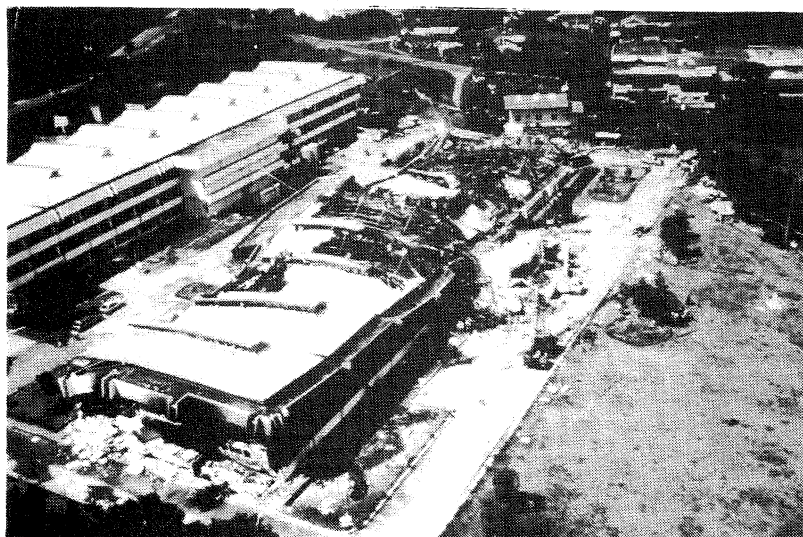
Figure 5.3.12: Soft soil effects? Two identical buildings after the earthquake in the Baguio Export Production Zone. The surviving one is on 'cut', the other on fill (Ian Gill, ADB)

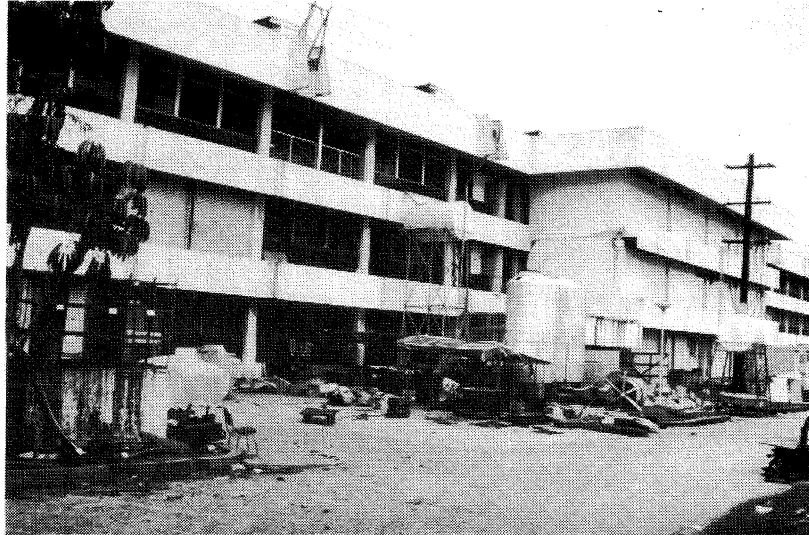
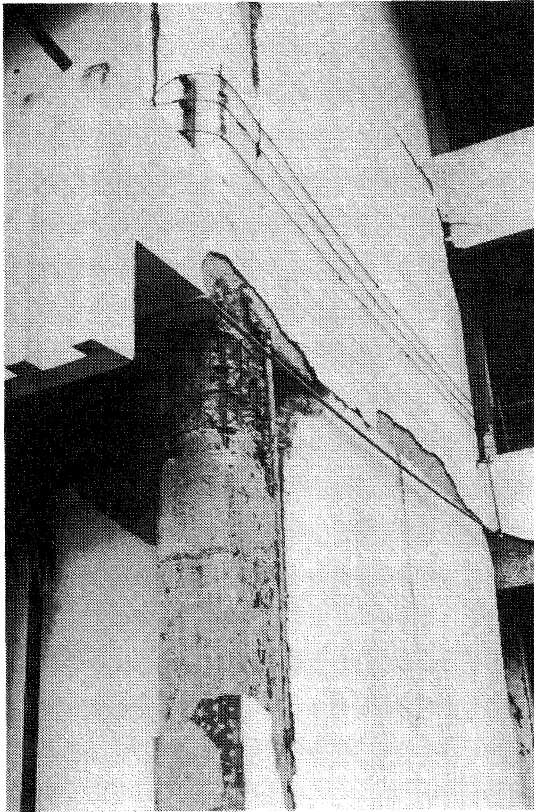
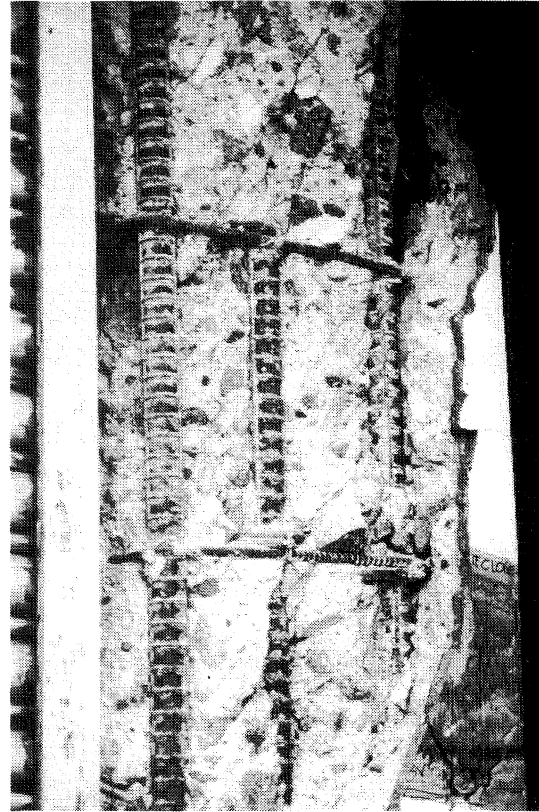
Figure 5.3.13: The survivor in the Baguio Export Production Zone was not unscathed. Damage to critical elements indicated this building was not far from collapsing like its neighbour

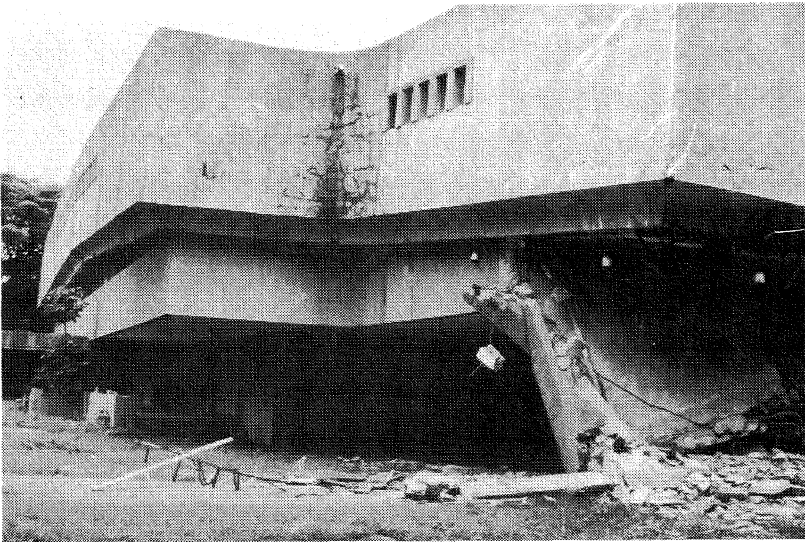
Figure 5.3.14: All but one student survived the collapse of the Library Building at the Central Luzon State University

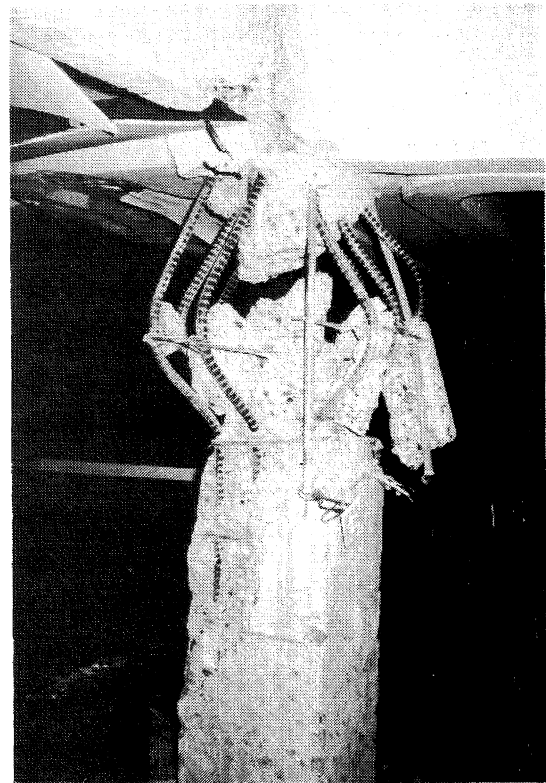
Figure 5.3.16: Interior of Central Luzon State University Library showing tapering collapse of the window mullions

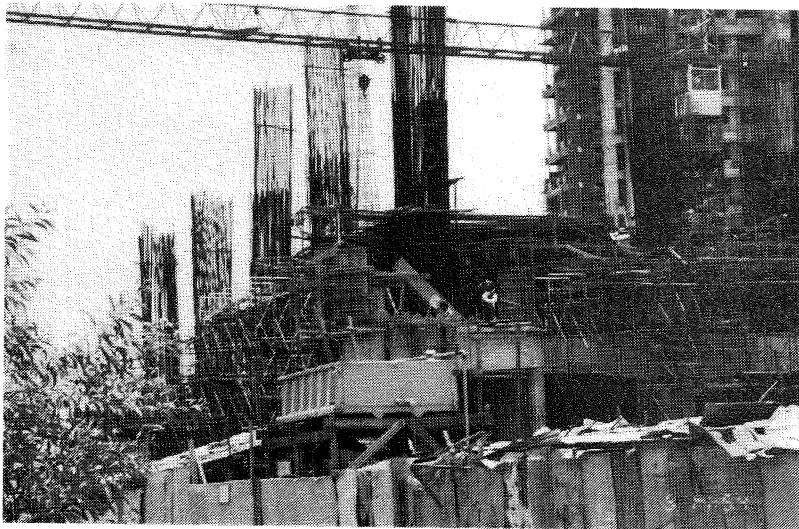
Figure 5.3.22: Multi-storey, cast insitu concrete frame, Manila. Note well confined beam-column joint region

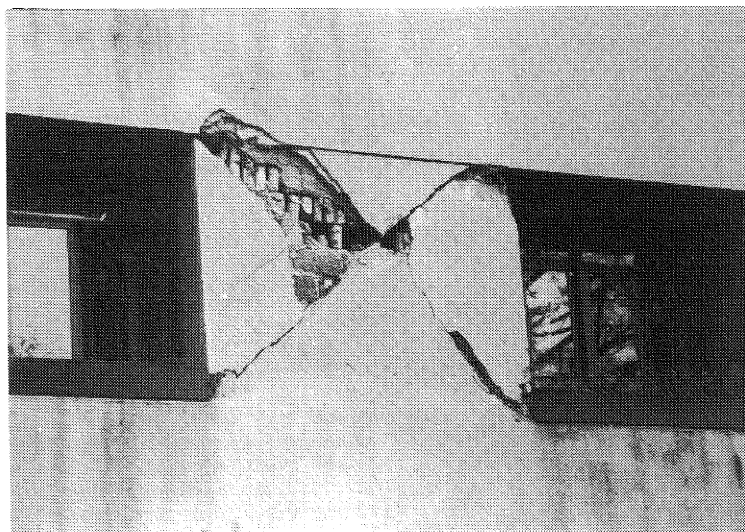
Figure 5.3.27: Hyatt Terraces Hotel, Baguio; infill masonry wall?

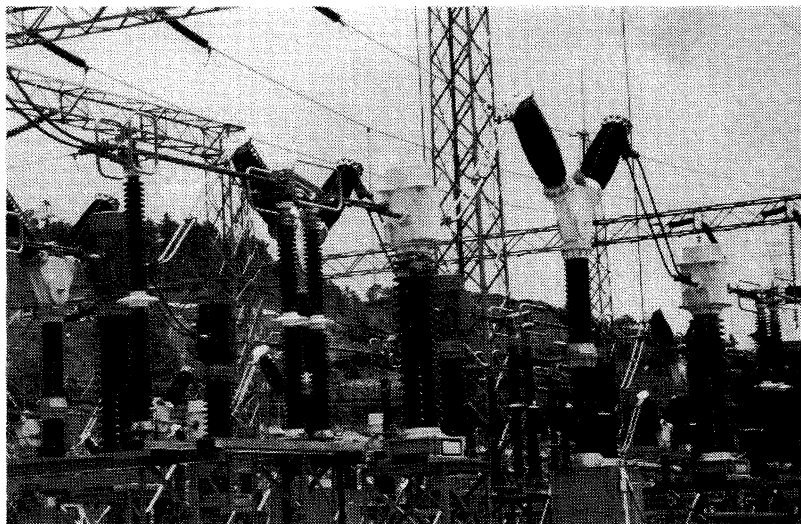
In the areas seen by the team, the NPC power distribution system incorporated up-to-date equipment and appeared to be well maintained. Refer Figure 5.4.1.

Figure 5.4.1: La Trinidad substation, Baguio, designed and built to international standards

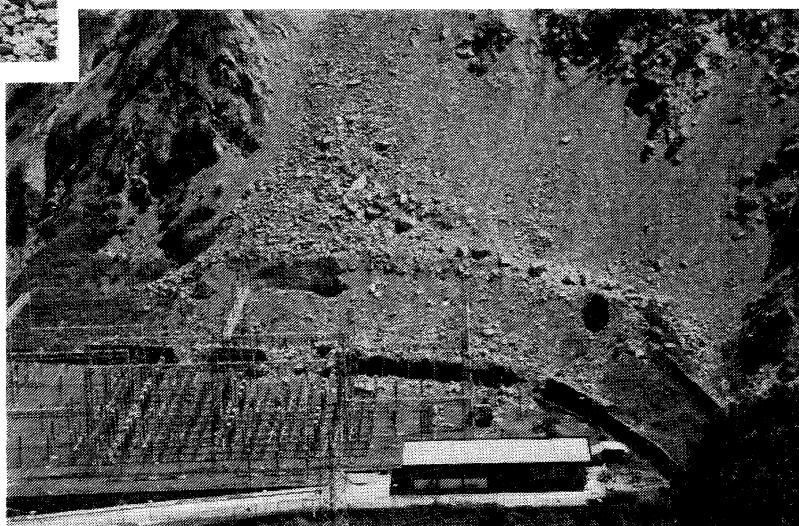
To the east of Baguio, the substation at Ambuklao Dam was damaged to a minor extent by rock from a rockslide entering the switchyard area. Refer Figure 5.4.3. The massive slide started high up the steep valley side with scree building up behind and overtopping two reinforced concrete scree barriers. One rock that entered the yard was at least a two metre cube. This damage did not have a direct effect on the power station shutdown. The station shutdown was caused by lake silts entering the low level intake to the penstocks, hence blocking the draft tube.

Figure 5.4.3: This large rockslide was stopped just short of the switchyard at the Ambuklao Hydroelectric Scheme by two rock barriers

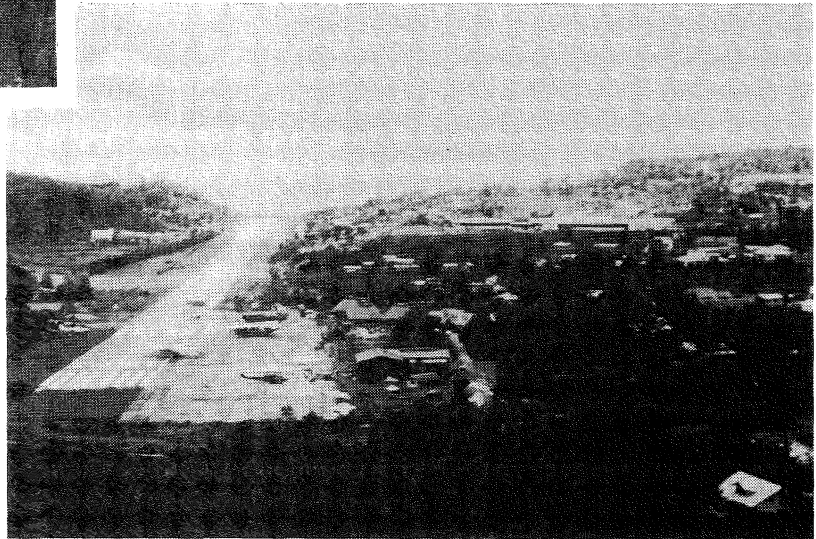
Figure 5.4.6: San Fernando Port. Damaged pier is third one along (Ian Gill, ADB)

The pier at the port of San Fernando (Figure 5.4.6) needs to be replaced and its failure in the earthquake will disrupt shipping to some extent. Light loading can probably be tolerated until its planned replacement is completed.

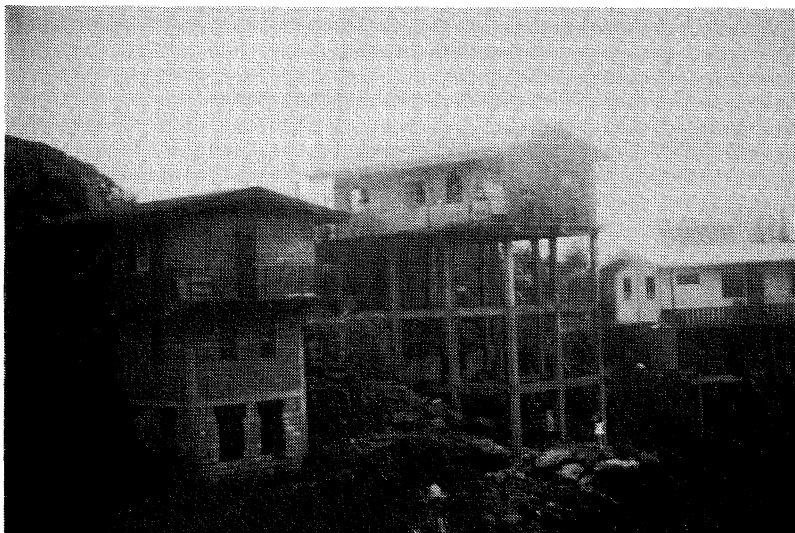
It is not common practice to require assessments of land stability for steep sites. Even on steep sites in Baguio most houses are supported on .6 x .6m reinforced concrete pads. Many houses consist of substantial reinforced concrete frames with lower storeys undeveloped as shown in Figure 7.1.1. Nonetheless residential structures performed very well in the earthquake.

Figure 7.1.1: Baguio City; reinforced concrete frame support to house at road level

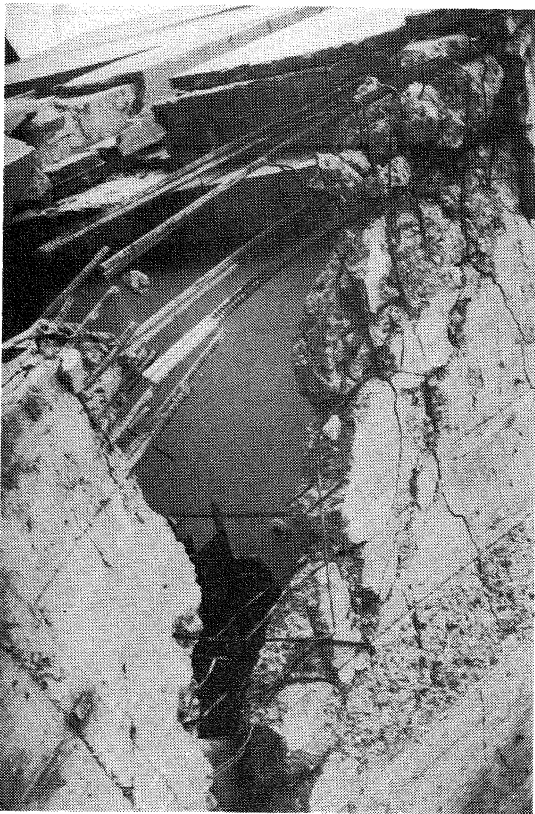
Figure C1.5: Tower block, Hyatt Terraces Hotel, Baguio; note light, widely spaced, ties and longitudinal bars spliced at one point

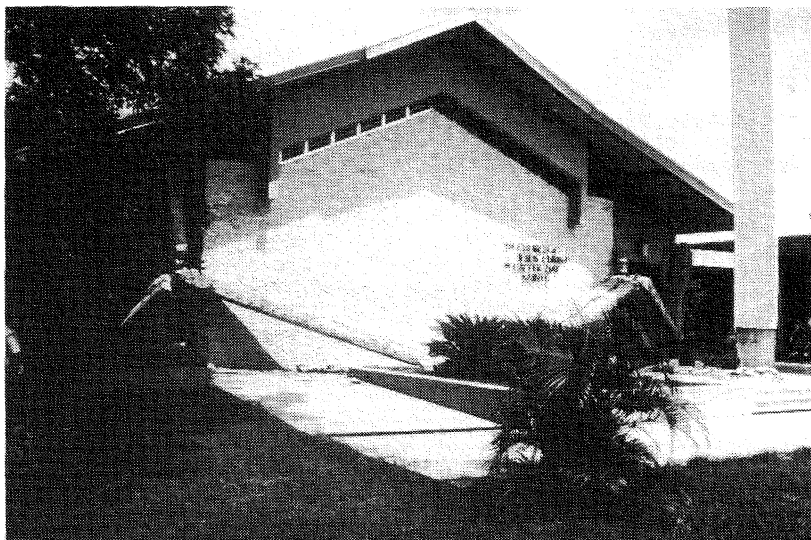
Figure C3.3: Church at Munoz; collapse of reinforced concrete barge board

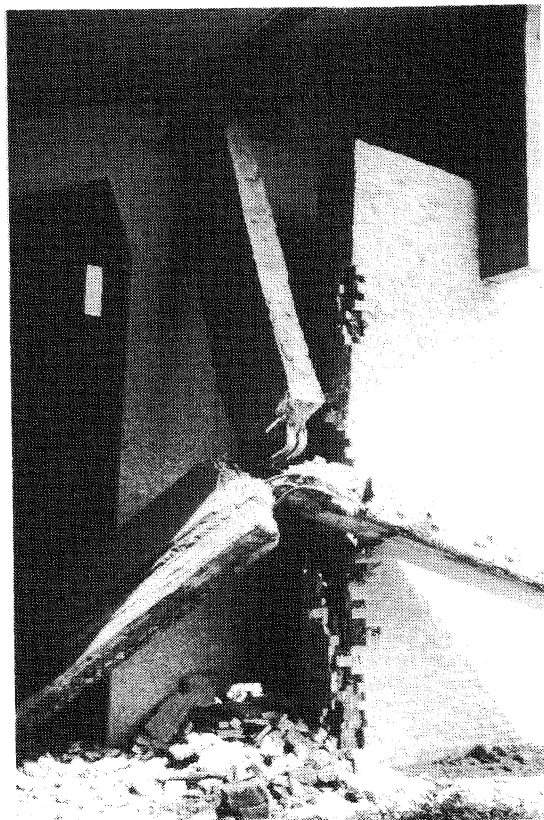
Figure C3.4: Church at Munoz; collapse of reinforced concrete barge board with its supporting cantilever beams

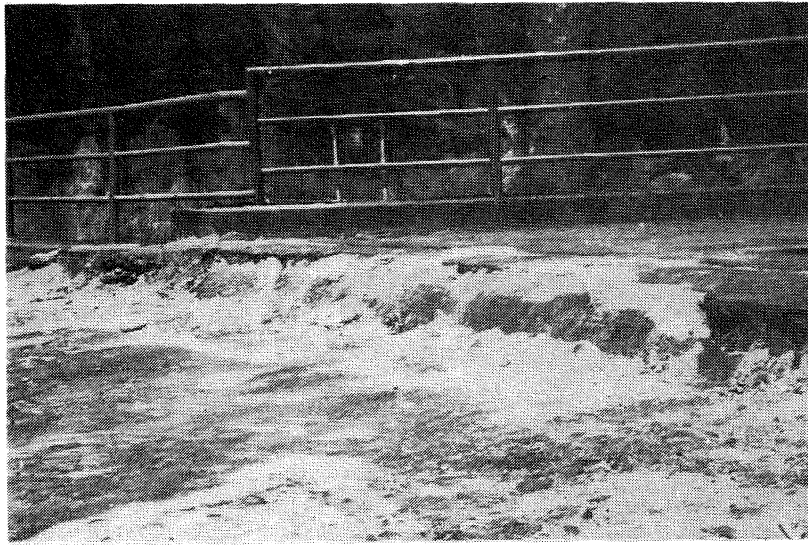
1. Settlement occurred along the dam crest. At the interface with the concrete spillway, settlements of about .4m were noticeable (Figure C4.3). Settlement of about .75m occurred on the upstream side of the crest, although it was partially associated with slumping of the upstream shoulder. A transverse crack developed at the interface of fill on the right abutment.
2. Shallow slumping of the upstream shoulder which resulted in intermittent longitudinal cracks along most of the crest (which had been infilled by the time of our visit), and on the upstream shoulder.
3. Tilting and separation along construction joints in the spillway wing wall (Figure C4.4). This movement

is believed to be caused by slumping in the upstream shoulder of the dam.

Figure C4.3: Ambuklao Hydroelectric Plant - settlement of rockfill embankment adjacent to spillway

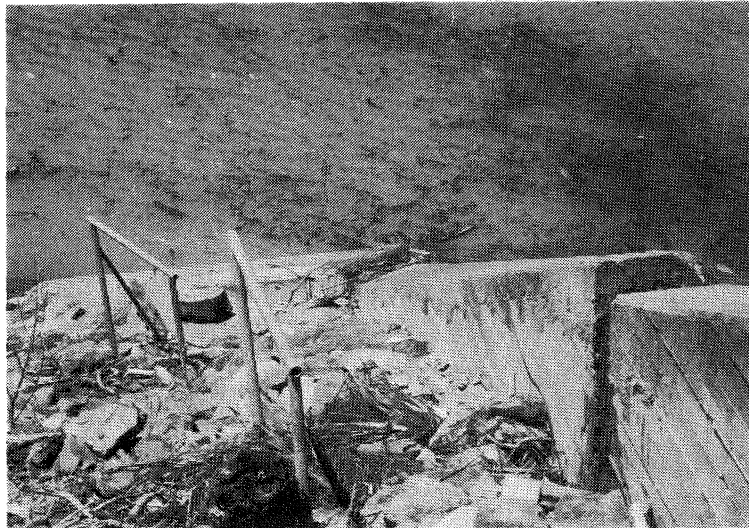
Figure C4.4: Ambuklao Hydroelectric Plant - tilting and separation of spillway wing wall segments due to settlement of rockfill dam
