Report on Field Visit

On July 16 1990, an earthquake of magnitude 7.8 caused widespread damage, disruption and loss of life in Central Luzon, north of Manila.

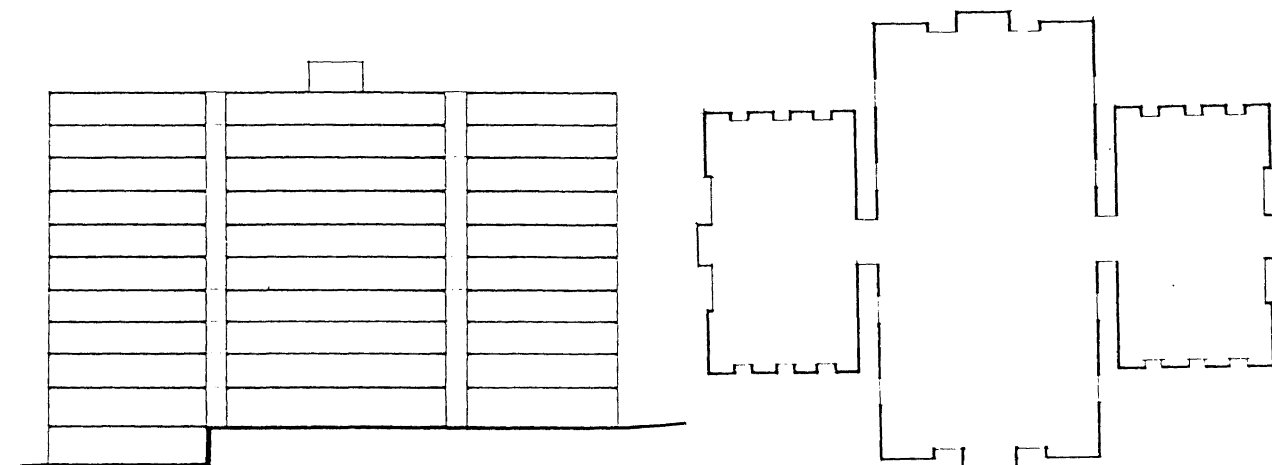
Figure C5.1: Montepinos Apartments, Baguio

Foundation conditions are unknown and may have played a part in causing damage. However, there is little doubt that failure of the block infill brought about the most serious structural damage.

Had the walls been of even reasonable reinforced concrete, this building would have survived without significant damage. This building highlights more than any other the need to consider block infill as structure and design accordingly. Such action in the first place would not have added greatly to the cost, but would have greatly increased its earthquake resistance. On the other hand, the fate of this building could have been very different if the earthquake shaking had been more intense and/or lasted longer.

Apart from the tilted section, reinstatement would be straightforward but costly. Strengthening of selected walls may be necessary. For the tilted block, reinstatement will depend on the condition of the remainder, and whether it could withstand any efforts to restore it to vertical.

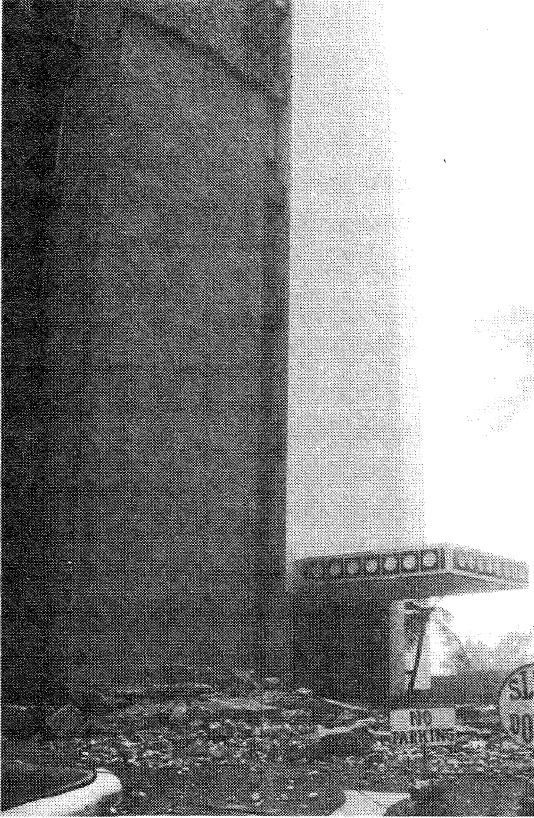
- Extensive loss of veneer from wall at entry. Refer Figure C5.2.
- Windows broken due to structural movement. Refer Figure C5.3.
- Cracked block wall panels. Refer Figure C5.4.
- Failure of one block due to block infill falling out with consequent rupture of columns, causing significant tilt.

Figure C5.2: Montepinos Apartments, Baguio; occupants did not run outside this building during the earthquake - they could see the large blocks of masonry falling from this feature wall

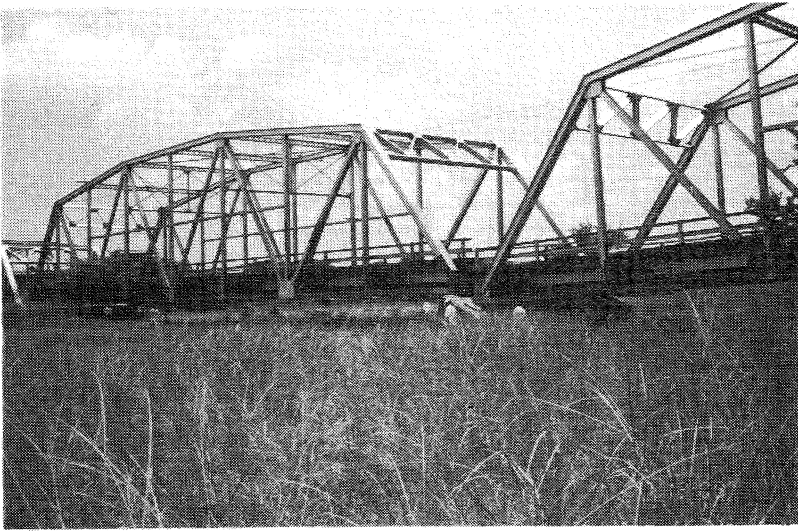
The trusses supported by the strengthened northern pier had come off their pin and rocker bearings, but were still supported by the broad pier cap. At the southern end, two trusses had slid off their supporting abutment and pier to rest on the floodplain. The sixth truss from the southern end had come off its southern rocker bearing allowing that end to rest on the floodplain. Considerable damage had occurred to the truss steel work, particularly where the truss had slid forward over the pier so that the pier had broken up through the bottom chord and deck.

Figure C6.2: Carmen Bridge; truss span no. 11 viewed towards the southwest

New piers could be built in line with, and downstream of the existing piers. These piers could consist of piles with sufficient depth to bear below any liquefiable soil layer. The ten mainly undamaged spans could be pushed across, one at a time, on to the new piers. Three new spans could be built to replace those destroyed. The whole structure could then be linked to resist future earthquake action while still allowing thermal movement.

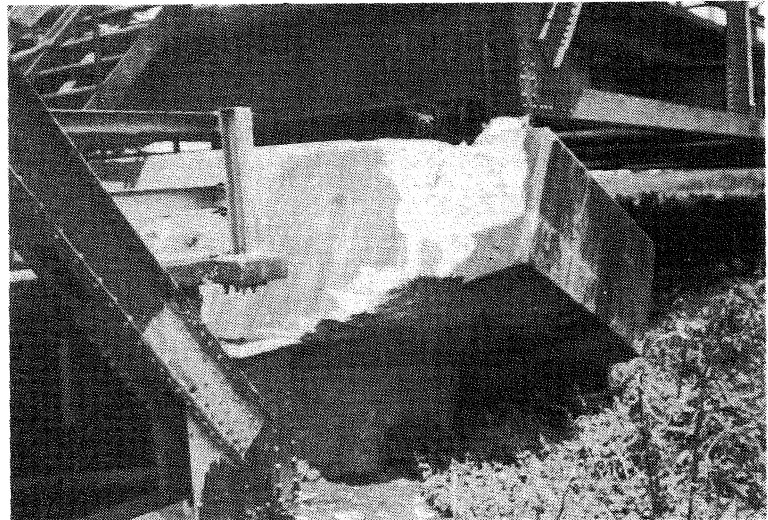
It would appear that liquefaction had a major part to play in this bridge collapse. Lateral spreading may have had some effect, but this was not obvious because the flood plain is relatively flat. Failure may have been initiated by out of phase oscillations of liquefied blocks of soil and the bridge structure, which led to inadequately anchored spans dropping off the southern piers and abutment. The large rotations of bridge piers may have been due to failed connections of pier to piles or shallow pile depth.

Figure C6.3: Carmen Bridge; liquefaction at pier between spans 11 and 12 viewed towards the northwest

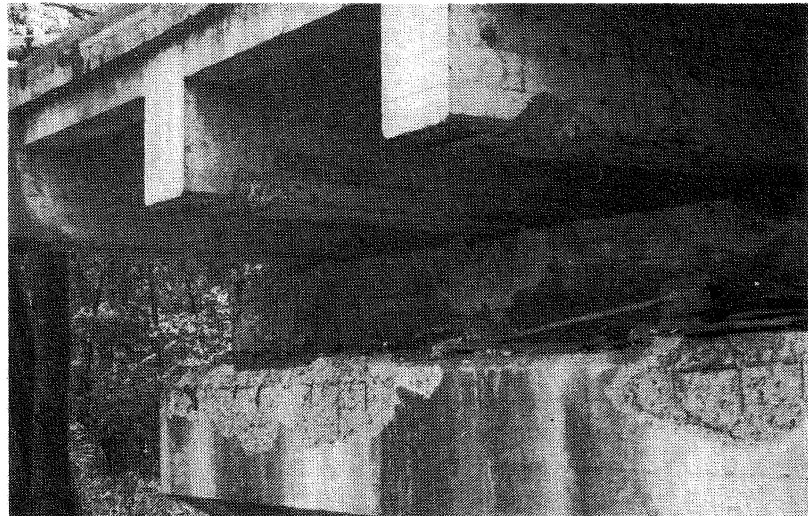
Liquefaction is considered to be the primary cause of bridge failure. Two of the three pier/pile structures in the river channel lost support so that settlement and rotation took place into the liquefied material. The third pier in the river channel (between the other two) rotated but did not settle. Lateral spread of the riverbank carried the western abutment towards the river channel without significant settlement. This lateral movement carried the two adjacent piers with the bridge deck towards the river, with build up of material behind the piers. At the third pier in the edge of the river, lateral movement or rotation was not as great, but the first steel span fell away and the concrete beams slid over the top of the pier. It is not clear whether the steel girder span pulled away from its western end pier support as the river channel piers failed, or the spans were pushed off as lateral spread forced the concrete beam spans forward. Damage to the concrete bridge deck interface at this common pier was not as great as at other span junctions that could be observed.

Figure C7.2: *Dagupan City; common pier to support steel girder and concrete beams*

This bridge will require complete replacement with a structure that is founded below the liquefiable material, but can allow lateral spread of the riverbanks without destroying the bridge.

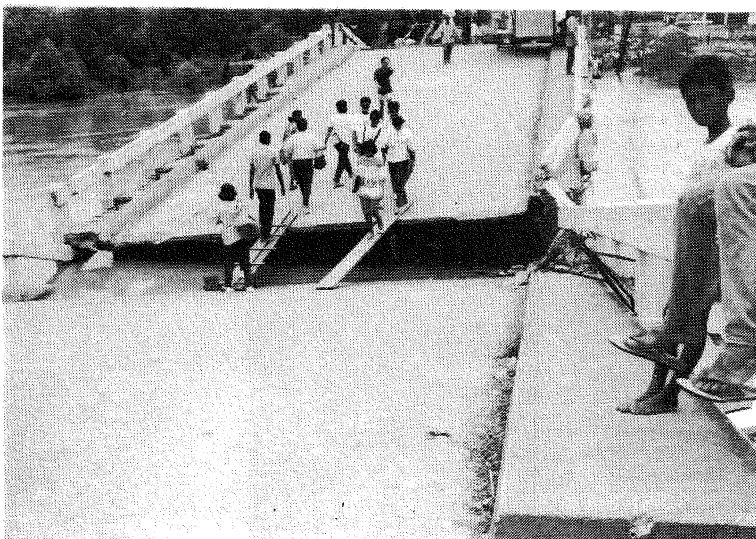
Figure C7.3: *Dagupan City; easternmost pier - rotation towards bank*
