## An Immediate and Preliminary Report on THE MANJIL, IRAN EARTHQUAKE OF 20 JUNE 1990

A. A. Moinfar<sup>1</sup> and A. Naderzadeh<sup>1</sup>

**Editorial Note:** This article is based on a brief English version of a fuller report by the authors originally published as Publication No. 119, July 1990 of the Building and Housing Research Centre.

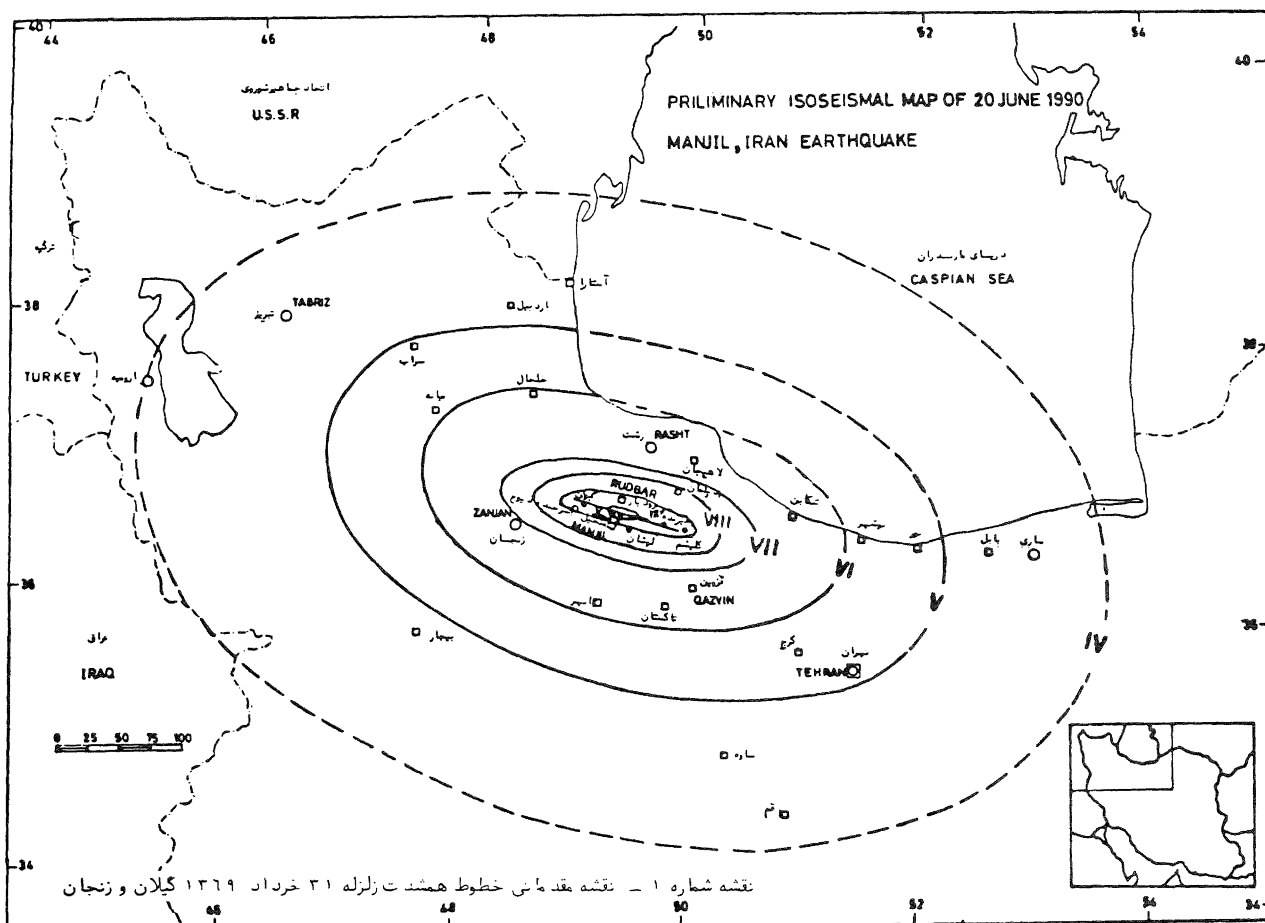
and Harzevil which are in the vicinity of the fault break associated with the earthquake. The maximum intensity in Manjil is estimated to have been X (MSK). The intensity in Rudbar (8 km north of Manjil) was about IX. In general, an area of about 15,000 km<sup>2</sup> was shaken with an intensity greater than IX (MSK). Figure 1 shows the preliminary isoseismal map for the 20 June 1990 earthquake.

FIGURE 1: PRELIMINARY ISOSEISMAL MAP OF THE 20 JUNE 1990 MANJIL, IRAN EARTHQUAKE.

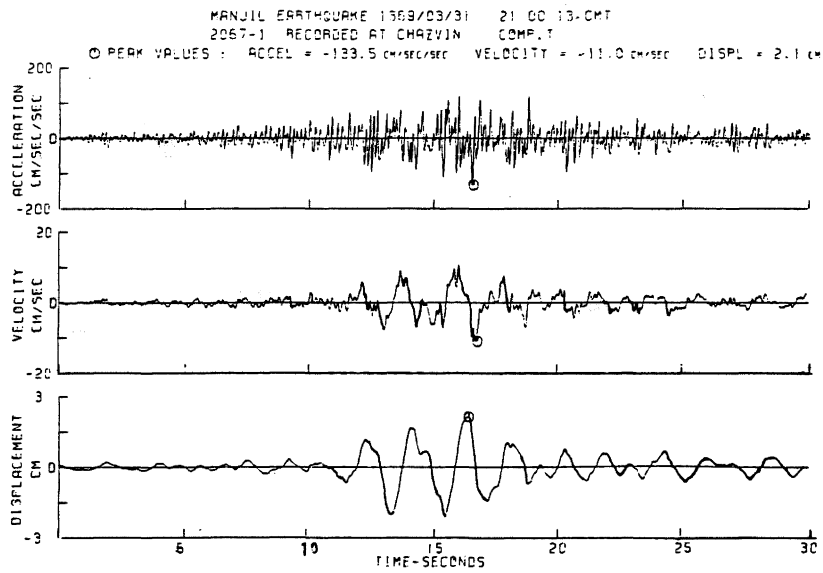
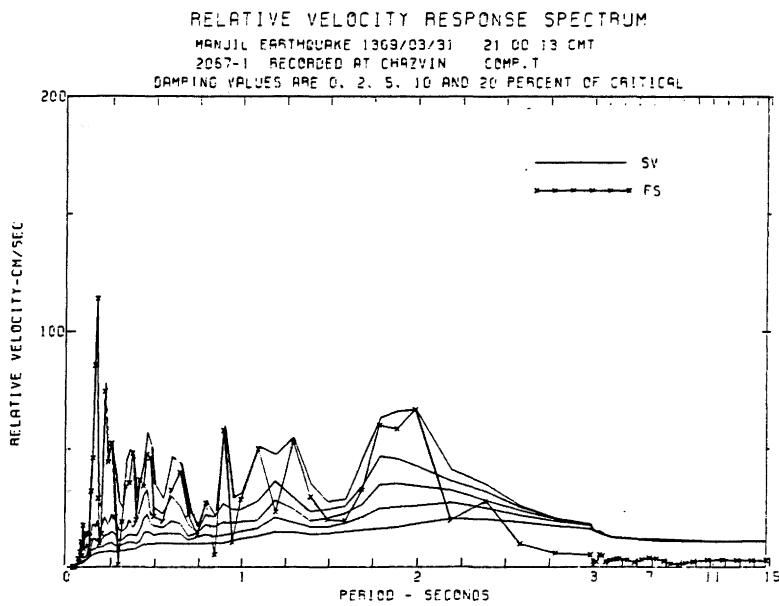
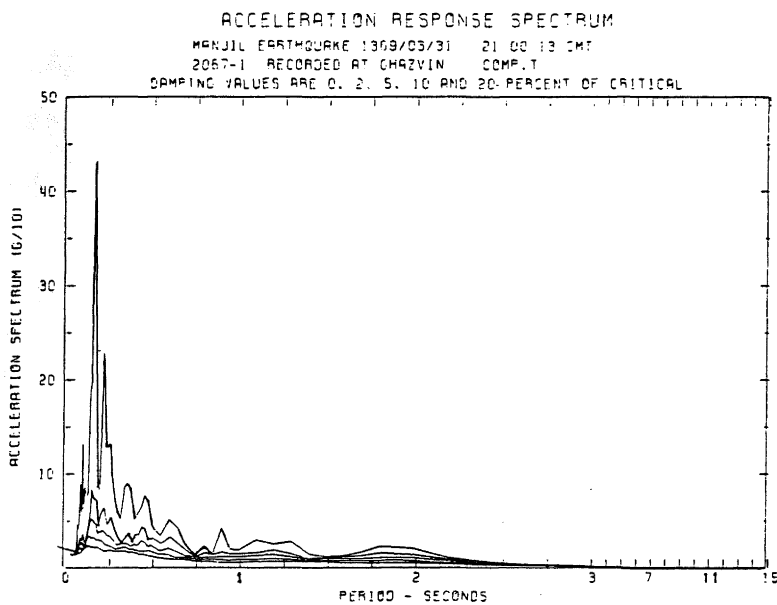
**FIGURE 43: ACCELERATION, VELOCITY AND DISPLACEMENT TRACES (Top), THE RELATIVE VELOCITY RESPONSE SPECTRUM (Middle) AND ACCELERATION RESPONSE SPECTRUM (Bottom) FOR THE TRANSVERSE COMPONENT RECORDED AT CHAZVIN**  
NOTE: SV = spectral velocity; FS = Fourier spectra.

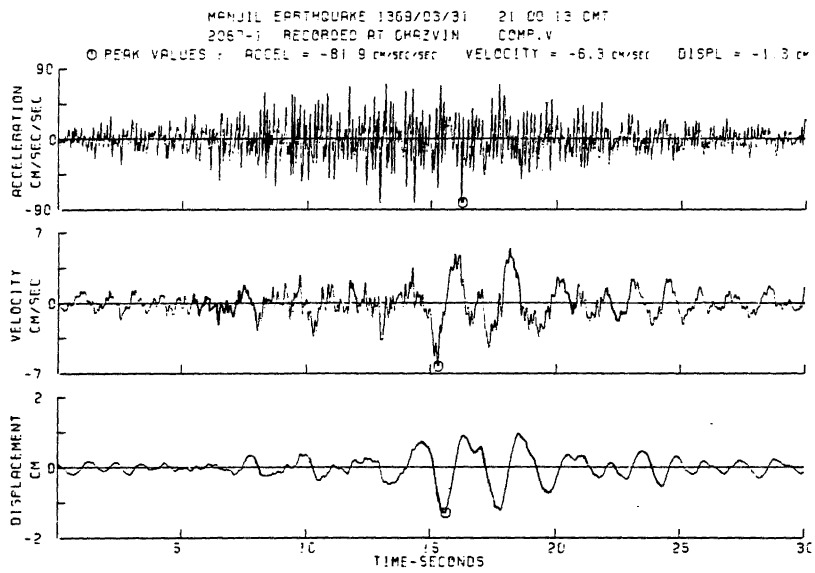
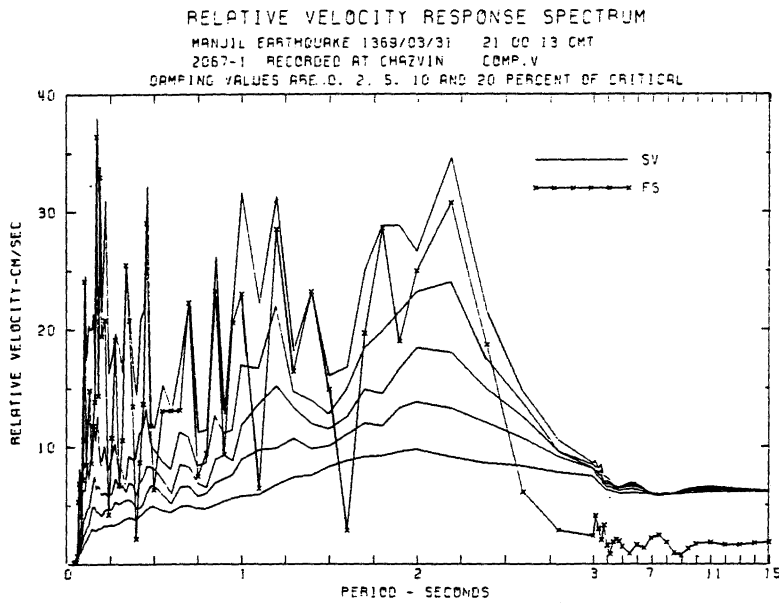
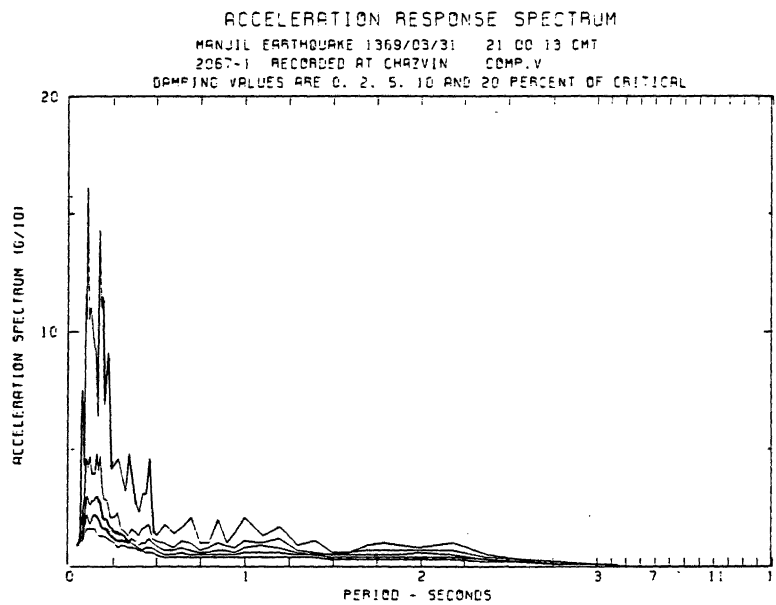
FIGURE 44: ACCELERATION, VELOCITY AND DISPLACEMENT TRACES (Top), THE RELATIVE VELOCITY RESPONSE SPECTRUM (Middle) AND ACCELERATION RESPONSE SPECTRUM (Bottom) FOR THE VERTICAL COMPONENT RECORDED AT GHAZVIN.

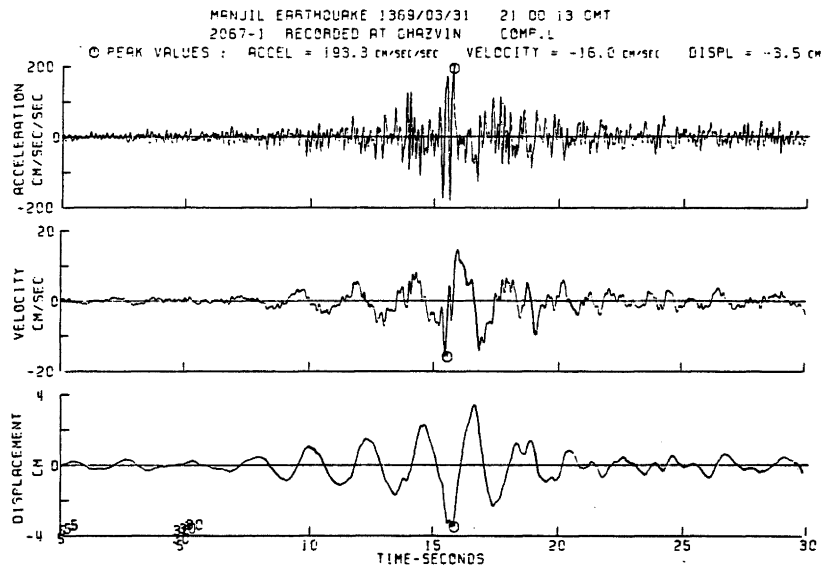
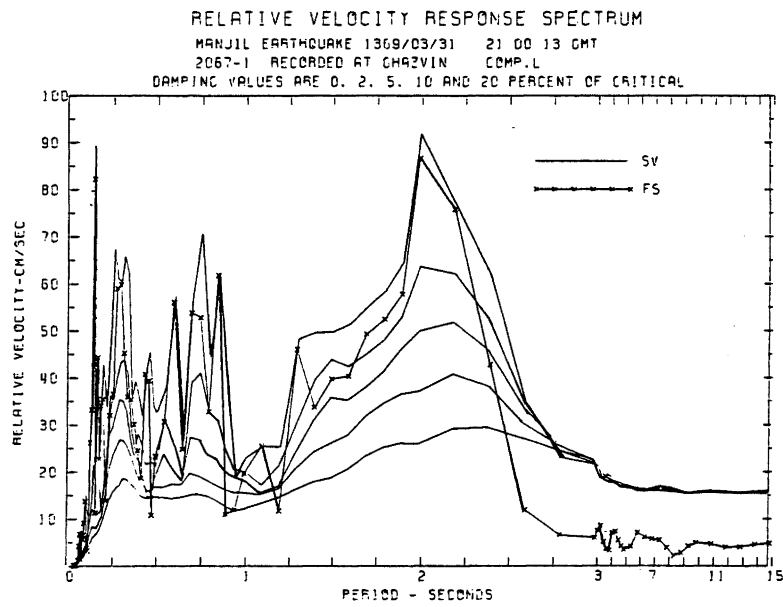
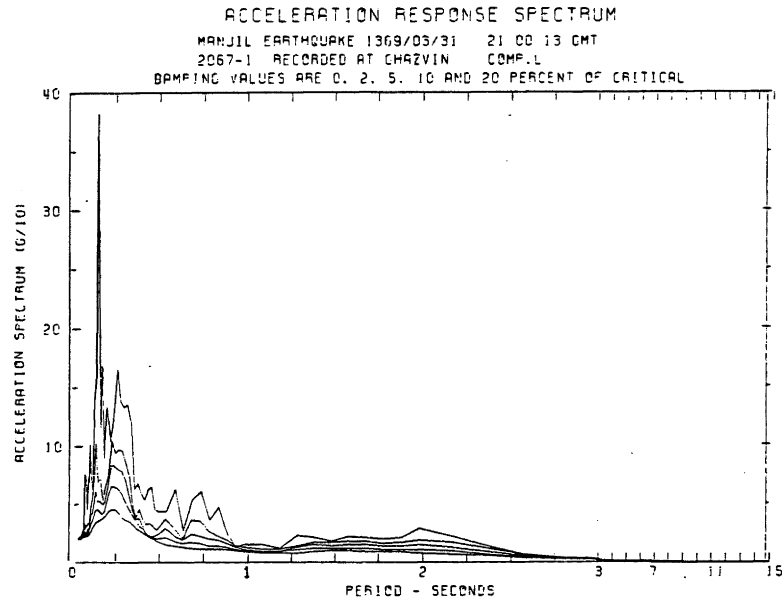
**FIGURE 45: ACCELERATION, VELOCITY AND DISPLACEMENT TRACES (Top), THE RELATIVE VELOCITY RESPONSE SPECTRUM (Middle) AND ACCELERATION RESPONSE SPECTRUM (Bottom) FOR THE LONGITUDINAL COMPONENT RECORDED AT GHAZVIN.**

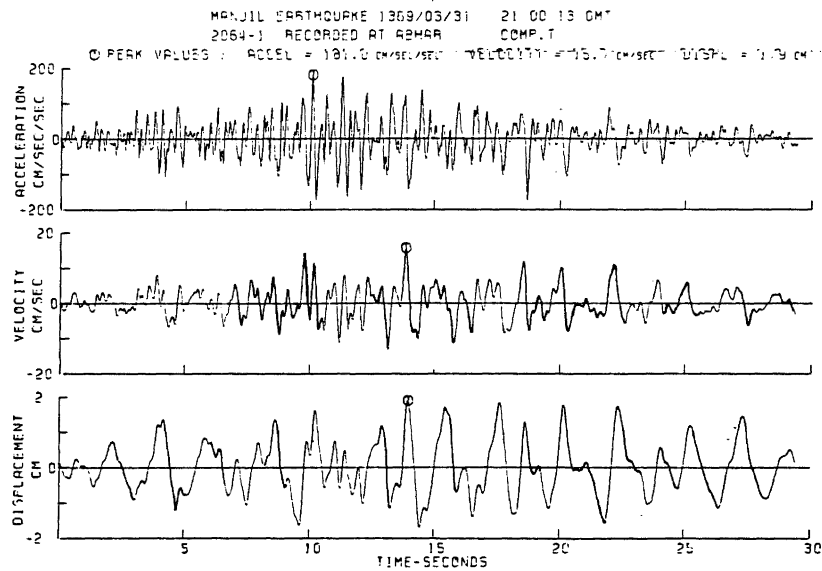
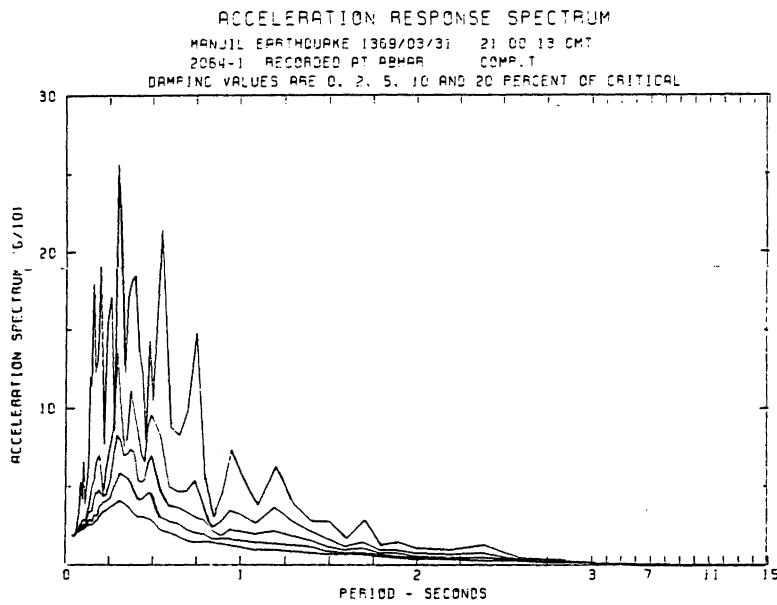
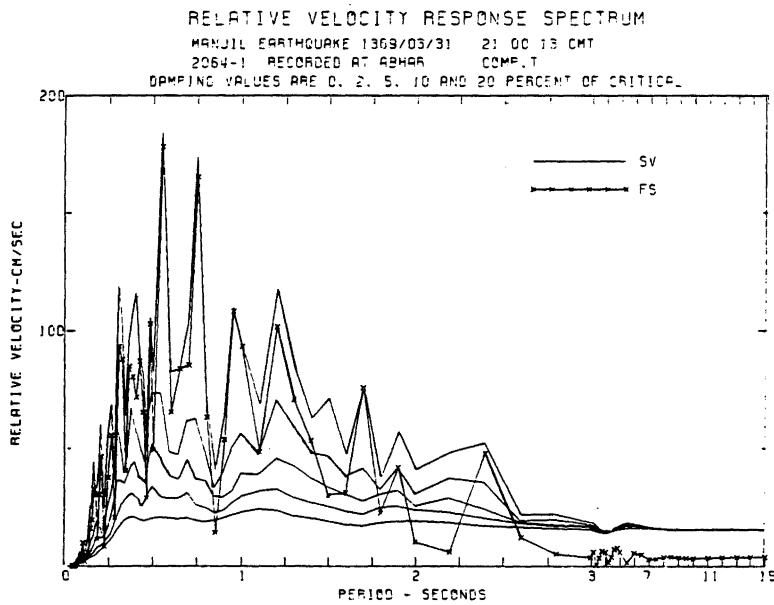
Based on local observations and evaluations of the overturned objects at the epicentral area, it is estimated that the horizontal peak ground acceleration was rather high and over 60% of g. The preliminary evaluation of the accelerograms obtained in Abbar (about 10 km from the end of fault) confirms this estimate. The Abbar accelerogram shows 0.65 g and 0.52 g for both peak horizontal and vertical components, respectively. Several other accelerographs including those in Tehran recorded the 20 June 1990 earthquake and these are now under analysis and evaluation. The peak ground acceleration recorded in Tehran was 2%g. Table 3 summarizes the peak ground accelerations obtained by strong motion accelerographs installed at several different locations.

FIGURE 46: ACCELERATION, VELOCITY AND DISPLACEMENT TRACES (Top), THE RELATIVE VELOCITY RESPONSE SPECTRUM (Middle) AND ACCELERATION RESPONSE SPECTRUM (Bottom) FOR THE TRANSVERSE COMPONENT RECORDED AT ABHAR.

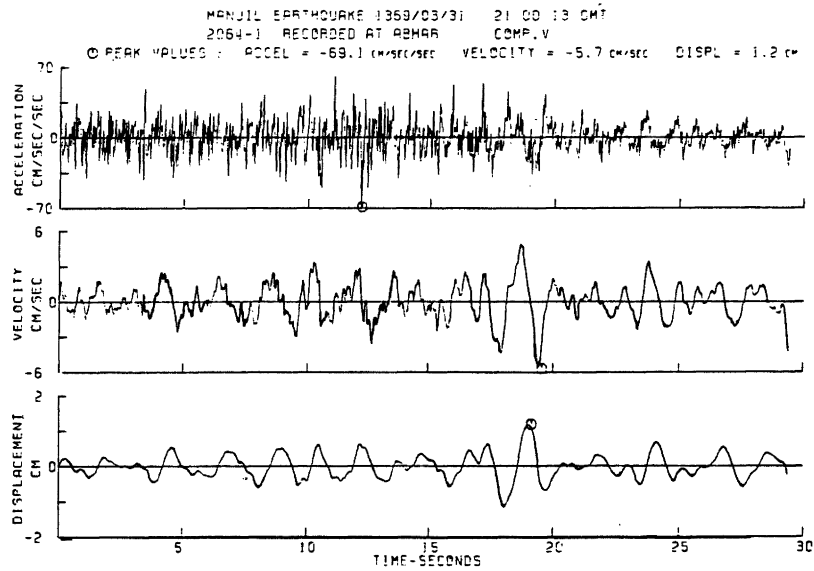
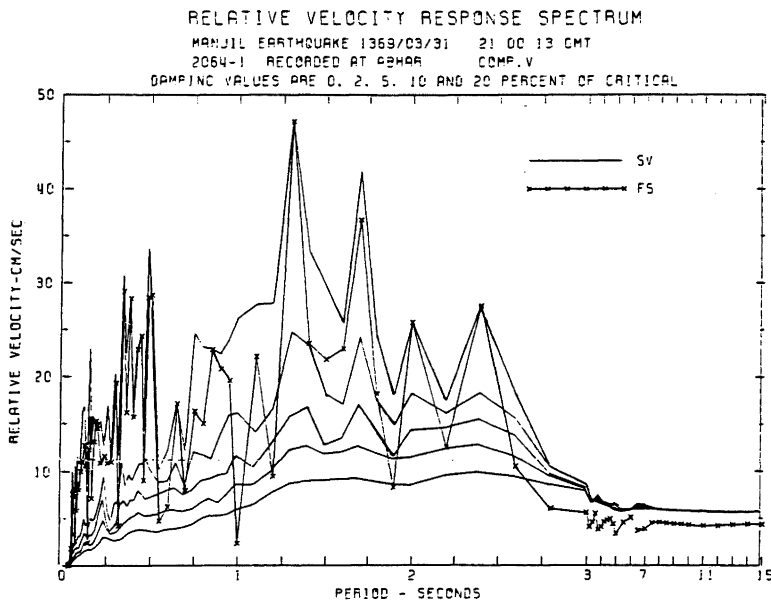
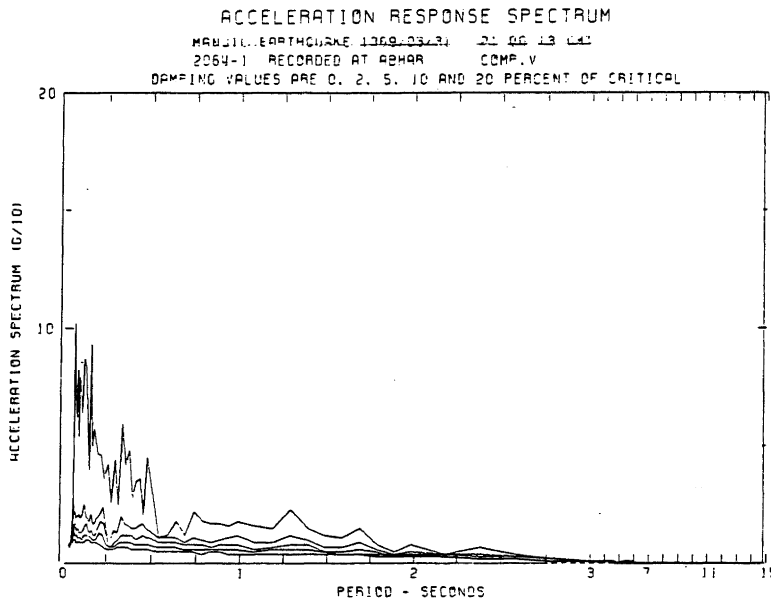
**FIGURE 47: ACCELERATION, VELOCITY AND DISPLACEMENT TRACES (Top), THE RELATIVE VELOCITY RESPONSE SPECTRUM (Middle) AND ACCELERATION RESPONSE SPECTRUM (Bottom) FOR THE VERTICAL COMPONENT RECORDED AT ABHAR.**

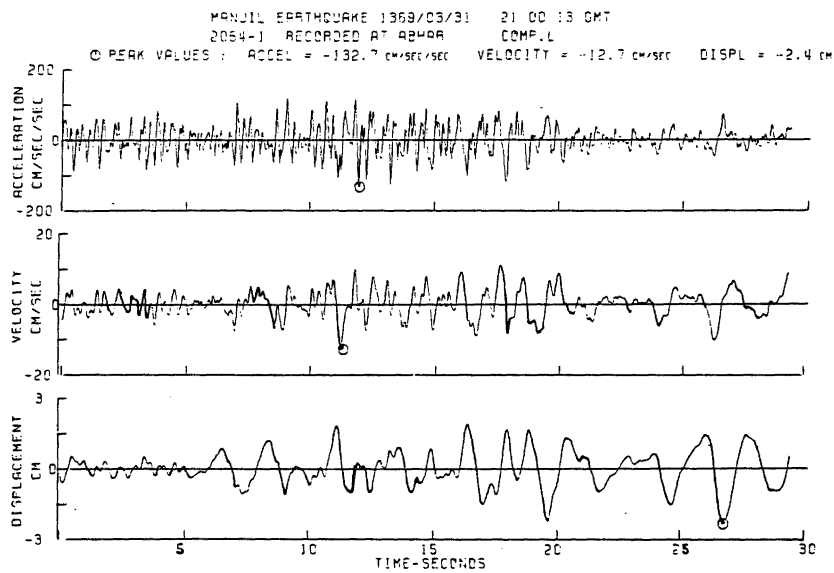
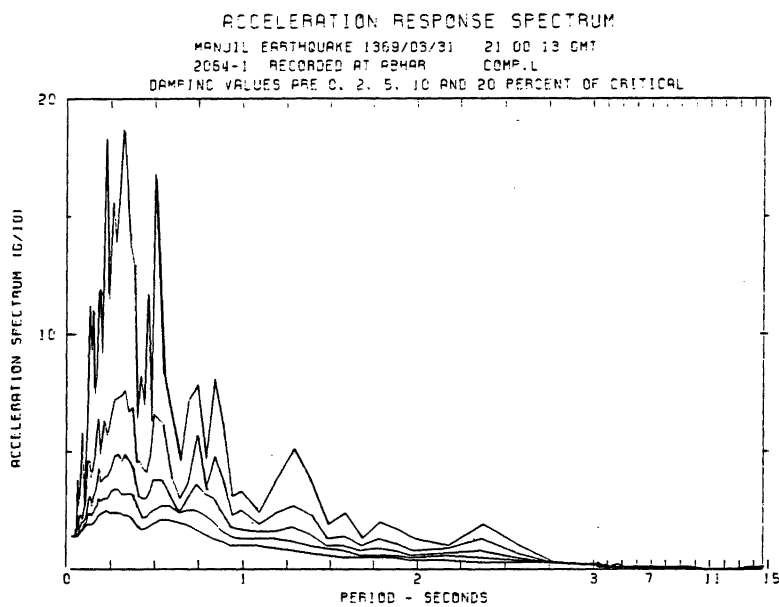
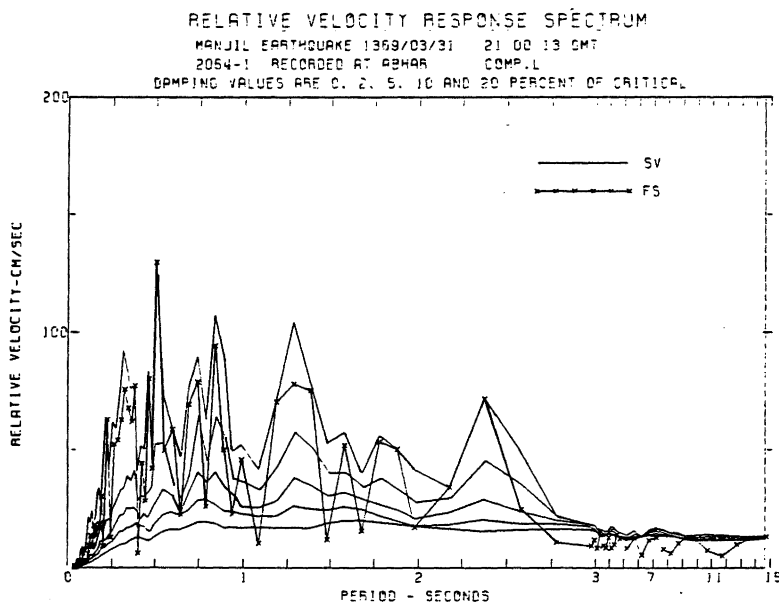
**FIGURE 48: ACCELERATION, VELOCITY AND DISPLACEMENT TRACES (Top), THE RELATIVE VELOCITY RESPONSE SPECTRUM (Middle) AND ACCELERATION RESPONSE SPECTRUM (Bottom) FOR THE LONGITUDINAL COMPONENT RECORDED AT ABHAR.**
