THE LAKE COLERIDGE EARTHQUAKES OF 1946

George Eiby

SUMMARY

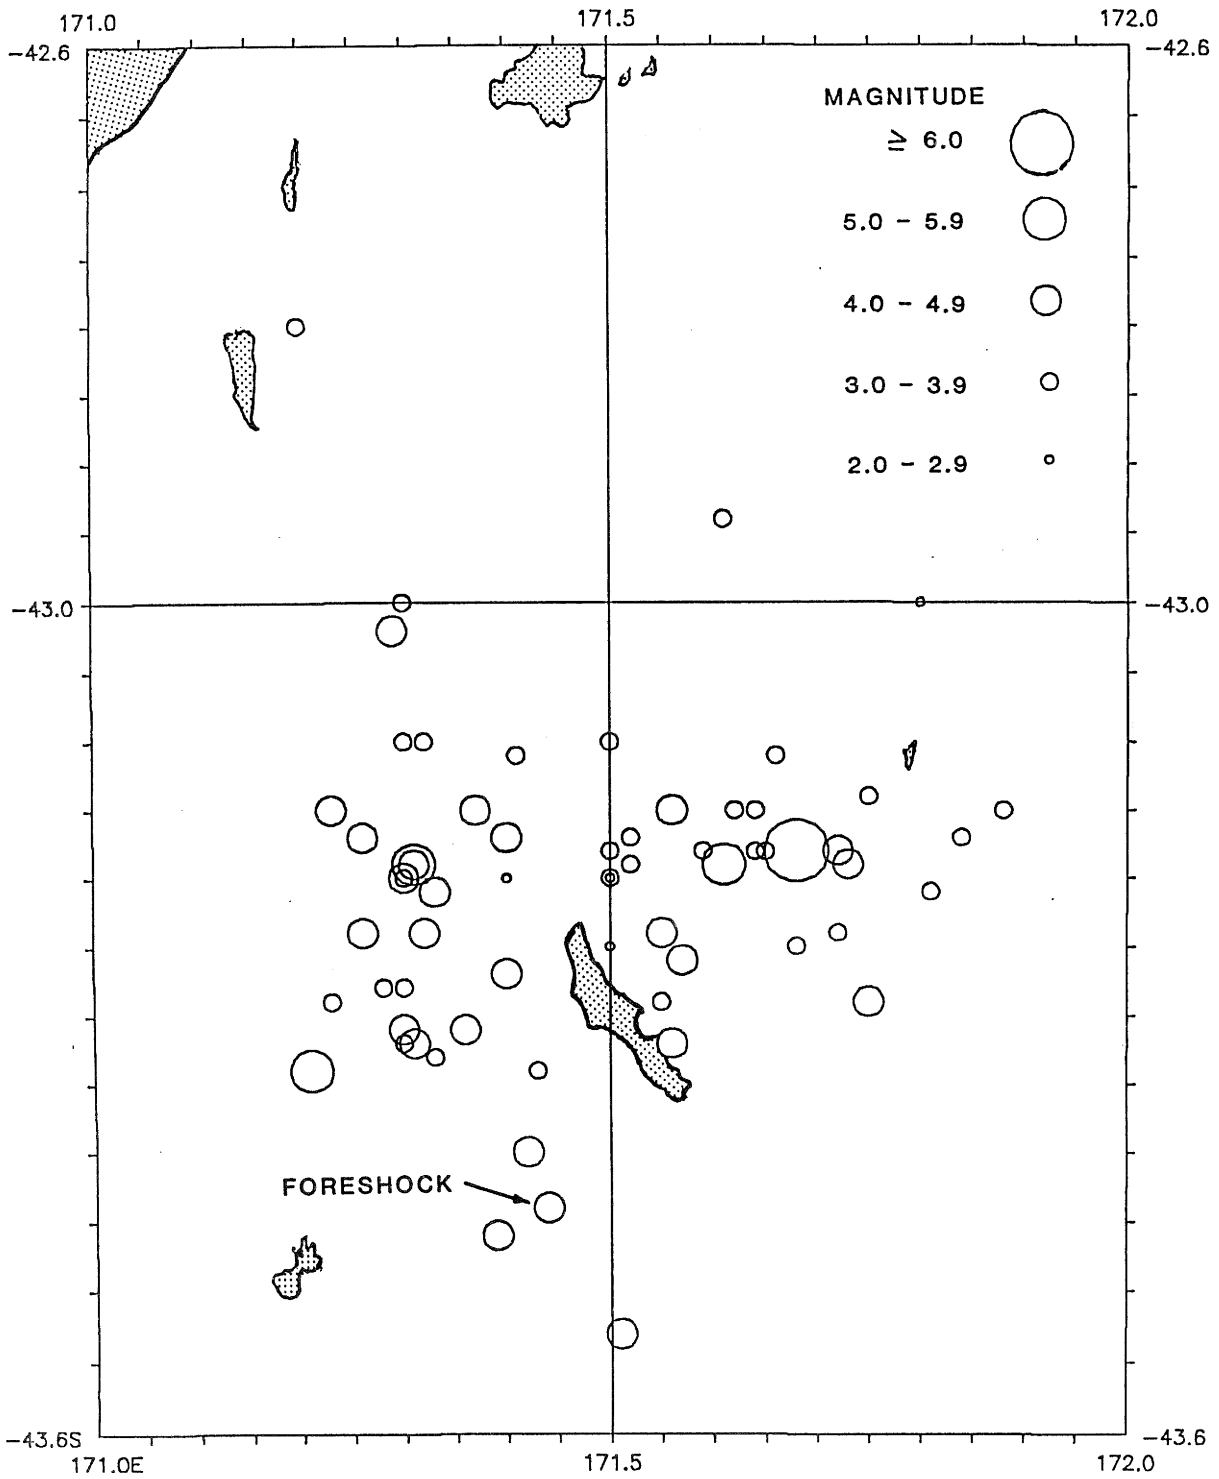
FIGURE 1. EPICENTRAL REGION OF THE LAKE COLERIDGE EARTHQUAKE, SHOWING THE RELATION OF FORESHOCK AND AFTERSHOCK EPICENTRES TO THAT OF THE MAIN SHOCK.

Figure 1 shows the distribution of aftershock epicentres about that of the main

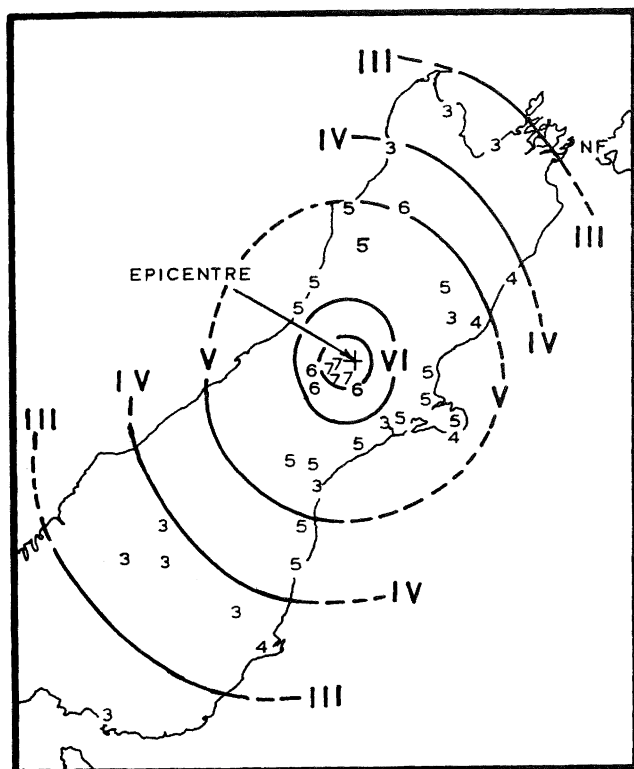
FIGURE 2. MODIFIED MERCALLI ISOSEISMALS FOR THE PRINCIPAL EARTHQUAKE ON 1946 JUNE 26 (Origin 46/091). IT HAS NOT BEEN POSSIBLE TO SHOW INDIVIDUAL OBSERVATIONS WITHIN THE MM-VII ISOSEISMAL ON THIS SCALE. THESE ARE SHOWN IN FIGURE 3.

Figure 2 shows Modified Mercalli isoseismals for the principal shock, at 12h 34m 39s.7 U.T., based on questionnaires returned by the Observatory's regular reporters together with information contained in the newspapers of South Canterbury and Westland, an unpublished two-page report to the Acting-Director of the Dominion Observatory by Mr H.F. Baird of the Magnetic Survey, Christchurch; the log book of the Lake Coleridge power station, and the records of the Regional Engineer of the N.Z. Electricity Department, Christchurch. Mr Baird, who visited the Lake Coleridge district on 1946 July 23, was the only person with seismological training to visit the area at the time. He was unfortunately taken sick and forced to return before completing his inspection.

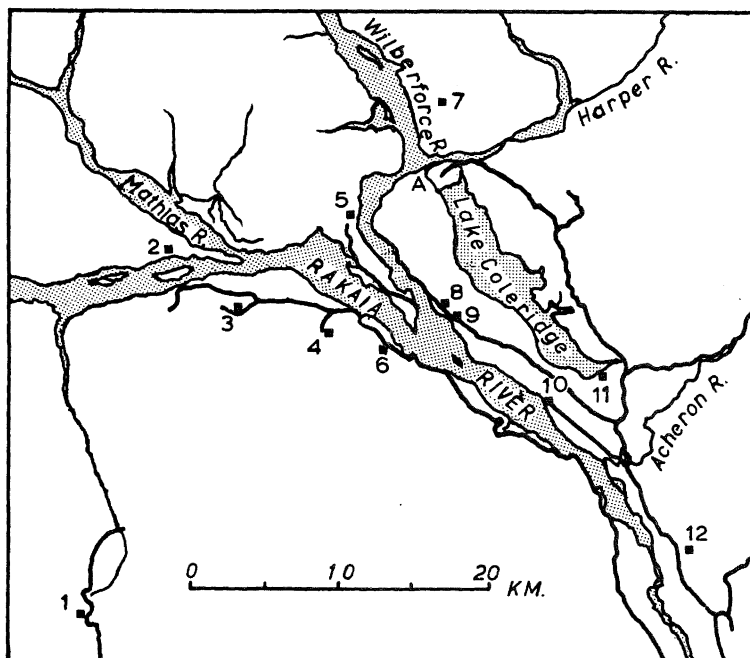
FIGURE 3. EPICENTRAL REGION, SHOWING PLACES NAMED IN THE TEXT. AN INTENSITY OF MM-VII WAS REPORTED EXCEPT AT PLACES WHERE A LESSER FIGURE FOLLOWS THE NAME.

The most severely affected region is shown in Figure 3. The area of maximum intensity is roughly 50 km. across and includes Lake Coleridge and the confluences of the Harper, Wilberforce, and Mathias Rivers with the Rakaia. The Lake and the rivers lie in wide glaciated valleys whose floors are about 500 m. above sea-level. The surrounding ranges rise steeply to over 2 000 m., but glaciation has reduced the height of some of the dividing hills. The power station at
