EFFECT OF THE EDGE CUMBE EARTHQUAKE ON MECHANICAL AND PROCESS EQUIPMENT AT THE TASMAN MILL

by W. C. Hodge¹ and M. Macfarlane²

SUMMARY

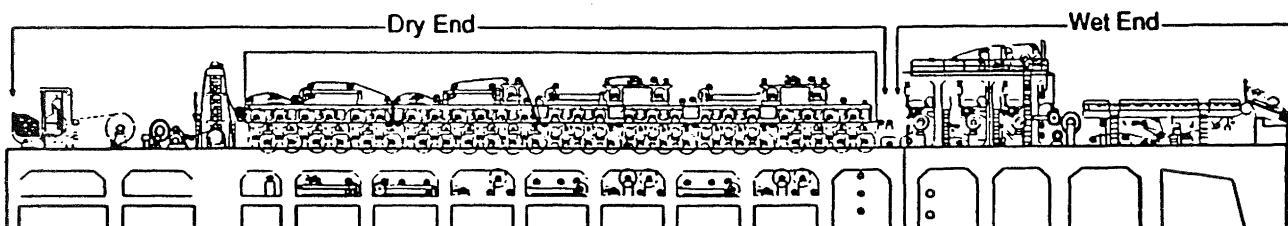
FIGURE 7. NO.1 NEWSPRINT MACHINE

Figure 7 shows a circle diagram of No.1 Machine, the oldest and lowest producer of the three machines. No.3 Machine Dryer Section took the heaviest damage and not surprisingly was also out of commission for the longest period. It took fifty seven days to dismantle the machine and fifty nine days to rebuild it. The width of all machines is nominally seven metres with lengths around 100 metres, the height of each machine varies slightly but in the order of 14 metres from the basement to the top of the press sections.
