LIQUEFACATION IN THE BULLER REGION IN THE 1929 AND 1968 EARTHQUAKES

J. B. Berrill¹, V. C. Bienvenu² and M. W. Callaghan³

This article describes the results of a search for sites of liquefaction in the 1929 M=7.6 Murchison and the 1968, M=7.1 Inangahua earthquakes in the Buller region of New Zealand. Evidence of liquefaction was found for nine sites in each earthquake; two sites were common to both events. Widespread ejection of sand occurred in the epicentral regions of both earthquakes. Liquefaction was more sporadic at larger epicentral distances, except in the North Beach area of Westport, the most distant 1968 site, where sand boils occurred over several hectares, together with the toppling of utility poles and some lateral mass movement. This area corresponded to the very young beach sands deposited since extension of the Westport harbour breakwaters towards the end of last century. Liquefaction was much less common in the river-lain sands in the same vicinity.

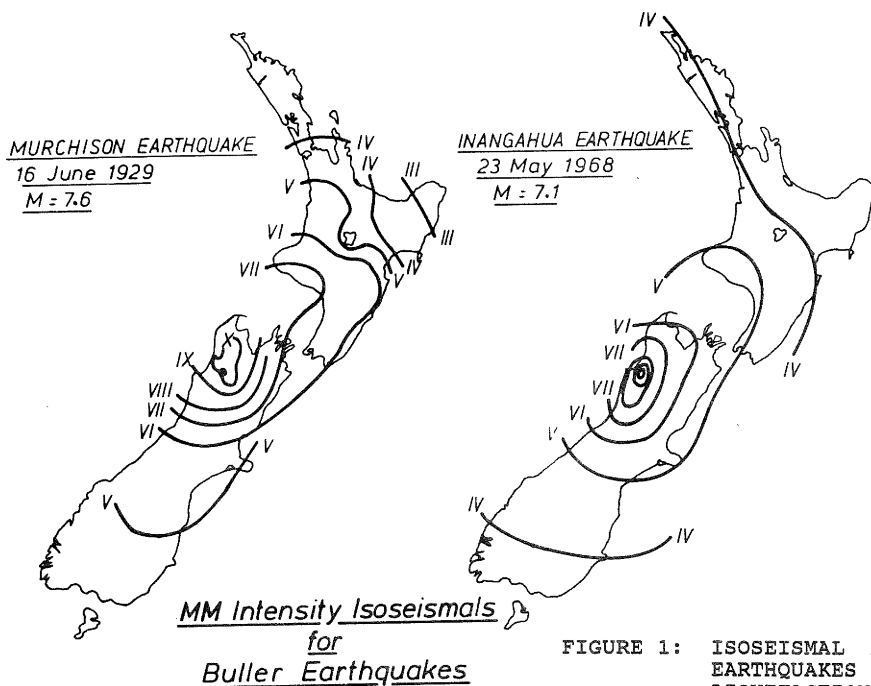
Figure 1 shows isoseismal patterns for the earthquakes. Both were shallow focus events with surface faulting, predominantly in a thrust mode. Brief seismological descriptions of the earthquakes are given in the appendix and further geological and seismological references may be found from the bibliography. It is of interest to note that most of the Inangahua aftershocks lie within the MM IX isoseismal, indicating this was the region of rupture, with rupture propagating southwestwards from a northern hypocentre.

FIGURE 1: ISOSEISMAL MAPS FOR THE TWO EARTHQUAKES IN WHICH LIQUEFACTION WAS IDENTIFIED.
