IMPACTS OF THE 14TH NOVEMBER 2016 KAIKŌURA EARTHQUAKE ON THREE WATERS SYSTEMS IN WELLINGTON, MARLBOROUGH AND KAIKŌURA, NEW ZEALAND: PRELIMINARY OBSERVATIONS

ABSTRACT

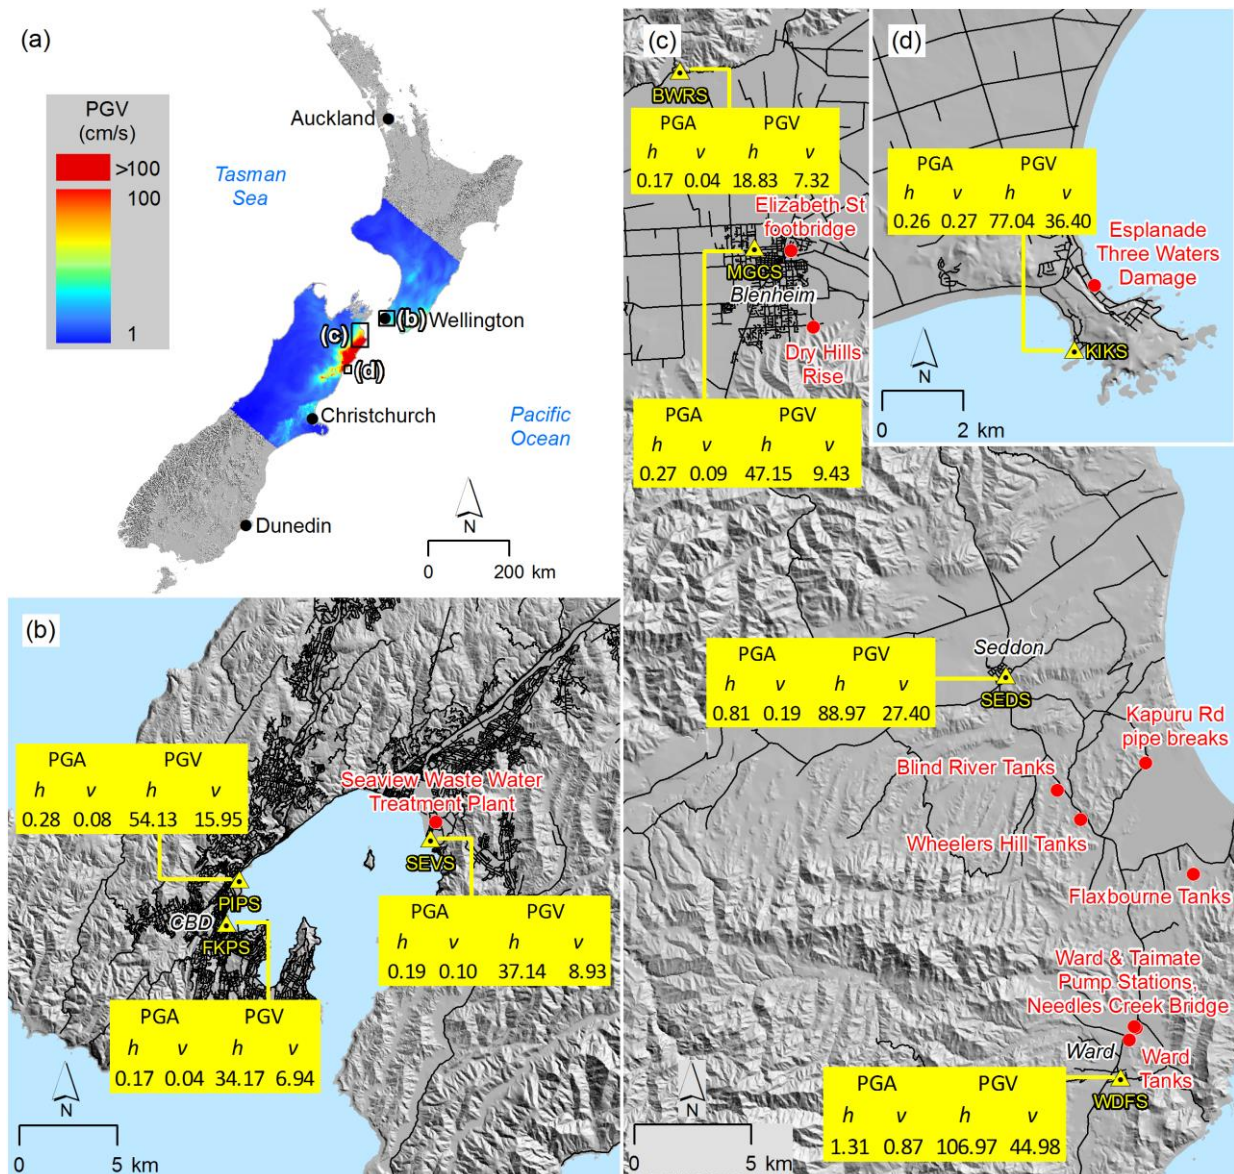
Figure 1. (a) Modelled maximum Peak Ground Velocity (PGV; cm/s) [4, 5] for central Aotearoa/New Zealand from the 14th November 2016 Kaikōura Earthquake. Locations of study areas (b-d) are shown. (b-d) Three waters damage locations; Selected Strong Motion Station locations (yellow triangles) shown, with measured Peak Ground Acceleration (PGA) and PGV values (cm/s); horizontal (h) and vertical (v) motions shown. Road networks also shown. (b) Wellington study area, with location of Seaview Wastewater Treatment Plant (Figure 2). SEVS = Seaview Station, FKPS = Frank Kitts Park Station, PIPS = Aotea Quay Pipitea Station. (c) Marlborough study area, with documented damage locations in Blenheim (Figure 3). See Figures 4-5 for Blind River Tanks observations and Figures 6-8 for Ward damage observations. BWRS = Waikakaho Road Station, MCGS = Marlborough Girls College Station, SEDS = Seddon Fire Station, WDFS = Ward Fire Station. (d) Kaikōura study area, see Figure 9 for Esplanade damage observations. KIKS = Kaikōura Station.

Seismic demand placed on the Wellington, Marlborough and Kaikōura areas by the $M_w 7.8$ 14th November 2016 Kaikōura Earthquake can be visualised with modelled regional maximum Peak Ground Velocity (PGV; cm/s) values [4-5] (Figure 1a). In the Wellington area, at Seaview the measured horizontal and vertical Peak Ground Acceleration (PGA) values were 0.19 g and 0.10 g, respectively; horizontal and vertical PGV values were 37.14 cm/s and 8.93 cm/s, respectively. In the Wellington Central Business District (CBD), horizontal and vertical PGA values ranged 0.17-0.28 g and 0.04-0.08 g, respectively; horizontal and vertical PGV values ranged 34.17-54.13 cm/s and 8.93-15.95 cm/s, respectively (Figure 1b). In the Blenheim area, horizontal and vertical PGA values ranged 0.17-0.27 g and 0.04-0.09 g, respectively; horizontal and vertical PGV values ranged 18.83-47.15 cm/s and 7.32-9.43 cm/s, respectively (Figure 1c). In Seddon, measured horizontal and vertical PGA values were 0.81 g and 0.19 g, respectively; horizontal and vertical PGV values were 88.97 cm/s and 27.40 cm/s, respectively (Figure 1c). In Ward, measured horizontal and vertical PGA values were 1.31 g and 0.87 g, respectively; horizontal and vertical PGV values were 106.97 cm/s and 44.98 cm/s, respectively (Figure 1c). Shaking levels are ~2 times stronger than experienced during the 2013 Lake Grassmere event, especially in Ward [33]. In Kaikōura, measured horizontal and vertical PGA values were 1.31 g and 0.87 g, respectively; horizontal and vertical PGV values were 106.97. The high values in Ward and Kaikōura reflect their close proximity to fault rupture zones, and lower values experienced in Seddon, Blenheim and Wellington reflect their increasing distance from the primary rupture zone [1, 2]. Some variability in shaking levels in the vicinity of each strong motion station is expected due to different soil conditions and topography. Below we describe initial functional impacts from this seismicity on three waters systems, with commentary on system performance and service level restoration.
