THE SEPTEMBER 1985 MEXICO EARTHQUAKE

PRELIMINARY REPORT OF THE NEW ZEALAND RECONNAISSANCE TEAM

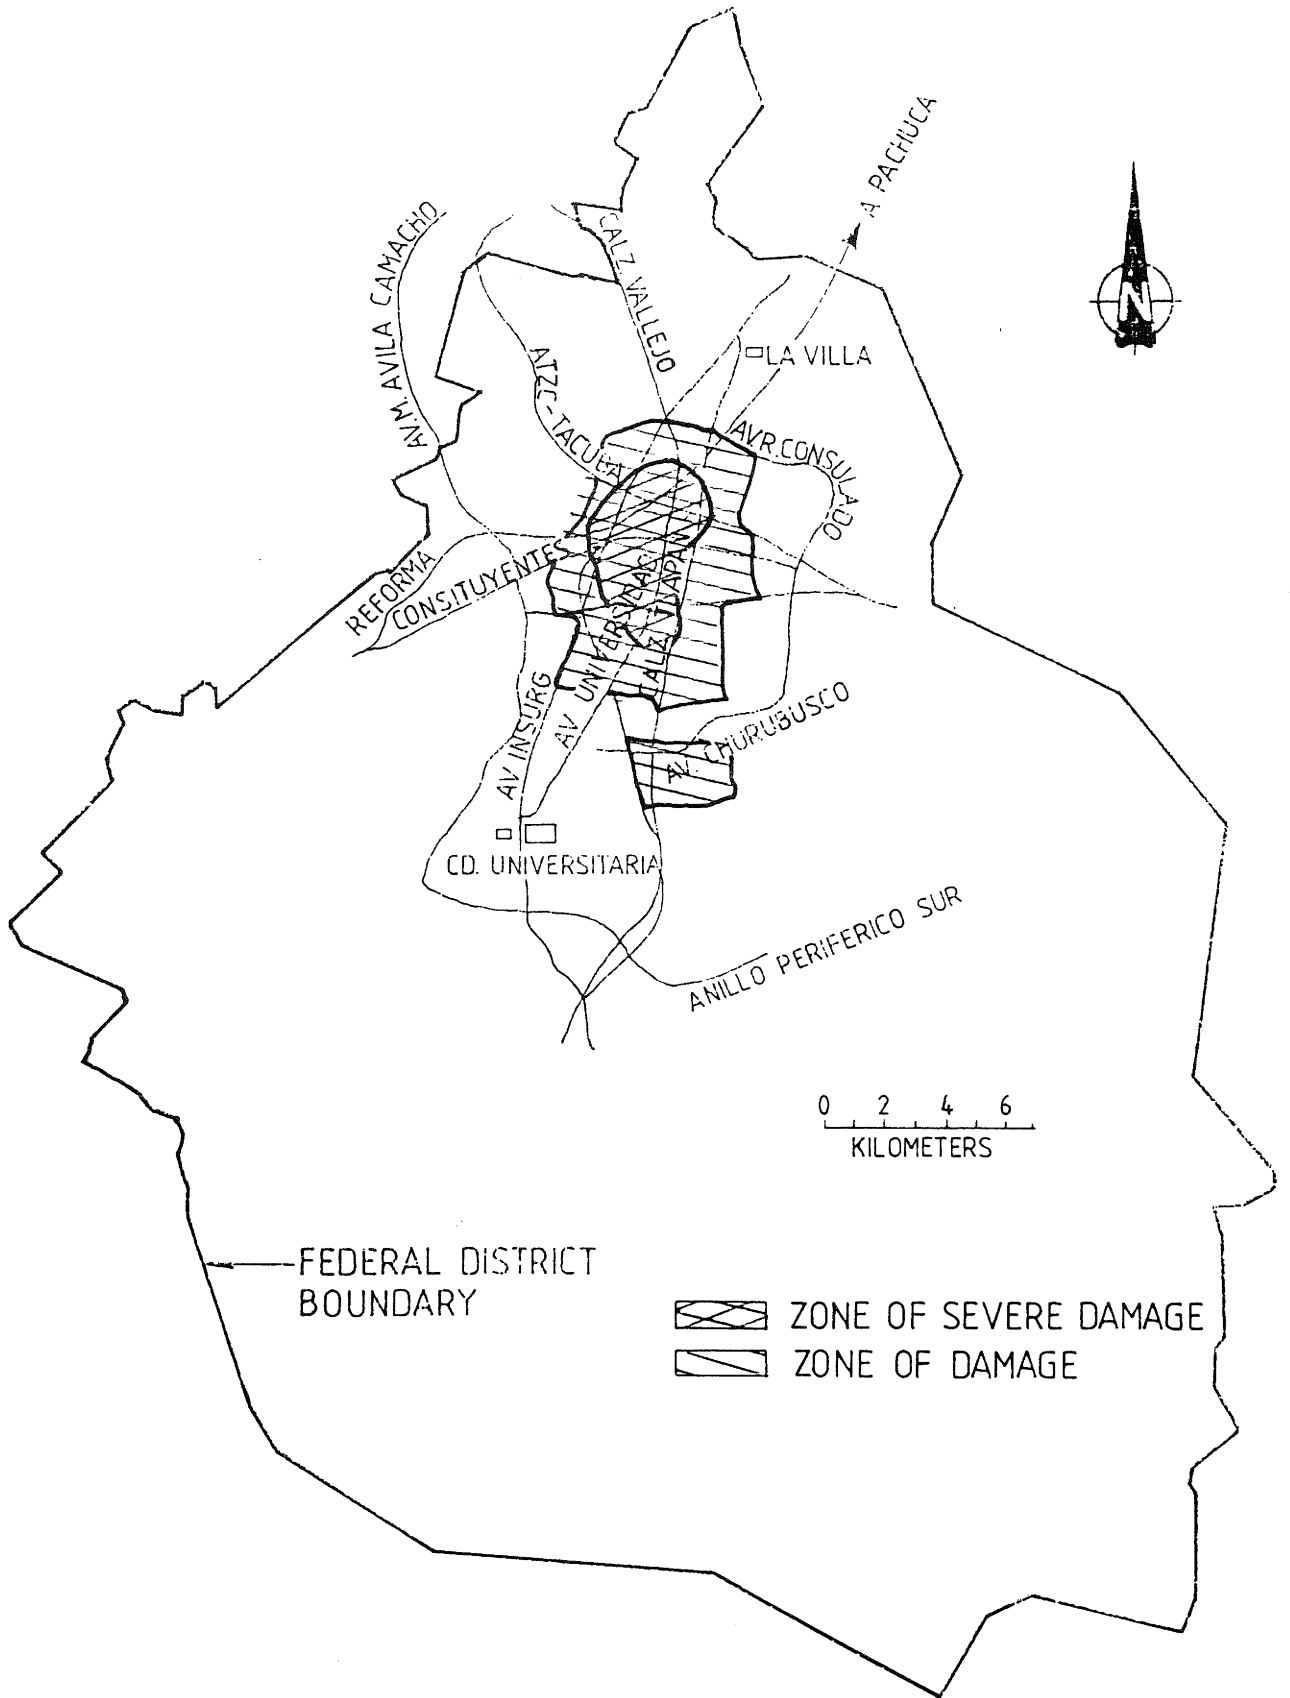
Figure 4 : Damage Zones, Mexico City

Mexico City covers an area in excess of 1000 km². Within this area damage to buildings was confined to an area of approximately 65 km² with a zone of approximately 25 km², where collapse or severe damage to buildings occurred. These two zones are shown in Fig. 4. The area of extreme damage or collapse however encompasses the central city zone in which many of the Government buildings are located and so it was the very heart of the city which was hit. As an indication of the extent of damage the following data was obtained from the office of Secretary General of Building Construction on 16 October 1985 (this data was being revised
