## 2. REDEVELOPMENT OF THE NORMAL SCHOOL CRANMER SQUARE, CHRISTCHURCH

G.K. Wilby\*

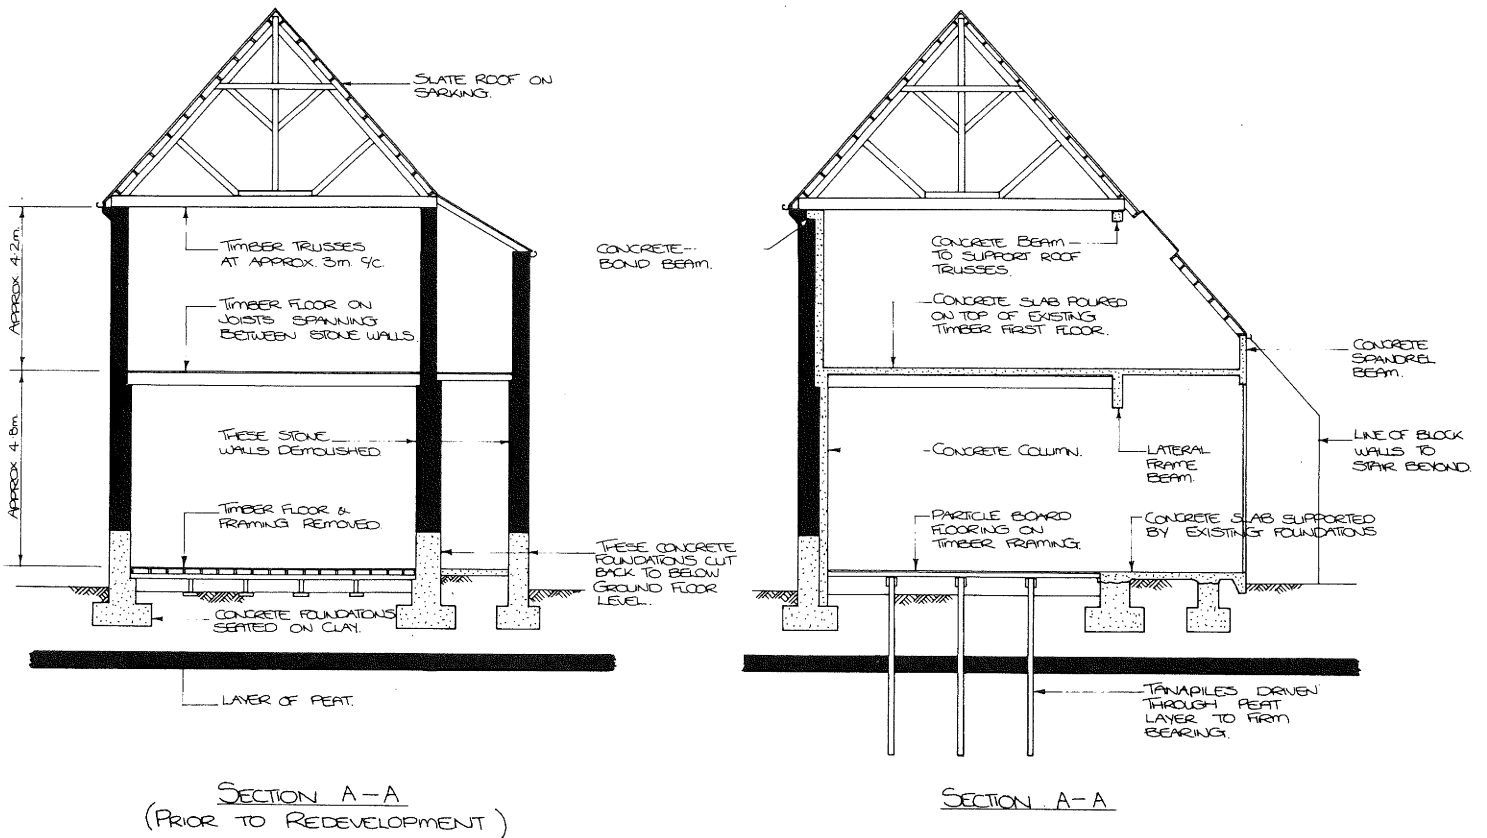
FIGURE 2

Reinforced concrete lateral load resisting frames were constructed along the line of the inner of the two stone walls that were demolished (see Fig. 2 & 4). These, together with the existing stone walls facing the street, gave adequate seismic resistance along the wings. Lateral load resistance across the wings was provided by the existing stone cross walls. Concrete block cross walls were also built at the centre of the large classrooms to give added seismic resistance and to provide separation between Units.

Reinforced concrete lateral load resisting frames were constructed along the line of the inner of the two stone walls that were demolished. The frames (see Fig.4) were of the half-frame and post type, a configuration chosen primarily to suit the architectural constraints. The frames were founded on the existing concrete foundations which had been cut back and reinforced to provide some hogging moment capacity.
