CHARACTERISATION OF TRANSPORT RESILIENCE AND MEASURES TO ENHANCE RESILIENCE IN THE RECOVERY AFTER THE 2016 KAIKŌURA EARTHQUAKE

Dougal Mason¹ and Pathmanathan Brabhaharan²

ABSTRACT

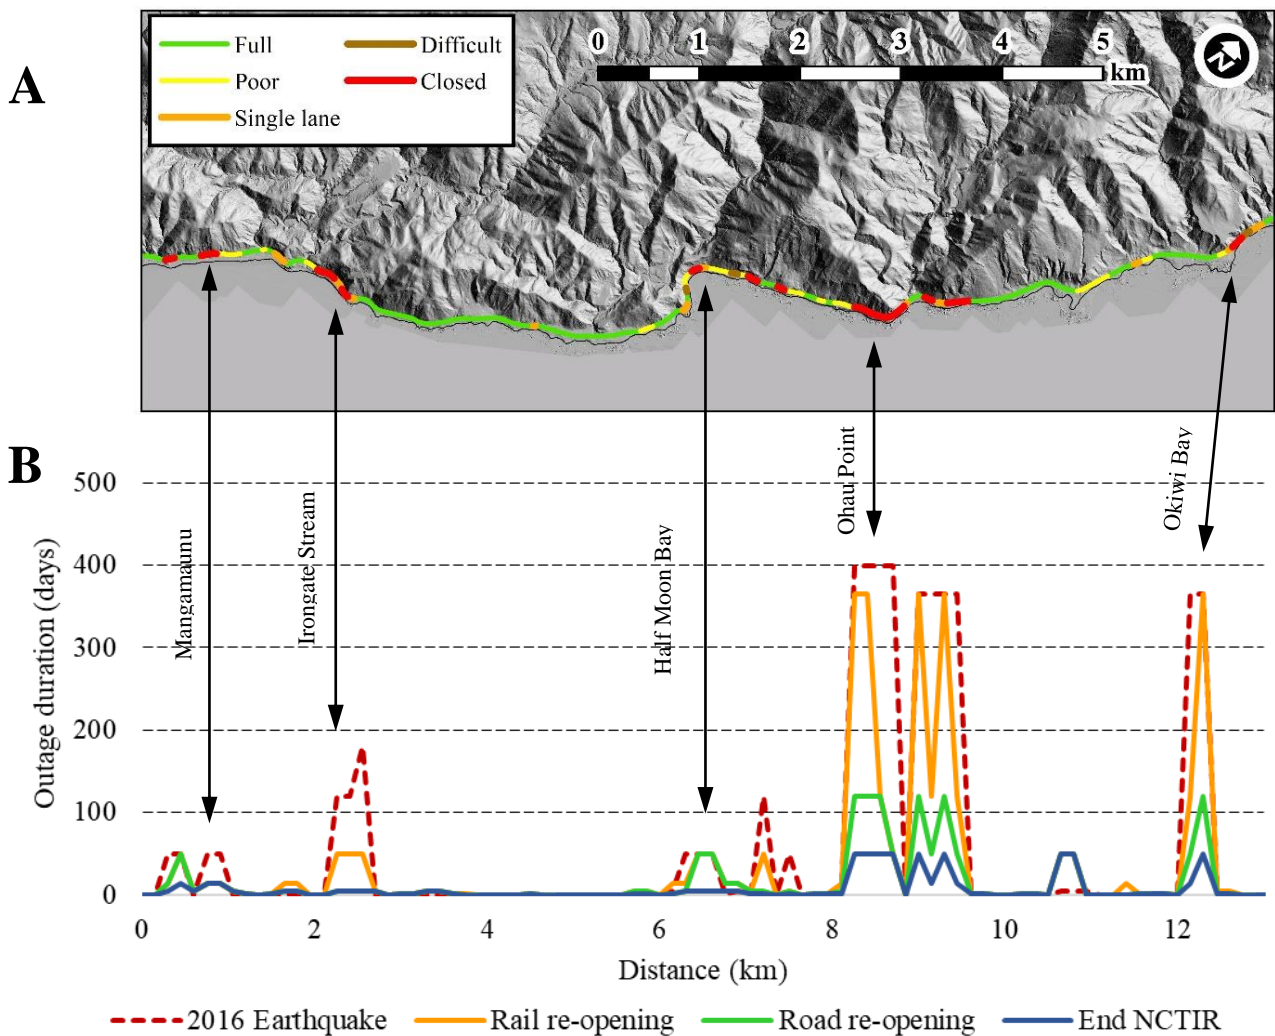
Figure 12 shows an extract from the resilience assessment, showing the outage resulting from the 2016 earthquake as well as the assessed potential outages along a section of the road corridor north of Kaikōura. These sections of corridor were assessed as highly vulnerable to further earthquake- or rainfall-triggered failure due to the fractured and disrupted nature of the rock mass underlying the slope and the presence of large volumes of landslide debris and colluvium on the slopes, as well as extensive areas of tension cracking and slope deformation. These slopes show a range of behaviours depending on the size and type of the hazard scenario, from small-scale slips and debris flows under relatively small, high frequency rainfall events to large landslides and debris avalanches/flows in severe storms or large earthquakes. This understanding of the vulnerabilities along the corridor enabled the asset owners to identify and prioritise critical sections of the corridor for engineering works to enhance resilience and to develop response measures for future events to minimise the impact of outages in those critical sections.

Figure 12: Extract from resilience assessment for SH1. (A) Map of the loss of SH1 availability in the 2016 earthquake between Mangamaunu and Okiwi Bay (see Figure 6 for location). (B) Graphical representation of individual site outages from the earthquake, and potential outages for a large magnitude earthquake (MM VII+) at the re-opening of the rail and road corridors and at the nominal end date for the NCTIR programme.
