# LIFELINES PERFORMANCE AND MANAGEMENT FOLLOWING THE 22 FEBRUARY 2011 CHRISTCHURCH EARTHQUAKE, NEW ZEALAND: HIGHLIGHTS OF RESILIENCE

# SUMMARY

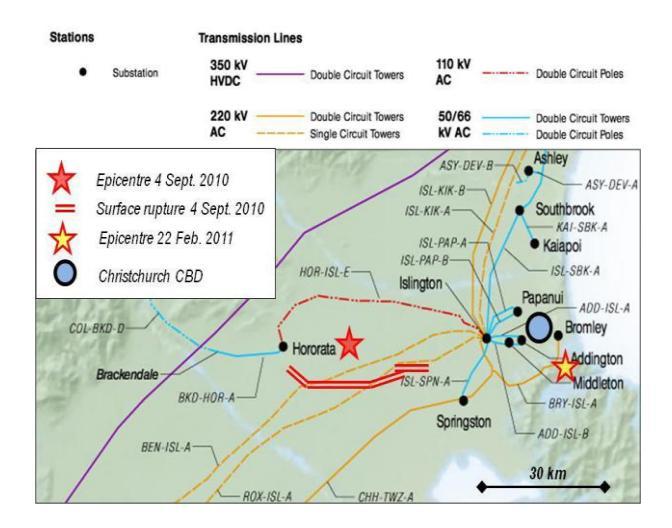
## Figure 4: Transpower assets (substations and transmission lines) affected by the 4 September 2010 and 22 February 2011 earthquakes (Photo credit: Transpower).

Only minor structural damage of transmission assets was experienced (McGhie and Tudo-Bornarel, 2011). Most of the damage caused by the 22 February 2011 earthquake to Transpower assets occurred at Bromley, which experienced very high ground accelerations (Figure 5) and Papanui substations. Some minor damage occurred at Transpower's Addington warehouse, which consisted of local buckling of the pallet racking structures and collapse of one shelf.

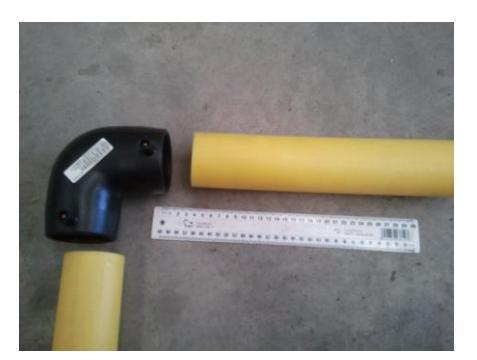
# Figure 14: Example of MDPE electrofusion joint for the Contact Energy pipes

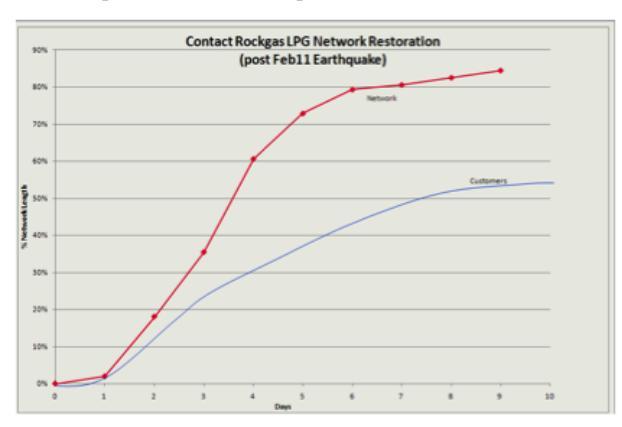
The gas mains outside the CBD cordon were re-livened within 9 days after the earthquake. Reconnection of customers continued during and after the re-livening operations of the mains and were completed within 10 days after the earthquake. Figure 15 presents the Contact Energy gas reticulation system and service restoration curves following the 22 February 2011 earthquake. As shown in Figure 15, 15% of the piping falls within the CBD cordon and could not be restored immediately after the earthquake. All services that could be restored were restored within 2 weeks. There were many customers who did not restore their gas services due to lost buildings, isolation from the CBD, or they left the area. As a result, in April 2011 Rockgas had lost 40% of their customer services and was providing only about 1/2 of the volumes they were supplying prior to the 22 February 2011 earthquake. Some additional service recovery will occur over time as some people return to Christchurch and as portions of the CBD are reopened. As at Nov 11, 6% of mains remains within the cordon and is not yet live. Customer re-livening has grown to around 80% of pre-earthquake customer numbers.

Despite the excellent performance in multiple earthquakes, as indicated in Figure 15, from a broader community perspective the gas system could not return to its pre-earthquake service levels due to the reduced number of customers as a result of the earthquake and related impacts.

Figure 15: Rockgas serviceability following the 22nd February2011 earthquake.

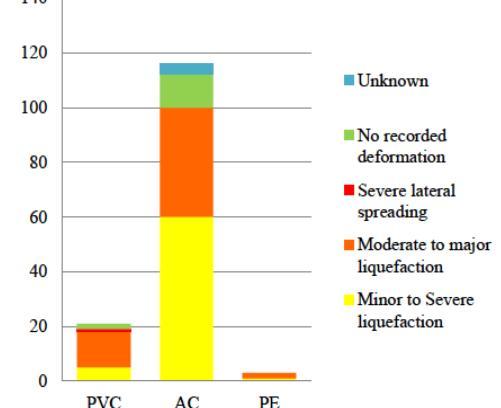
HDPE pipe is being extensively used for all new pressure mains as it was found to perform well in the 4<sup>th</sup> September and 22<sup>nd</sup> February earthquakes and 13<sup>th</sup> June aftershock. Figure 17 show preliminary results on the performance of different pipe material for the Kaiapoi water network following the 4<sup>th</sup> September earthquake.

Figure 17: Kaiapoi water network following the 4<sup>th</sup> Sept, Darfield Earthquake: a) (Left) Percent of total length of different pipe materials within different ground deformation areas; b) (Right) Number of repairs made on mains and rider mains in different levels of ground deformation areas. (Knight, 2011).

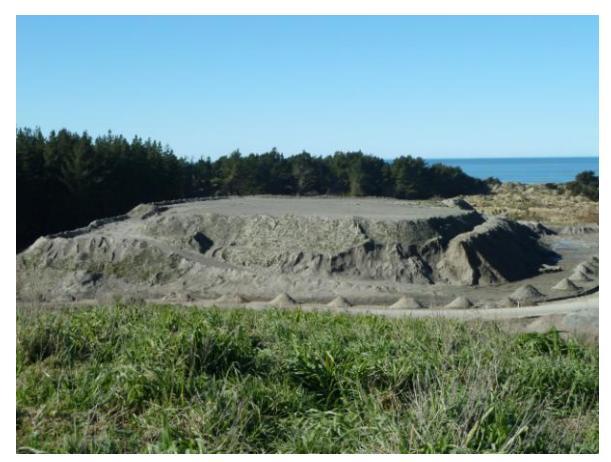
Because of the severity of the road damage following the 22 February 2011 earthquake and the huge volumes of silt, further strategic locations were identified to temporarily stockpile silt (Figure 19; D. Harris, personal communication, 2011).

Figure 19: Estimated > 400,000 tonnes of liquefaction silt removed from the Christchurch urban area after the February 22 earthquake at the Burwood landfill disposal site.
