# SEISMIC PERFORMANCE OF REINFORCED CONCRETE BUILDINGS IN THE SEPTEMBER 2010 DARFIELD (CANTERBURY) EARTHQUAKE

## SUMMARY

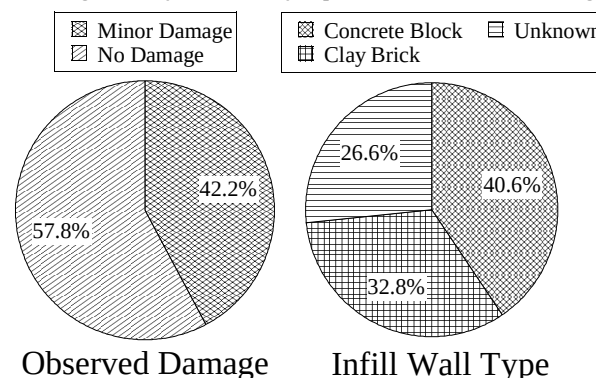
Two weeks after the main shock, a detailed damage survey was carried out by a team of researchers of the Foundation for Research, Science and Technology (FRST) Seismic Retrofit Project [9] from the University of Canterbury. A previously established inventory of pre-1970s RC buildings was expanded with an additional dataset and damage observations. Figure 3 presents some of these findings.

About 42% of the 65 surveyed RC buildings showed signs of minor damage, including cracks in the main structural elements and infill panels. Clay brick and concrete block infill

walls were commonly found in most pre-1970s RC frames buildings, mostly without any separation or seismic detailing.

**Figure 3:** Observed damage in pre-1970s RC buildings stock and type of infill walls.
