# THE "EJE CAFETERO" EARTHQUAKE, COLOMBIA OF JANUARY 25 1999

J.I. Restrepo<sup>1</sup> and H.A. Cowan<sup>2</sup>

This paper summarises the main findings of a reconnaissance team to the region organised by the New Zealand Society for Earthquake Engineering.

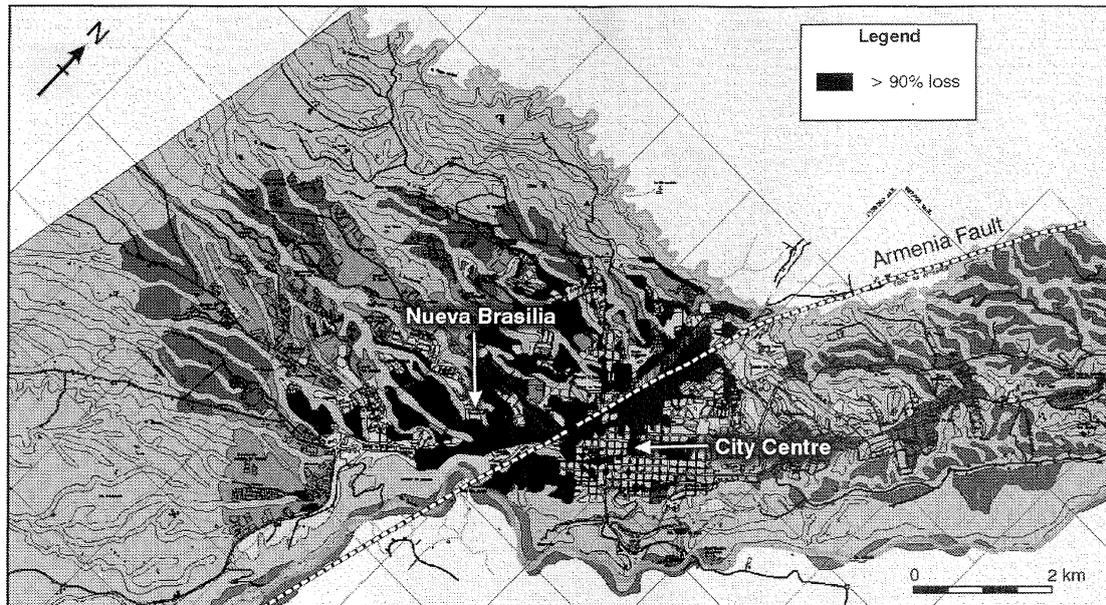
Extensive structural damage and collapse of buildings occurred along a corridor near the centre of Armenia (Figure 8). Buildings in this corridor had been founded on anthropic fills adjacent to the escarpment of the Armenia fault. The presence of the fills induced ground amplification there. Substantial structural damage and collapse of some buildings also occurred in locations with anthropic fills in Pereira.

Figure 8: Damage pattern to Armenia (Adapted from [7]).

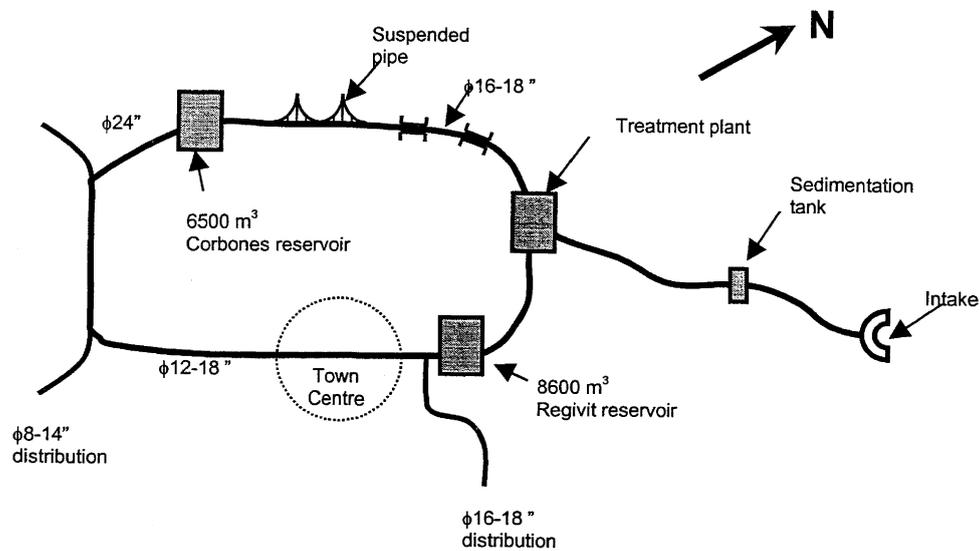
Figure 19: Plan view of the water supply network in Armenia [12].

Most of the damage was concentrated in 50 to 100 mm diameter pipes. The spread of damage in the network in Armenia correlated well with the distribution of building damage shown in Figure 8 [12]. In addition to the damage in the network, the 6,600 m<sup>3</sup> reinforced concrete rectangular

reservoir in Corbones (Figure 19), leaked due to the relative displacement between two walls at a poorly built construction joint. Four weeks after the earthquake the number of reported faults was about four times above average.

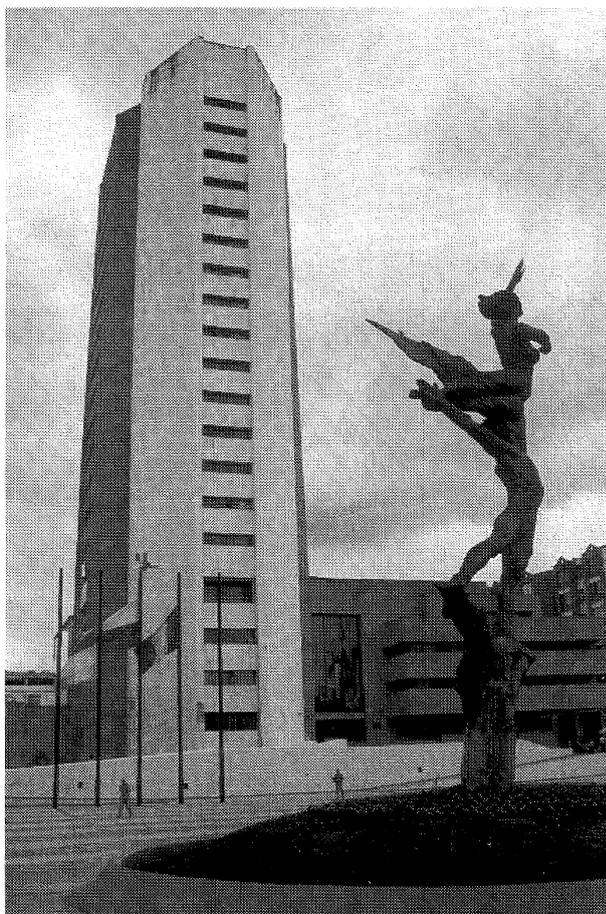
The interior fittings and office furniture and the façade in the lower five storeys of the 20-storey Quindío Regional Government Building in Armenia (Figure 31) were

*Figure 31: View of the Quindío regional government building.*
