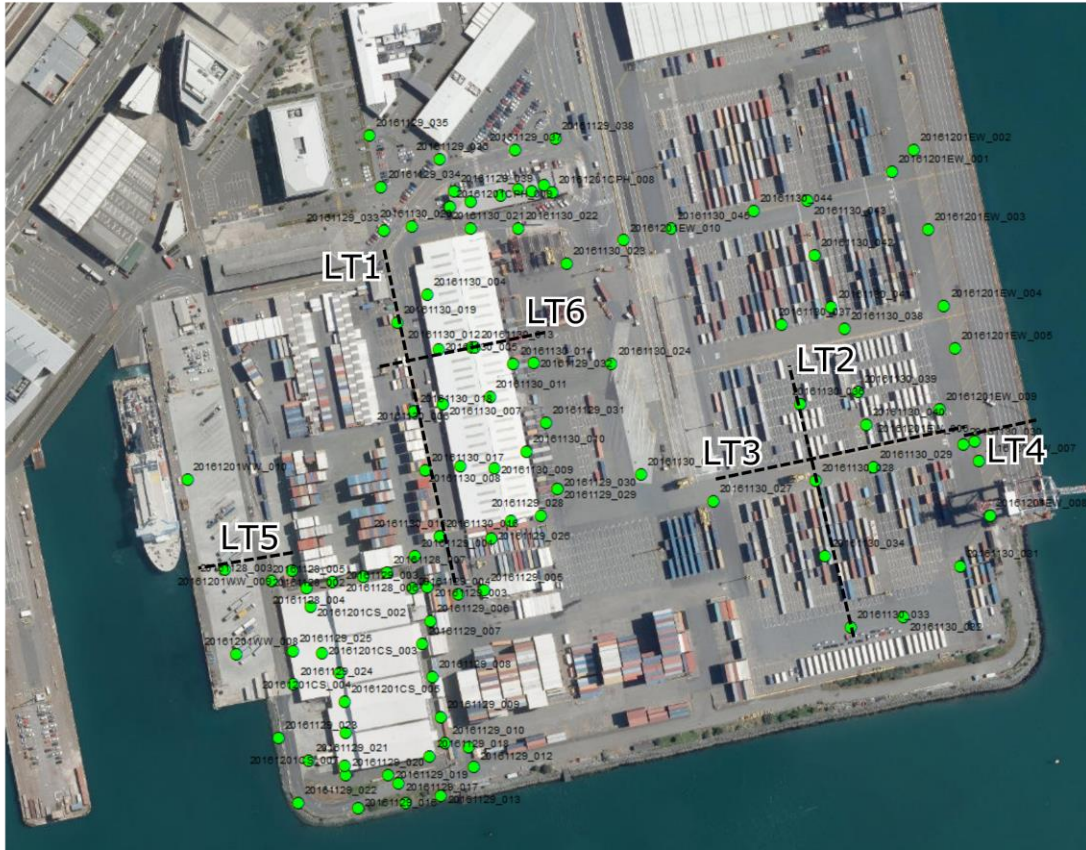
Figure 16: Locations (green circles) where ground-based LiDAR scans were obtained at the CentrePort. Additional scans were captured inside the Cruise Ship Terminal to the North that are not shown. Transects from the LiDAR data shown later in the report are identified. Note that the basemap is from ESRI prior to the earthquake.

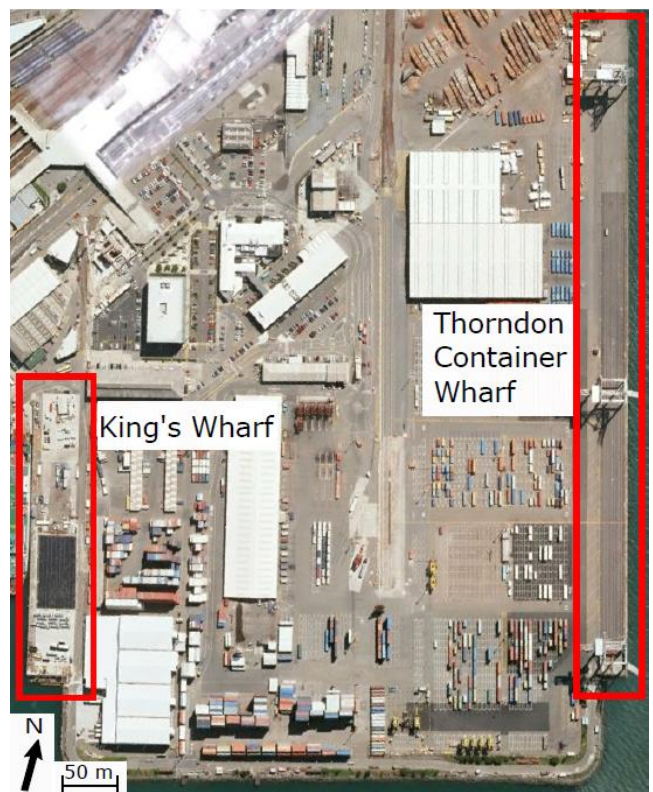
CentrePort Wellington has two wharves: Thorndon Container Wharf and King’s Wharf (see Figure 18). The port’s primary container operation takes place on Thorndon Container Wharf, which is on the eastern side of the port. King’s Wharf, which is on the western side of the port, supports primarily roll-on/roll-off cargo.

Figure 18: Aerial photograph highlighting the locations of the Thorndon Container and King’s wharves of CentrePort Wellington (Base image from Google Earth™)

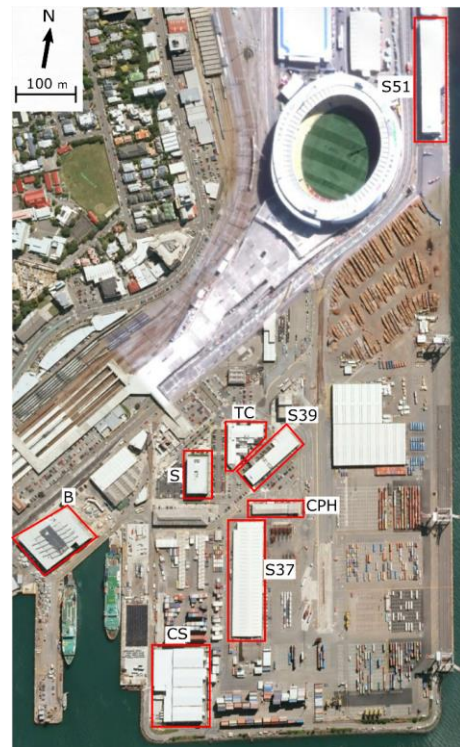
The CPH building ($S41.27829^{\circ} E174.78618^{\circ}$, see Figure 24) is founded on reinforced concrete (RC) spread footings connected with RC grade beams (Figure 25a). There were no apparent signs of structural distress, and the building was operational at the time of the reconnaissance in late November 2016. The building and immediately surrounding fill settled relatively uniformly. Settlement appeared to be more or less uniform across the building footprint, as there were no apparent signs of relative movement or tilt of the ground floor of the CPH building from the visual investigation. However, a preliminary analysis of the LiDAR scans indicate a slight tilt (i.e., of 0.105 degrees) in the large operations room on the east end of the building. Ground a few meters to the west of the CPH building did not appear to settle significantly, because it was supported by the buried precast seawall that ran along the bulkhead of the partially demolished Pipitea Wharf, which minimized liquefaction-induced settlement of the ground above it. The building and fill settled approximately 230 to 260 mm relative to the elevated ground supported on the seawall (Figure 25b).

Figure 24: CentrePort Wellington map showing buildings surveyed (Base image from Google Earth™).

The CS building (S41.28105° E174.78483°, see Figure 24) is supported on a composite shallow foundation with RC spread footings and mats. The building consists of an irregular-shaped single-story open loading bay in its western part (herein called the Shed) and a rectangular-shaped large cold storage facility on its eastern part (herein called the Freezers). The structural frames and supporting foundations of these two parts of the building appear to be independent. From observation, the structural system of the Shed is composed of concentrically-braced steel frames. The QuakeCoRE-GEER team members were given access to the Shed and the ground around the building, but not to the Freezers. The differential ground movements across the building footprint induced structural deformation in the CS building. Seaward lateral ground movements on the order of 1 m occurred towards the western and southern slopes in the southwest corner of the CentrePort reclaimed land.

The S39 building (see Figure 24) is supported on Frankie piles. The old buried mass concrete seawall (i.e., Old Seawall) runs parallel and adjacent to the southeast wall of the building. Additionally, along the southeast wall, a segment of the historic Fryatt Quay Wharf deck (Figure 3) was left intact. The ground to the south of the seawall and wharf settled 220 mm relative to the top of the wharf deck and the pile-supported building (Fig. 33a). Approximately 100 to 190 mm of settlement was observed along the southwest wall of the building (Figure 33b). On the northwest side of the building, the ground adjacent the building settled approximately 50-100 mm relative to the building. The

The TC building (see Figure 24) is immediately to the northwest of the S39 building, and is supported on driven RC piles. Liquefaction ejecta was observed along the short southwest wall of the building, and 150 mm of ground settlement relative to the building was measured.

The western half of the S37 building (see Figure 24) is founded on the deck of the buried, partially demolished pile-supported Pipitea Wharf, and the east wall of the building is supported on piles. The precast seawall that formerly ran along the bulkhead of the Pipitea Wharf is now buried and runs south-to-north through about the centerline of the building. The ground floor slab not supported on piles, the old wharf deck, or the precast seawall settled up to 550 mm relative to these structures (Figure 34a; the value is based on measurement from LiDAR scan for this building). The ground settled approximately 375 mm relative to the building along the exterior of the east wall of the S37 building (Figure 34b). Approximately 16 m west of the western wall of the S37 building, a buried row of piles from the old Pipitea Wharf protruded from the ground as the surrounding fill settled approximately 300 mm relative to the piles (Figure 17).

The S building (see Figure 24) is a 5-storey reinforced concrete building founded on piles, which was built in 2006. The corners are on driven reinforced concrete piles while the interior columns are founded on cast-in-place concrete piles. No ground improvement was performed under the building. The building suffered structural damage, and is being investigated thoroughly by CentrePort. No signs of foundation damage were visible at the ground surface during the QuakeCoRE-GEER

The B building (see Figure 24) is supported on piles with stone column ground improvement performed over the southeastern (seaward) half of the building footprint. The surrounding ground settled approximately 50 to 90 mm uniformly relative to the building (Figure 36). No other significant movements were observed.
