**THE TAVEUNI EARTHQUAKE
FIJI
ON 17 NOVEMBER 1979**

A.W. Paterson* R.L. Williams**

Following the 17th November 1979 Taveuni earthquake, the authors were sent by the Fiji Government to inspect earthquake damage. The damage was assessed at \$0.75m. This paper is based on their reports and makes recommendations relevant to Pacific Island construction.

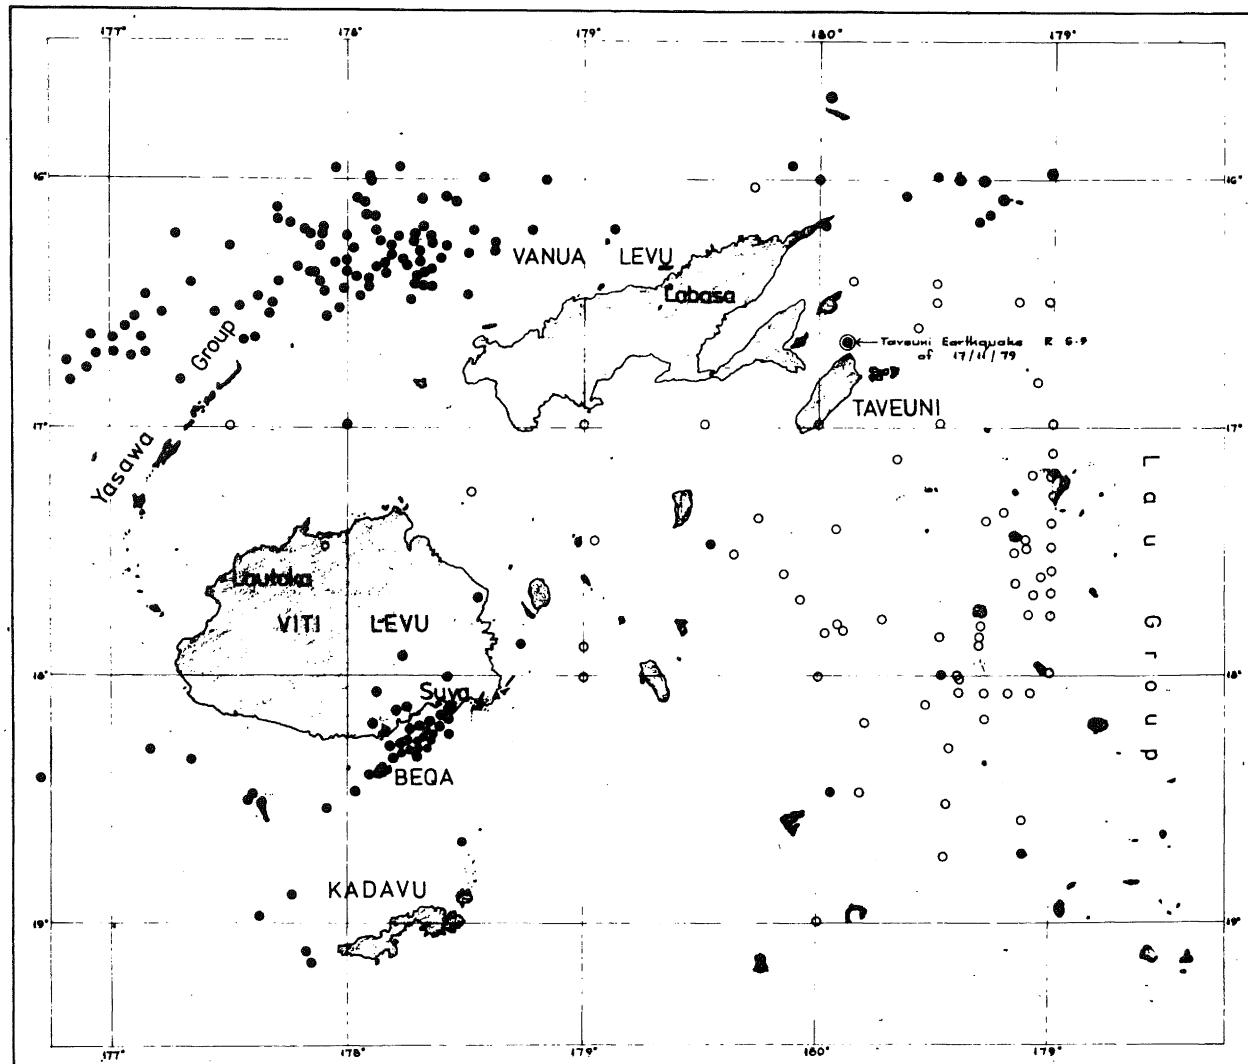
Fig. 1 Taveuni earthquake epicentre & modified mercalli Ratings

Observations by the Fiji Ministry of Lands and Mineral Resources on the aftershocks using portable equipment indicate an epicentre as shown on Figure 1. The epicentre appears to lie below a 600 metre deep channel between Rabi and the north western tip of Taveuni. The local geology is principally of young volcanic origin.

The ground motion in the Matei region was severe particularly on exposed ridges. Strong motion causing significant damage occurred for about half the length of the island and in the Buca Bay area. Figure 1 shows Modified Mercalli intensities assigned by the authors. Structural damage was not as extensive as one might have expected due to a number of factors i.e.
