DAMAGE TO CIVIL ENGINEERING STRUCTURES DUE TO THE NEAR IZU-OHSHIMA EARTHQUAKE OF JANUARY 14, 1978

Toshio Iwasaki * and Kazuhiko Kawashima **

ABSTRACT

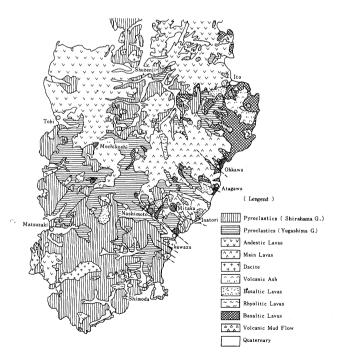
FIGURE 3: GEOLOGICAL MAP OF IZU PENINSULA

As shown in the geological map of Izu Peninsula edited by Shizuoka Prefecture (Fig. 3) the geology of this area is represented by Yugashima Group and Shirahama Group consisting of Neocene volcanic ejects, volcanic lavas on those Groups, and volcanic

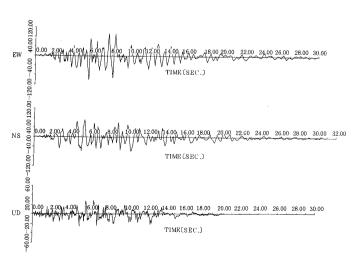
FIGURE 6: ACCELERATION RECORDS MEASURED ON A BASEMENT FLOOR OF ITOH TELEGRAM AND TELEPHONE OFFICE (8)

The record closest to the fault was obtained on a basement floor of Itoh Telegram $\,$ and Telephone Office where the epicentral distance is nearly 30 km. Time histories and response spectra of the record are shown in Figs. 6 and 7, respectively . The maximum values of accelerations, velocities and displacements of the earthquake motions are as follows:

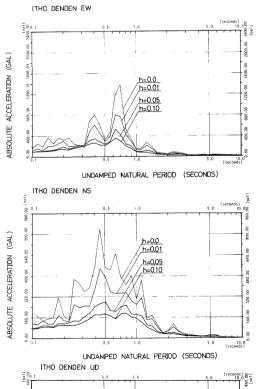
FIGURE 7: RESPONSE SPECTRA OF THE ACCELERATION RECORDS MEASURED ON 1TOH TELEGRAM AND TELEPHONE OFFICE (8)

The maximum values of EW component, are considerably larger than those of NS component. On the other hand there are some differences in frequency characteristics between the spectra, as shown in Fig. 7, in EW and NS components. The differences on the maximum values of the motions and the spectra between the both components can be explained by the fact that the earthquake records were obtained near the fault and that the direction of the fault line was EW.

- The duration of strong shaking was 15-20 seconds.
- ii. The predominant periods in the EW component are 0.4 and 0.7 seconds. The maximum amplification factor is 3.07 for 5% of critical damping at the former peak period.
- iii. The predominant period in NS component is 0.5 seconds, at which the maximum amplification factor is 3.9 for 5% of critical damping.
- iv. The predominant period in UD component is 0.4 seconds, at which the maximum amplification factor is 2.9 for 5% critical damping.
- v. The ratio, A_V/A_h , of the maximum acceleration of UD component to that of horizontal components is 0.32 and 0.44 for EW and NS component, respectively. According to the maximum values observed at the various sites as shown in Fig. 5, the ratio, A_V/A_h , is 0.45 on an average.

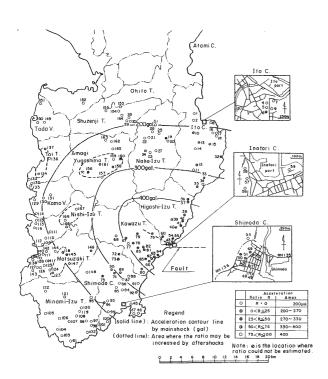
FIGURE 8: LOCATIONS OF 168 CEMETERIES, RATIOS OF OVERTURNING OF TOMBSTONES, AND MAXIMUM ACCELERATIONS ESTIMATED.

Furthermore, Fig. 8 indicates locations of 168 cemeterieswhere overturning of tombstones were carefully surveyed. The figure also shows ratios of the number of tombstones overturned to the number surveyed at each cemetery, and peak accelerations of the main shock estimated in view of those ratios. Fig. 9 compares the strength of the ground motions during the main shock of January 14 and the aftershocks of January 15.

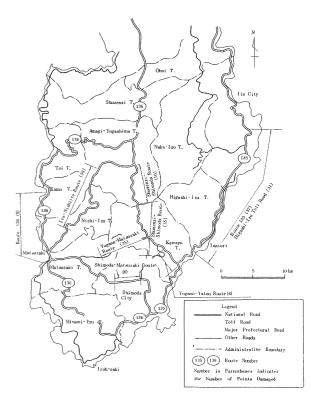
FIGURE 10: DISTRIBUTION OF ROADS DAMAGED

Earthquake damage on road structures were mainly distributed on Route 135 (national road), Higashi-Izu Toll Road and Shuzenji-Shimoda Route (principal prefectural road) as shown in Fig. 10. The areas heavily damaged are considered to be in good agreement with the distributions of maximum acceleration estimated in Fig. 8.
