# ASSESSMENT OF DAMAGE TO THE CEILINGS AND SPRINKLER DOWNPIPES OF AN INDUSTRIAL PLANT FROM THE 2012 7.6MW SÁMARA EARTHQUAKE IN COSTA RICA

Ricardo Roldán<sup>1</sup> and Alfredo González<sup>2</sup>

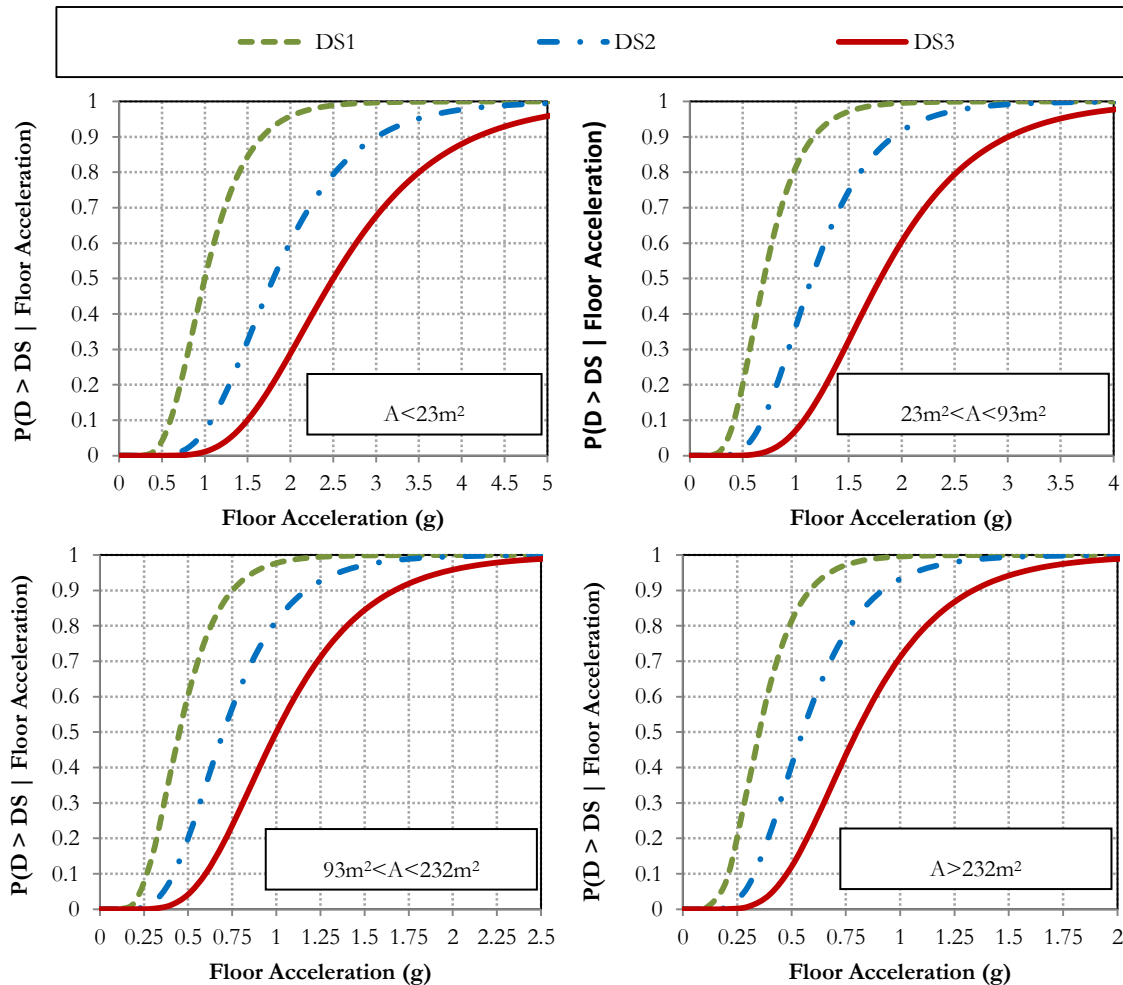
Following the above discussion, and assuming that the roof acceleration was a value between 0.6g and 1.0g, it is apparent that the suspended ceiling system responded as expected, for a ceiling system with the geometry, area and characteristics found *in-situ*. Moreover, as shown in Figure 7 (bottom right), if the roof experienced acceleration values near 1.0g, the ceiling system would have had a 70% probability of exceeding damage state 3. This corresponds to total collapse. Clearly this was not the case, suggesting that the actual acceleration in the roof was less than 0.8g (median value for DS3 for a similar ceiling system according to FEMA [11]).

Figure 7: Fragility curves from FEMA [11] for: ceiling systems under seismic category D/E with lateral and vertical supports for:  $A < 23 \text{ m}^2$  (top left),  $23 \text{ m}^2 < A < 93 \text{ m}^2$  (top right),  $93 \text{ m}^2 < A < 232 \text{ m}^2$  (bottom left), and  $A > 232 \text{ m}^2$  (bottom right).  $A$ =Area.

Moreover, the fragility curves from FEMA [11], shown in Figure 7 and Table 1, suggest that if the CSCR10 recommendation of maximum area without joints of 232 m<sup>2</sup> had been followed, the damage inflicted to the ceiling system would have been smaller provided that the roof acceleration was close to 0.7g.

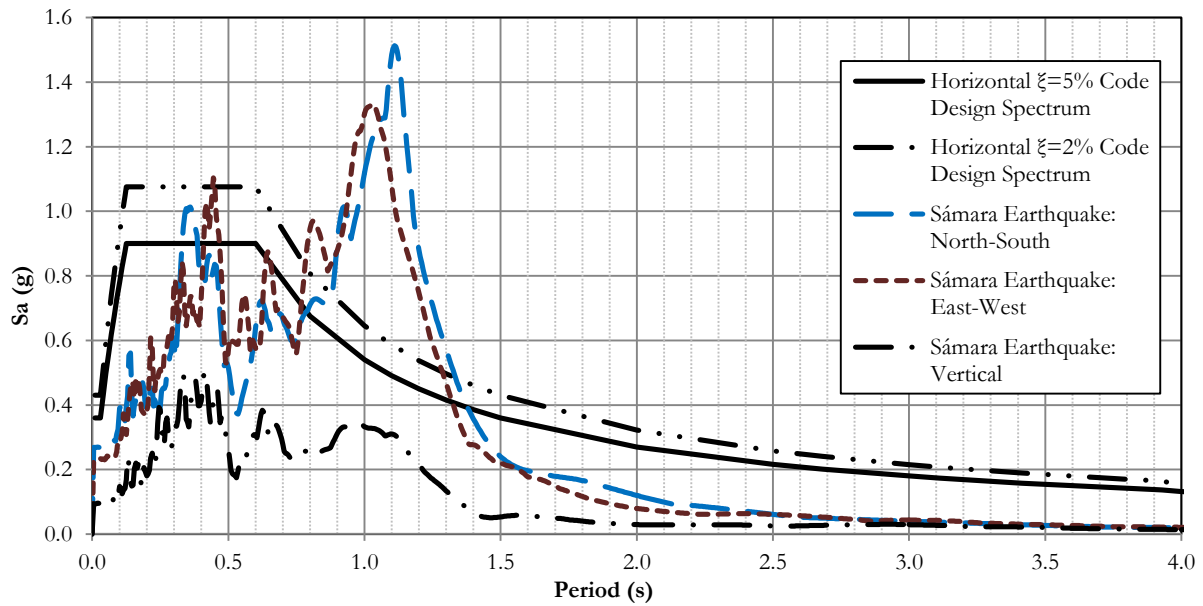
According to the designer of the structure [14], the building has an elastic period in the braced direction of 0.35 +/- 0.05 s. This period range coincides with the plateau of the design spectrum of the site illustrated in Figure 8. The elastic period in the steel frame direction is 0.8 +/- 0.1 s [14].

Since the structure is a 1-storey industrial building, the spectral acceleration from a response spectrum similar to the one shown in Figure 8 represents, in an approximate manner, the floor (roof) acceleration and thus the peak floor acceleration can be estimated from the response spectrum from Figure 8. As such, we estimated that the maximum horizontal spectral acceleration in the building site for the

**Figure 8: Comparison of 2% damped elastic spectra (both vertical and horizontal components) in a seismic station located 13km off the structure with the CSCR10 2% and 5% damped design spectra.**

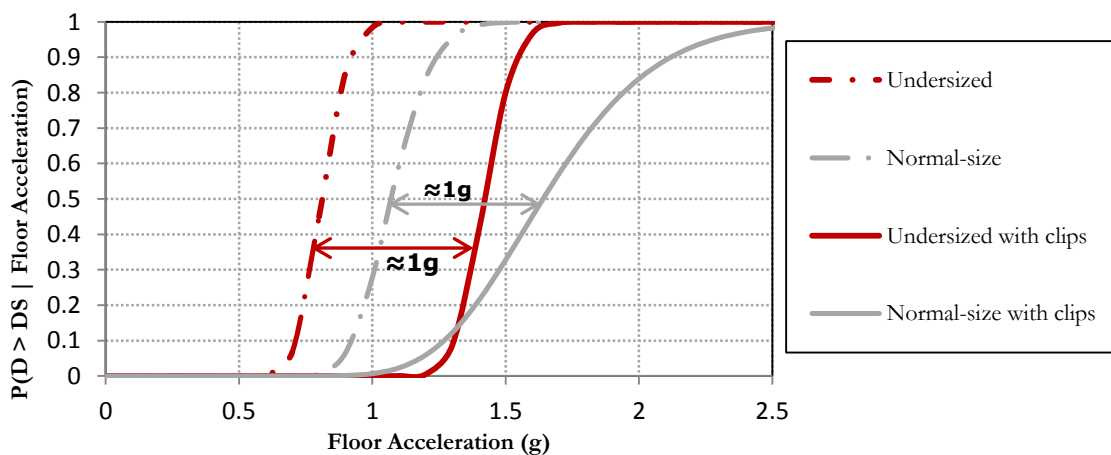
From Figure 9, it is clear that by adding retainer clips, the floor acceleration at which the minor damage state has a 50% probability of being exceeded increases by more than 1.0g and, by all means, is higher than 1.4g even for undersized tiles. Notably, the fragility curve from Figure 9 was developed from shake table experiments for a ceiling system of 24 m<sup>2</sup>, but the fact that the retainer clip highly improves the behaviour for minor damage state is evident. The presence of retention clips can change the response of a 24 m<sup>2</sup> ceiling system from “permissible damage” to “minor damage.”

**Figure 9: Fragility curves from Badillo-Almaraz *et al.* [12] for “minor damage” for ceiling systems of 24 m<sup>2</sup> with compression posts with normal-size tiles, undersized tiles, normal-size tiles with clips and undersized tiles with clips.**

As explained, no retention clips were called for in the drawings and we did not observe any during the visit. After investigating the behaviour of the ceiling system and the study of results from shake table tests [12], it can be concluded that the presence of the retention clips could have helped to drastically reduce the loss of tiles during the Samara earthquake. It is recommended that similar details are specified in future versions of the CSCR.
